TOWN OF WILLISTON

TOWN-WIDE WATERSHED IMPROVEMENT PLAN - PHASE 1

FINAL REPORT

Stone Project ID 12-055

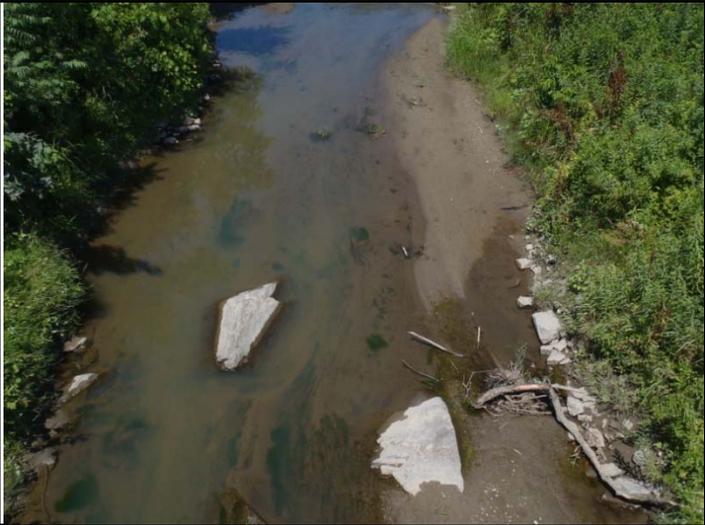
<p>Photo 1. Evidence of significant sedimentation</p>	<p>Photo 2. Downstream view of River Cove Road bridge during flood stage (4/28/2012)</p>

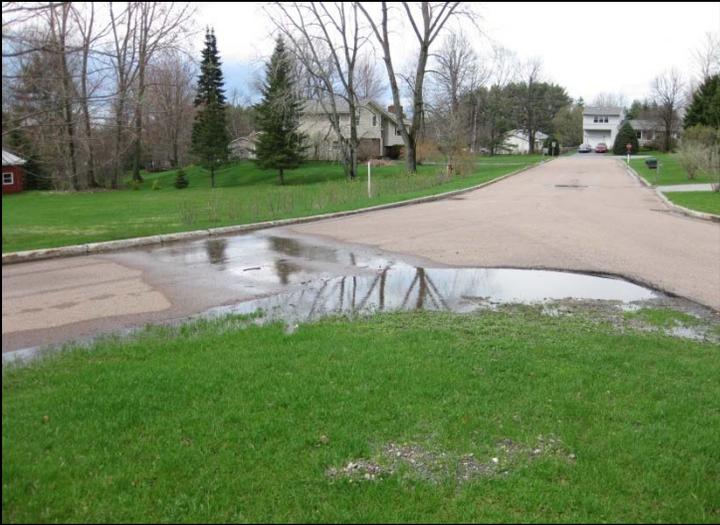
Photo 2. Runoff ponding in the cul-de-sac and overflowing to the north along Palmer Court.

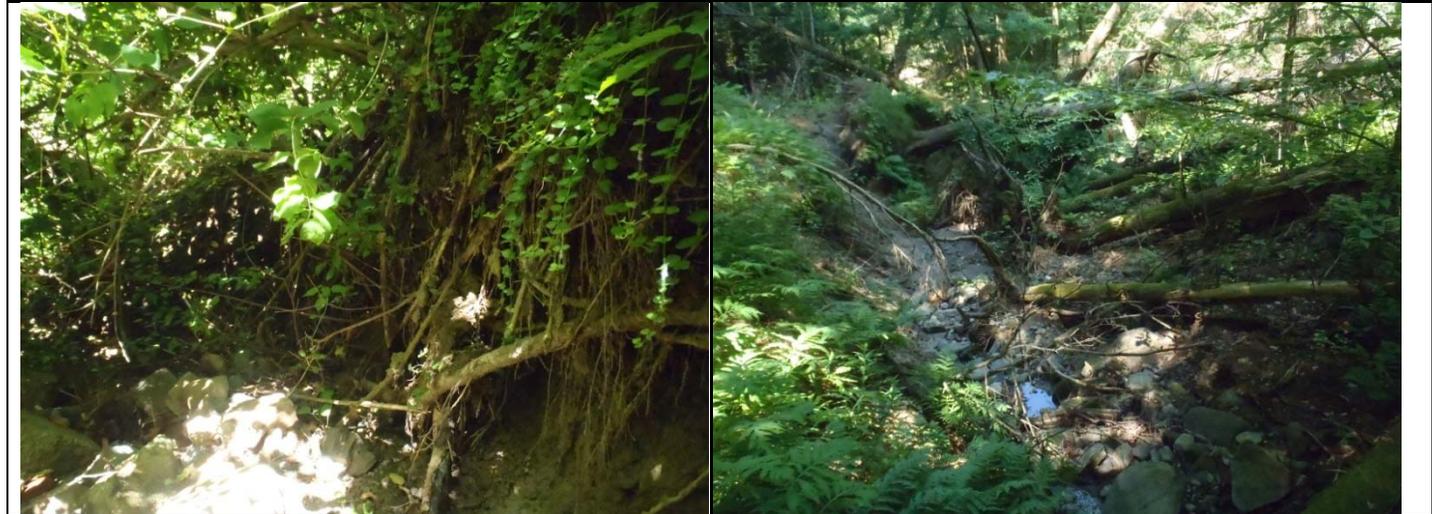
Photo 3. Overgrowth and undercutting **Photo 4.** Mass failure on approach to Allen Brook

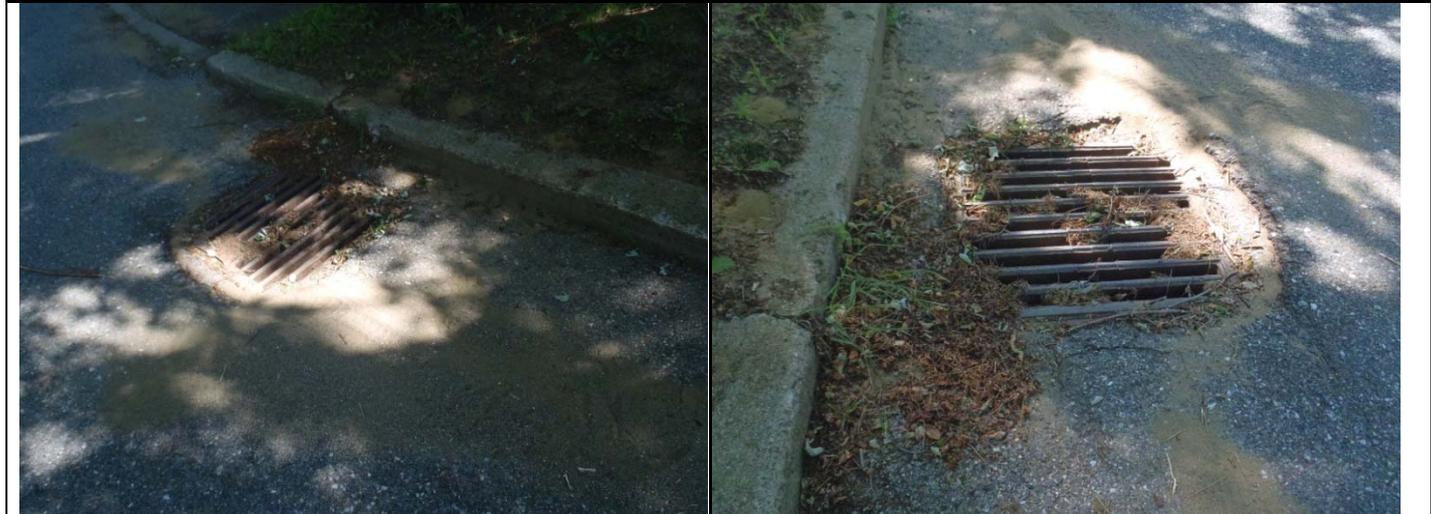
Photo 1. **Photo 2.** Debris accumulated at catch basin inlet

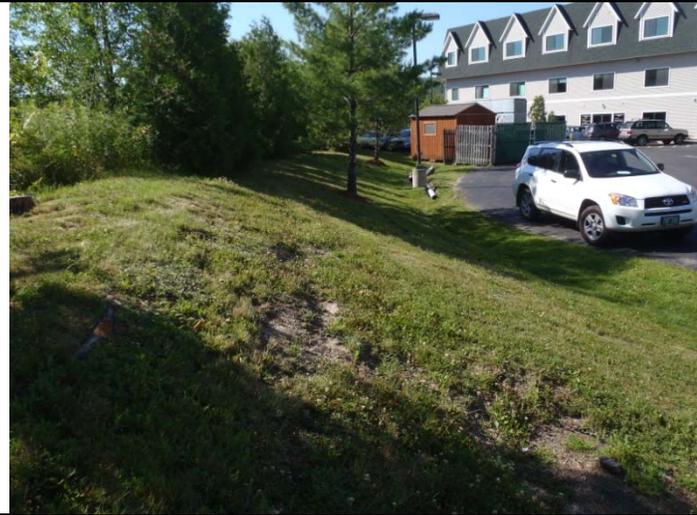
Photo 1. Water Damage

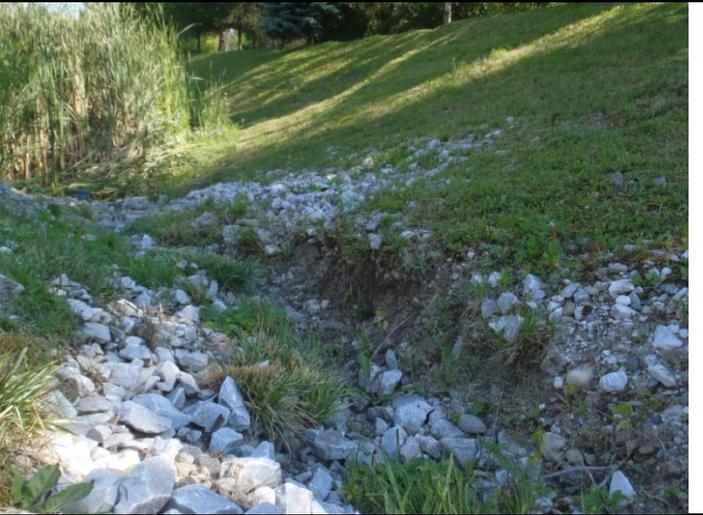
Photo 2. Channeling in rip rap

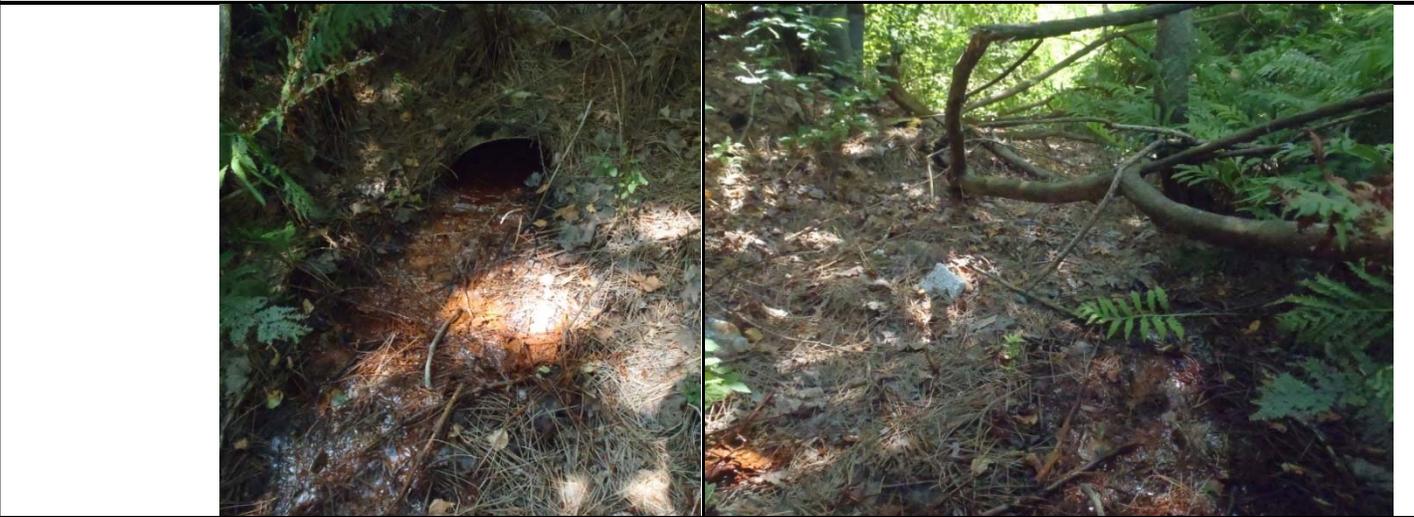
Photo 1. Blocked outfall, iron staining

Photo 2. Gully above outfall

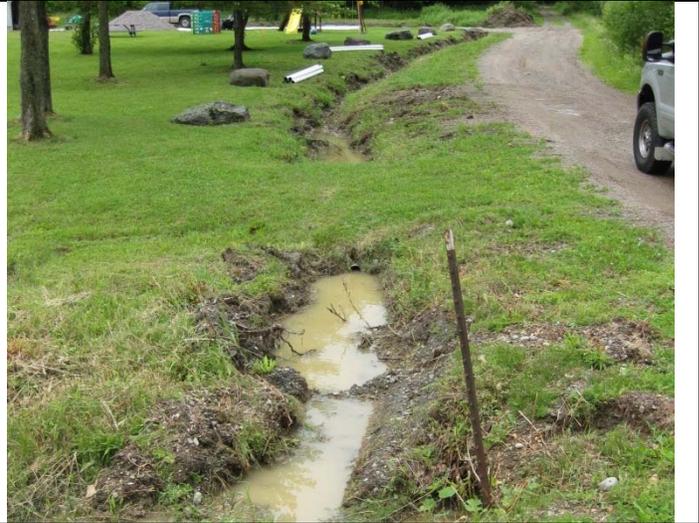
Photo 2. Water ponding along Amber Lane

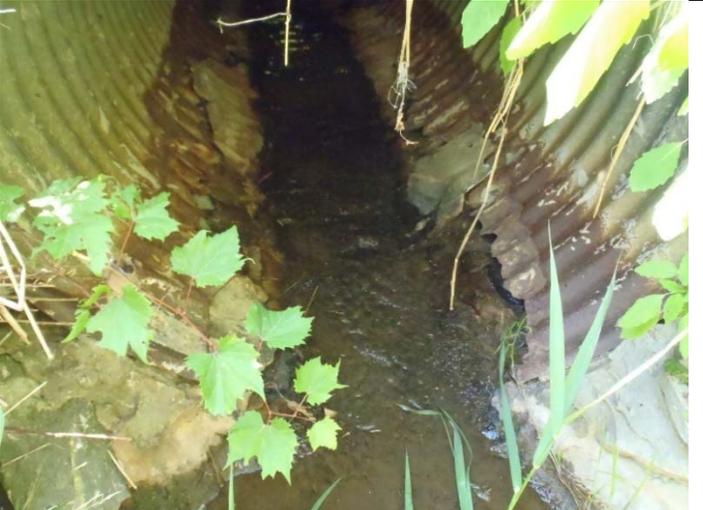
Photo 1. Inlet, grass on sides matted down	Photo 2. Deteriorated culvert

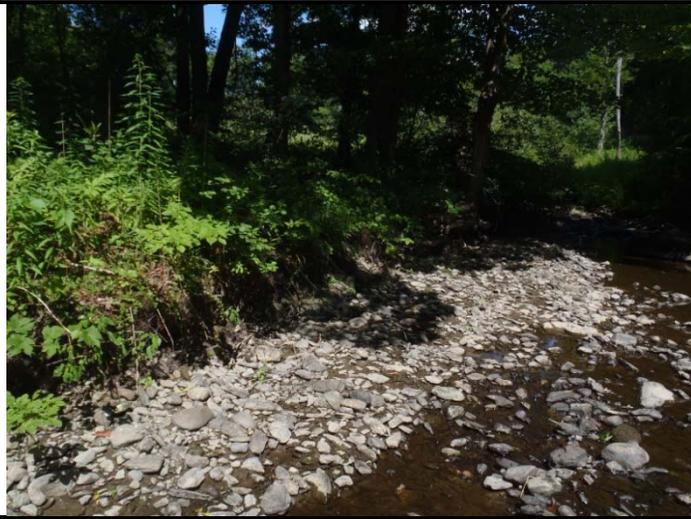
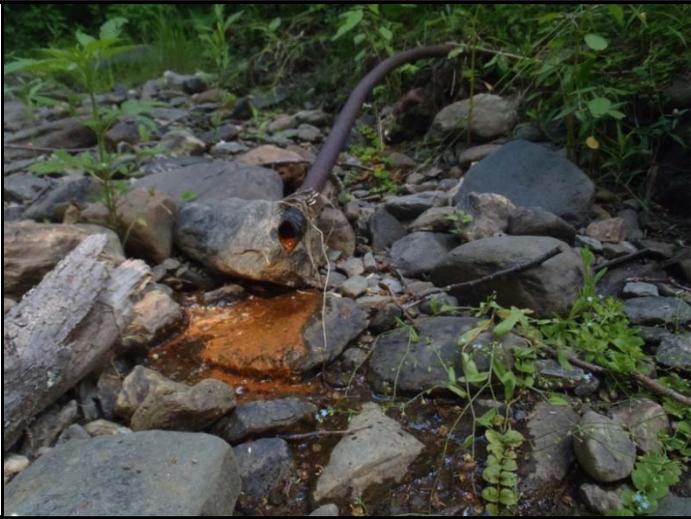
Photo 1. Bank cutting	Photo 2. Old metal pipe outlet

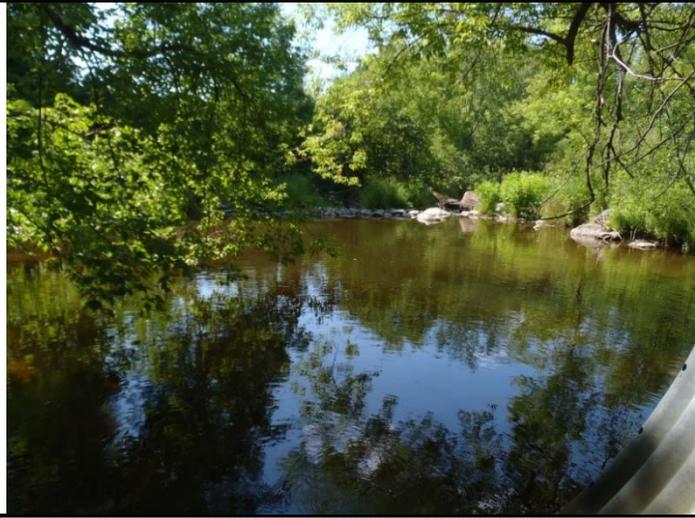
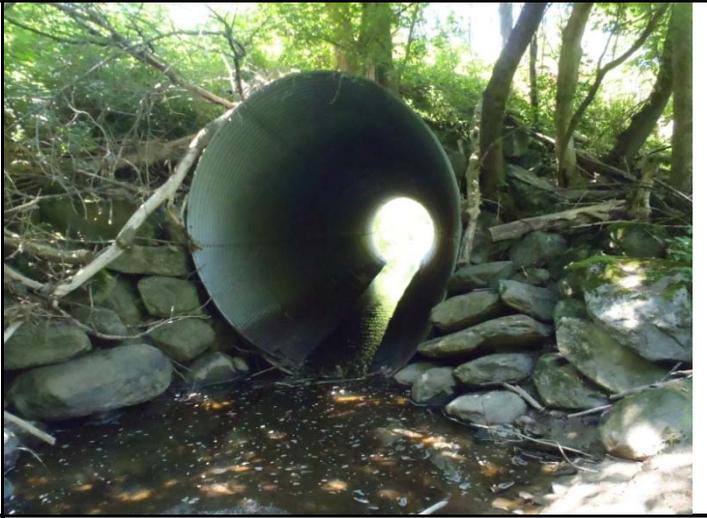
Photo 1. Large scour pool	Photo 2. Inlet, with possible undermining

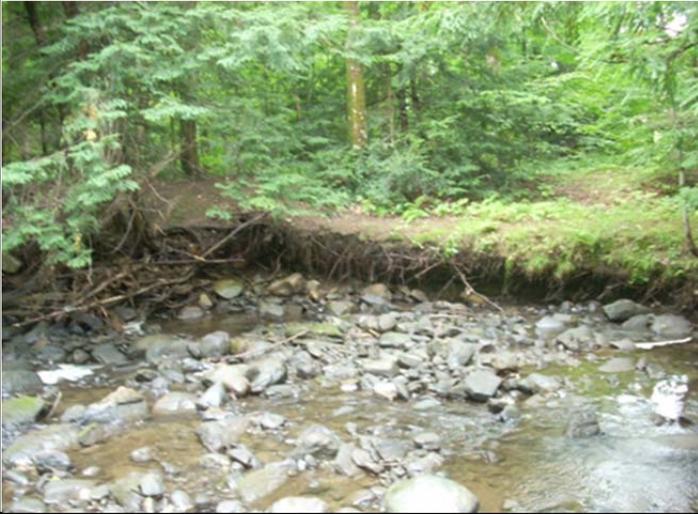
Photo 1. Streambank has been undermined	Photo 2. Localized bank collapses

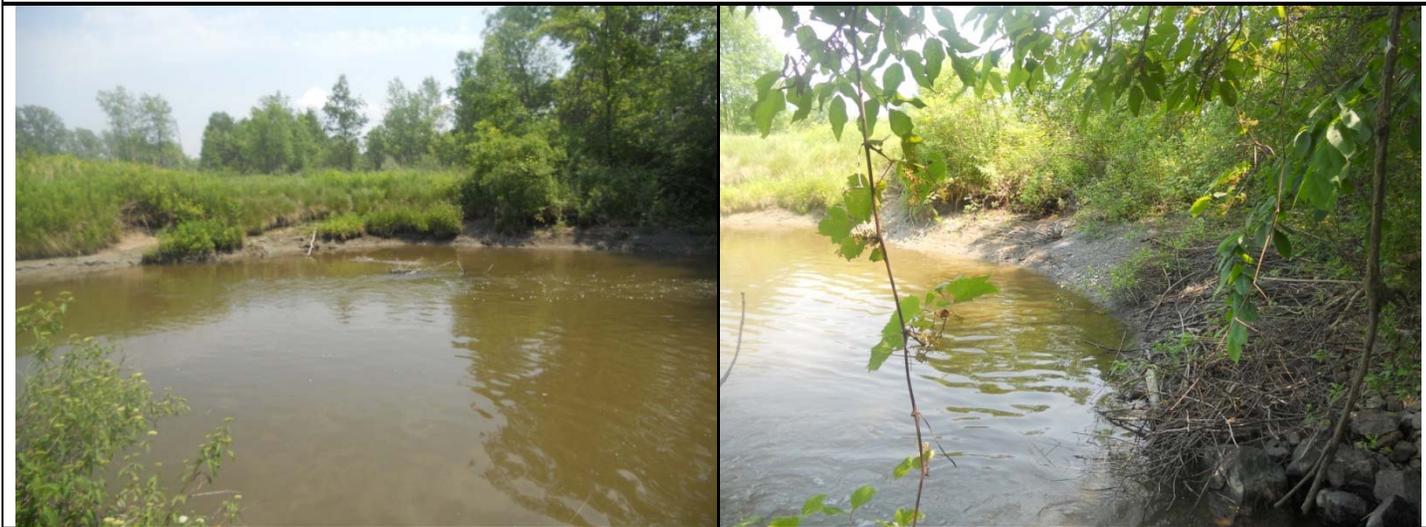
Photo 1. Scour pool at outfall

Photo 2. Bank scouring

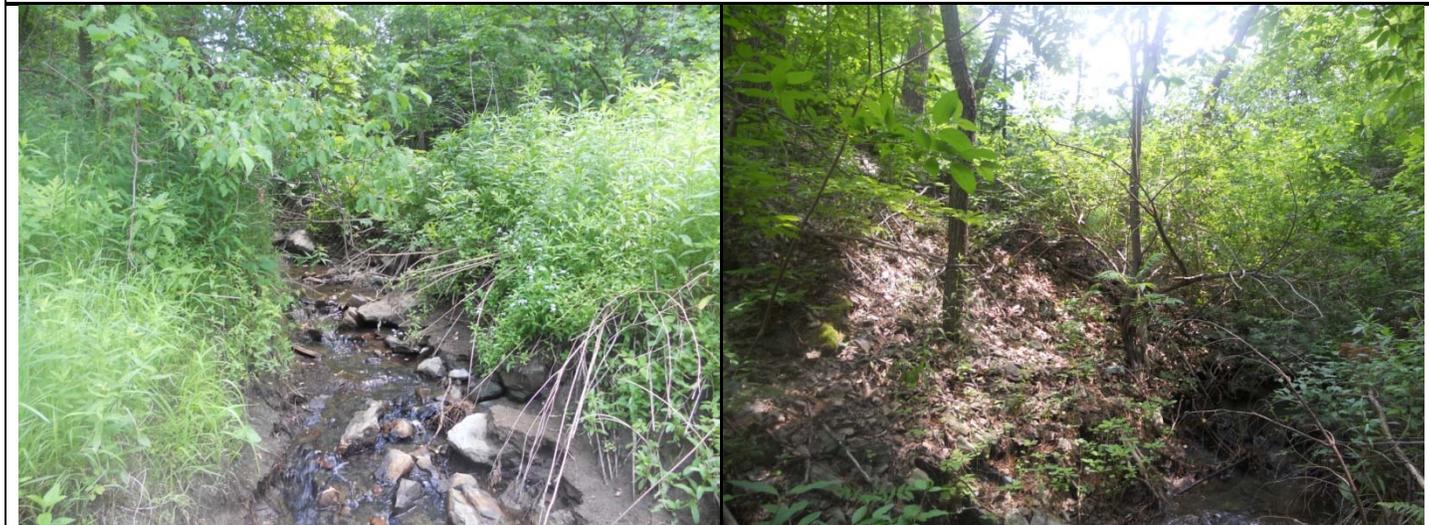
Photo 1. Bank erosion in tributary **Photo 2.** Steep bank leading into tributary

Prioritization Ranking Factors							
Relative Impact	Frequency	Current Condition	Urgency	Impact to public infrastructure?	Realistic to fix?	Impacts beyond water resources?	Part of a larger or systemic problem?
2	1	1	1	No	No	No	Yes
Relative Impact: Minor, but on-going, erosion present at toe-of-slope.

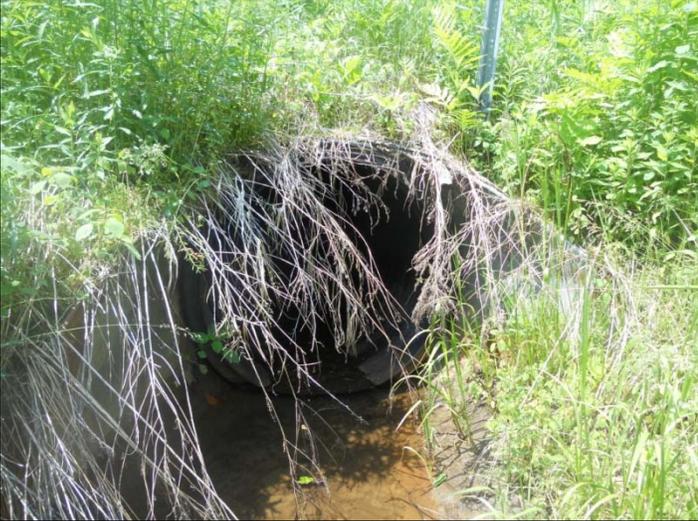
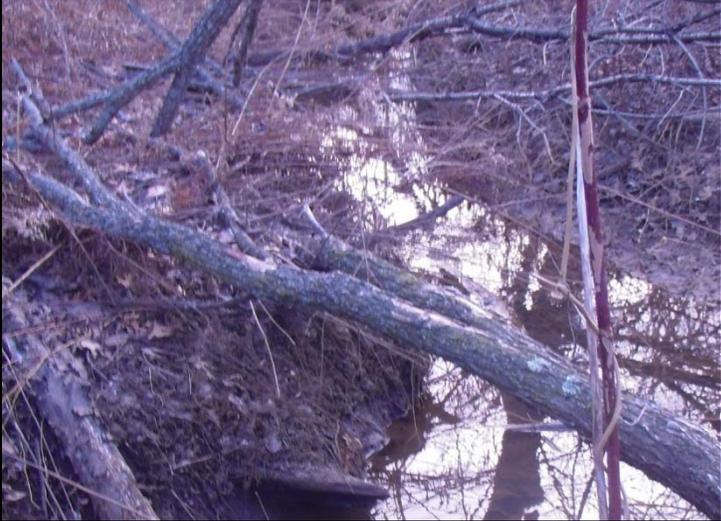
Description of Observed Conditions:
 36" black plastic corrugated culvert carries unnamed tributary under Marshall Ave. Culvert is undersized and is causing erosion upstream and downstream. A headcut has formed downstream of the Marshall Avenue crossing. The headcut does not appear to be migrating rapidly upslope, but increasing urbanization in the upslope watershed may make the stabilization of this feature a higher priority.

Photo 1. Existing 36" plastic culvert	Photo 2. Incised channel

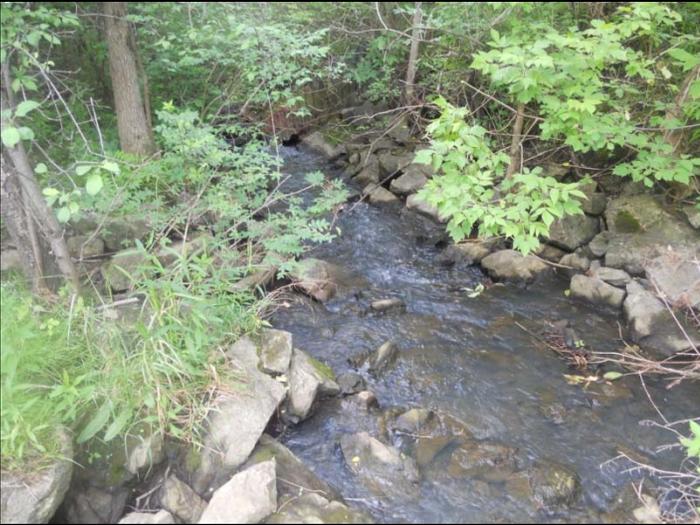
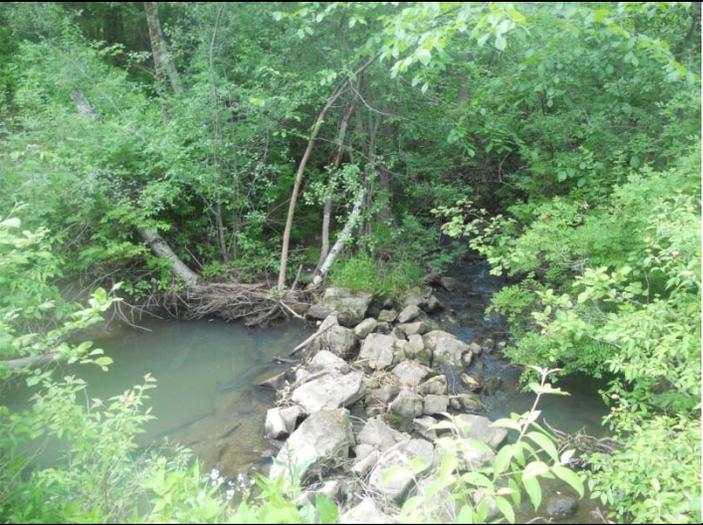
Photo 1. Downstream view towards culvert	Photo 2. Upstream rock weir causing pooling

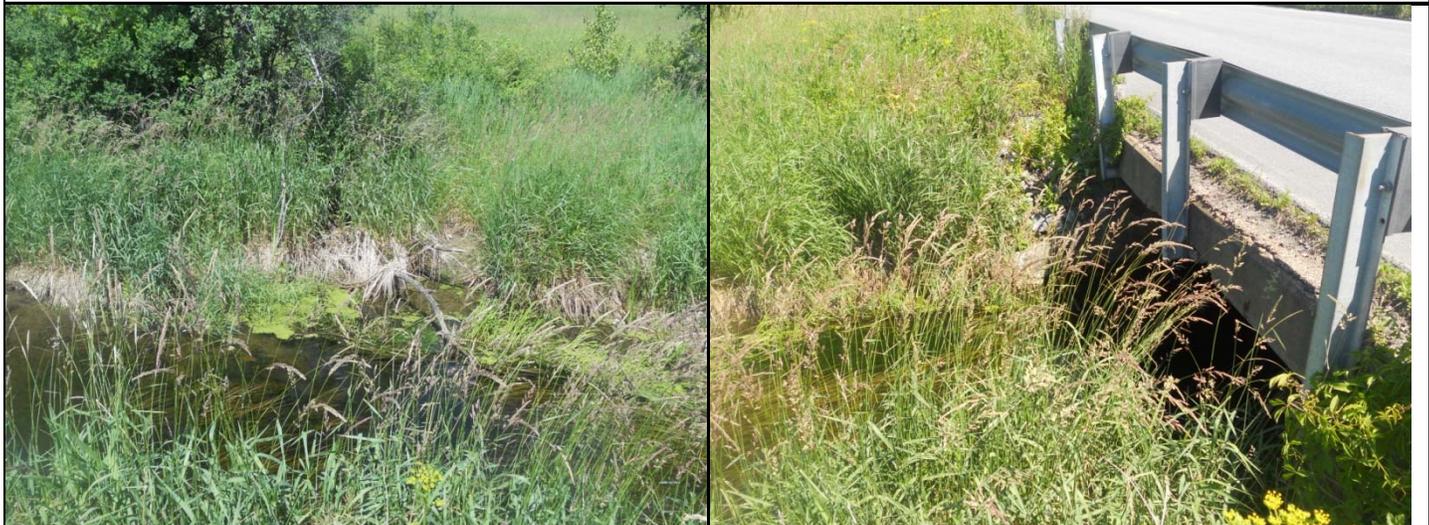
Photo 1. Upstream bank scouring

Photo 2. Entrance to bridge

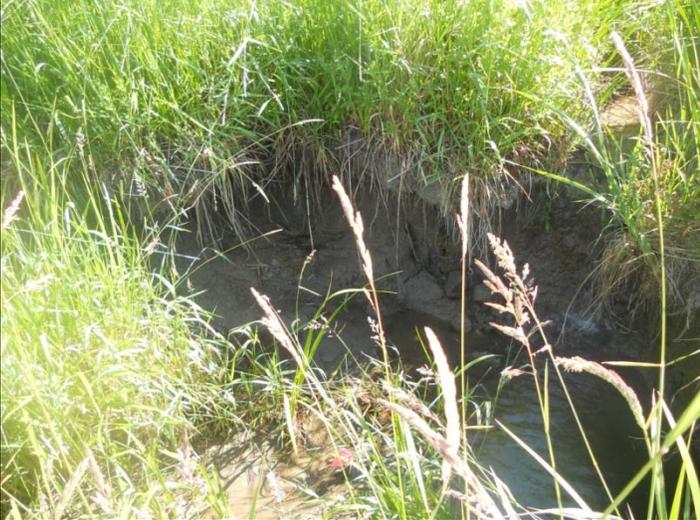
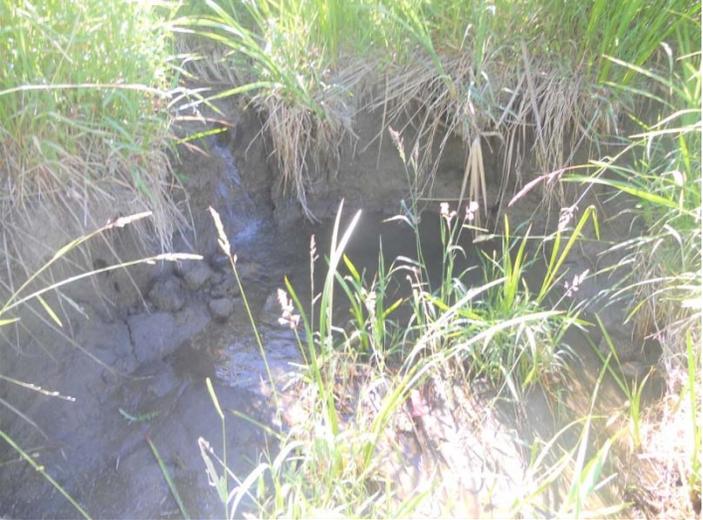
Photo 1. Bank erosion	Photo 2. Head cut

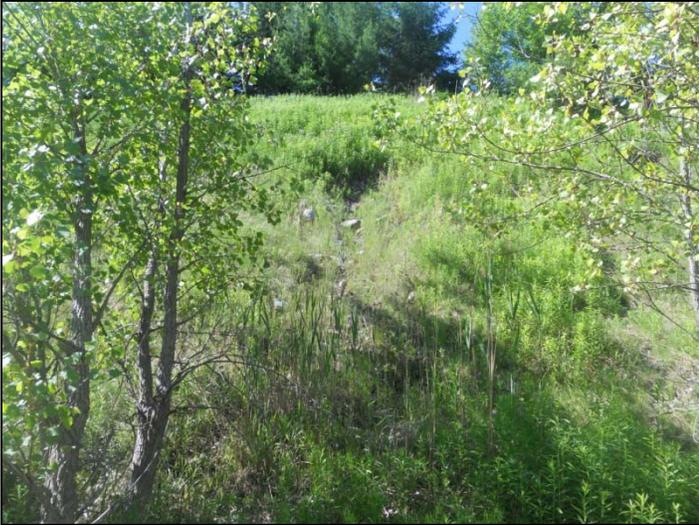
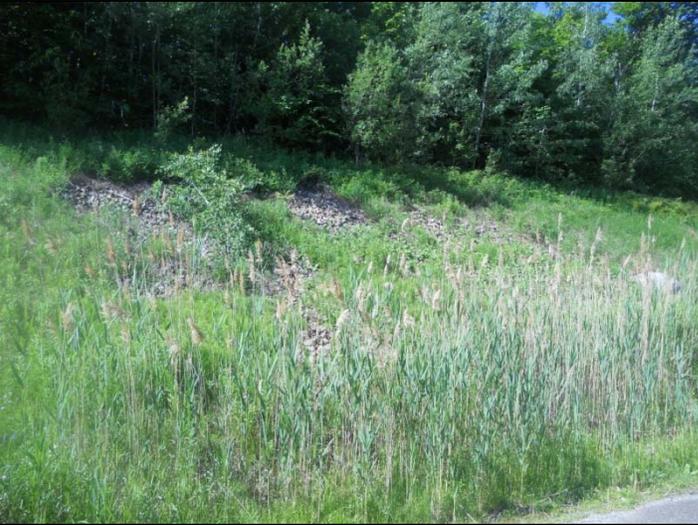
Photo 1. Gullying behind Home Depot	Photo 2. Bank armor behind Wal-Mart

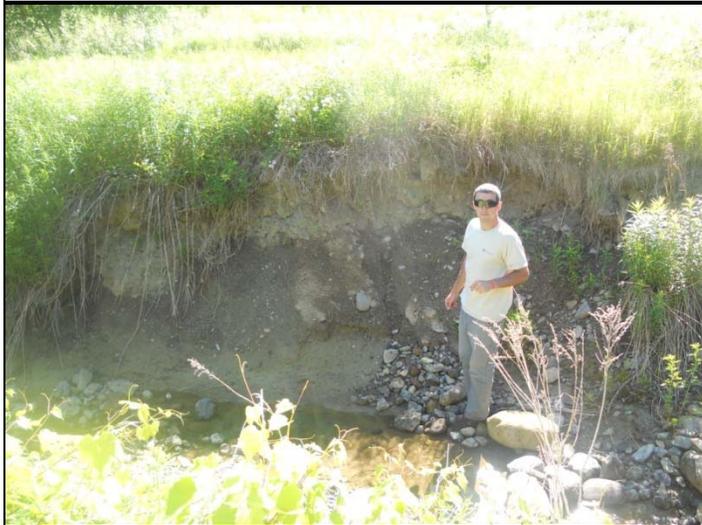
Photo 1. Under cutting

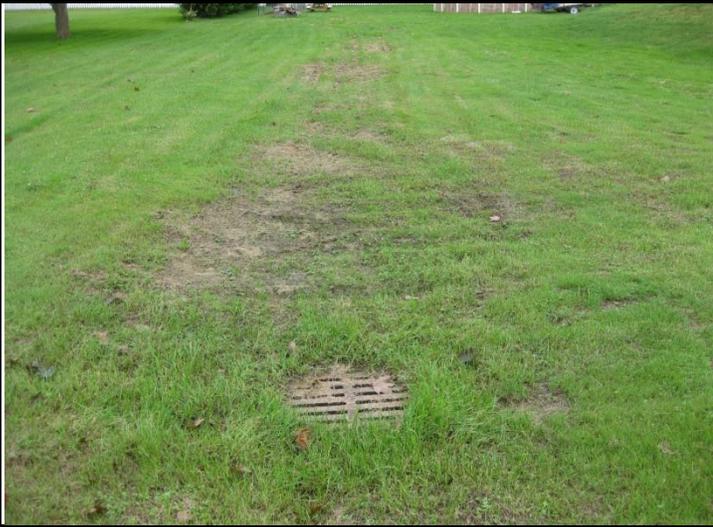
Photo 1. Evidence of overland flow and poor drainage

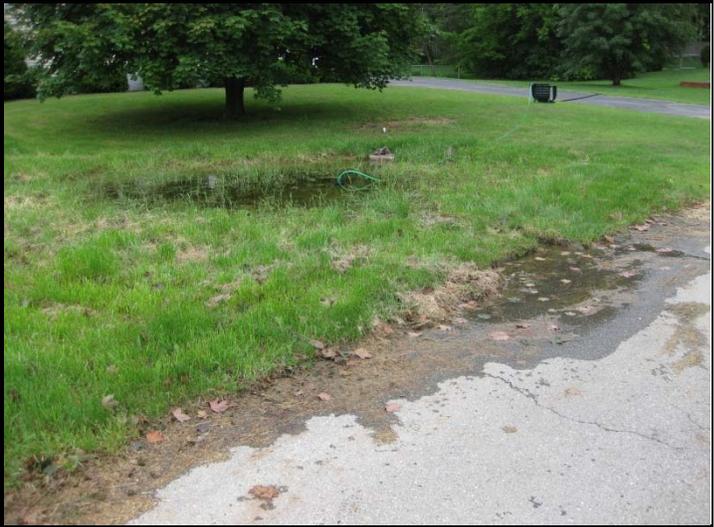
Photo 2. Standing water, as reported by local residents

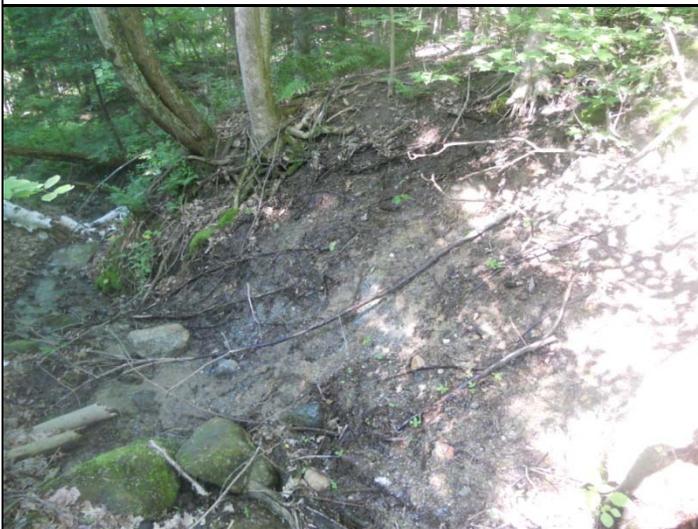
Photo 1. Bank erosion in channel

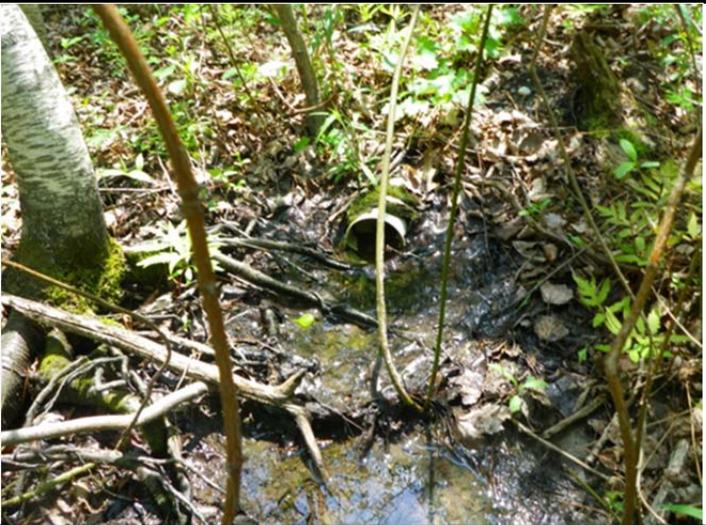
Photo 2. Primary source of runoff.

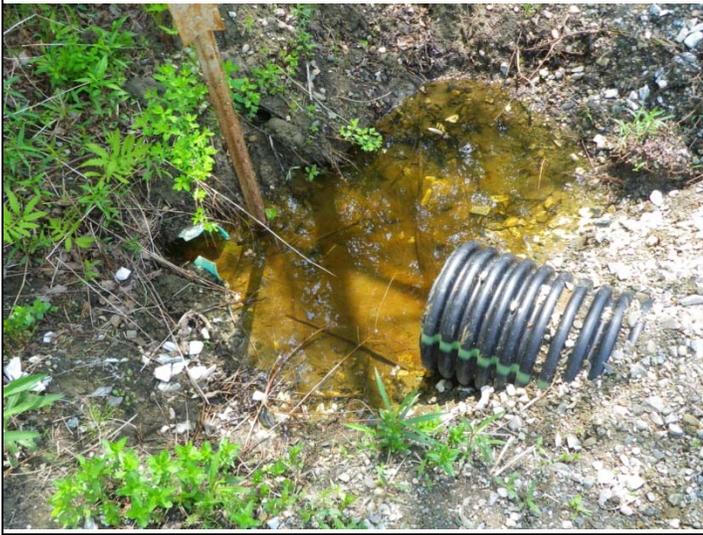
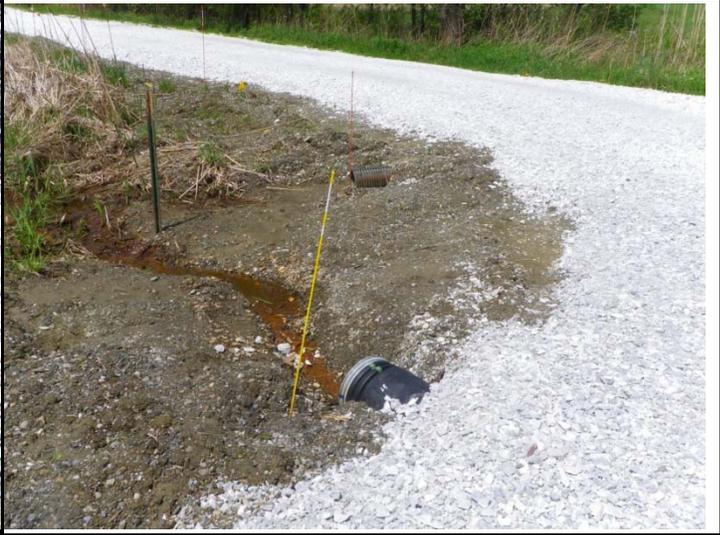
Photo 1. New 12" culvert flowing into small 6" pipe	Photo 2. New culverts

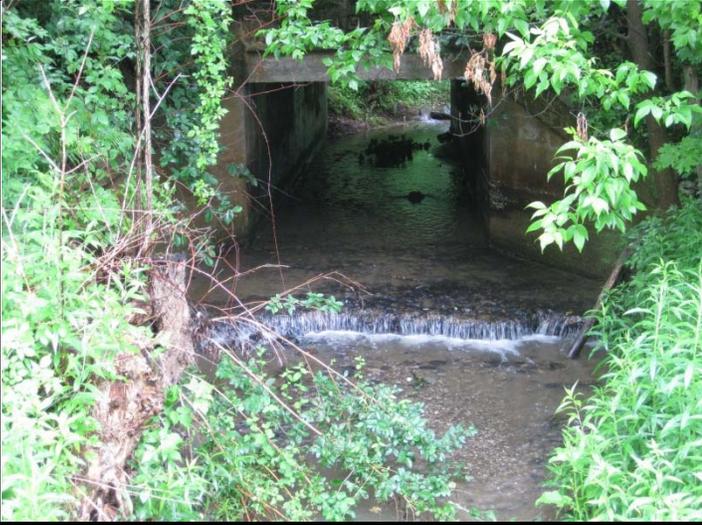
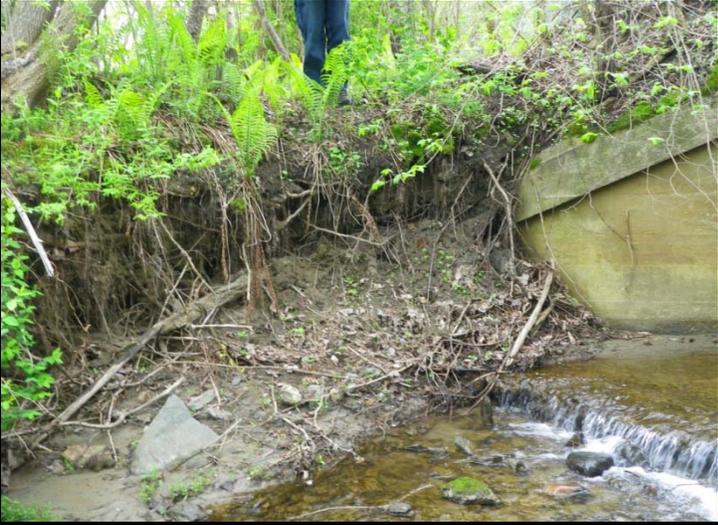
Photo 1. Headcut at the outlet of box culvert under railroad bed.	Photo 2. South bank undercutting

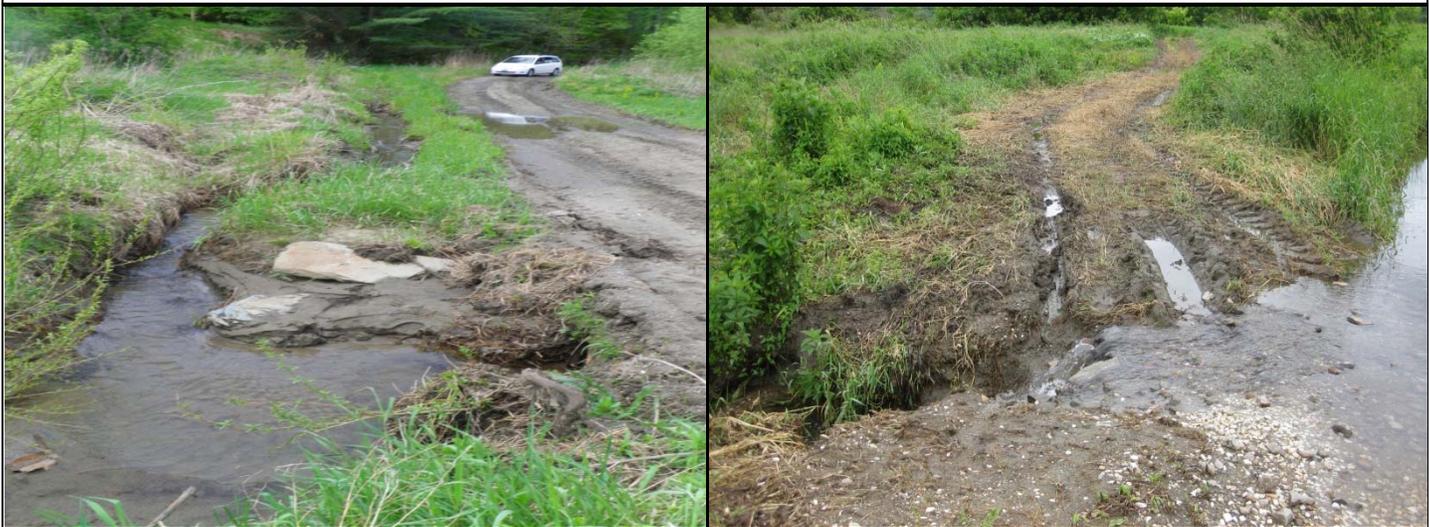
Photo 1. Straightened stream flowing to culvert **Photo 2.** Erosion occurring at the discharge point.

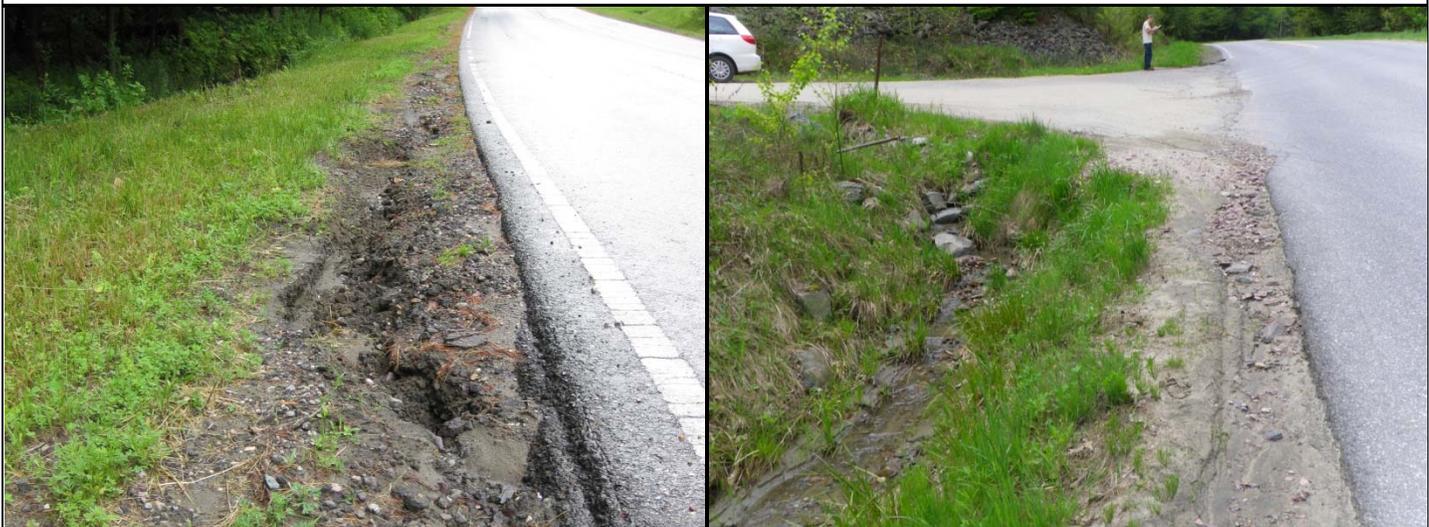
Photo 1. Road decay along No. Williston Road

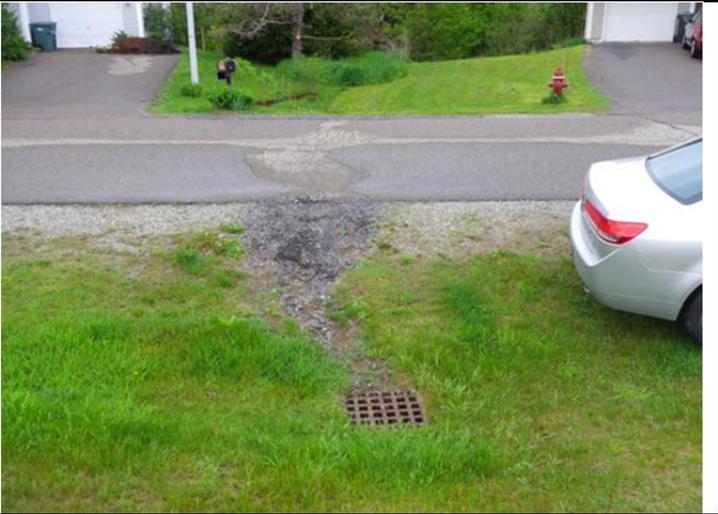
Photo 2. Soil/Rock depositing at "mid-circle" catch basin
