Sucker Brook Watershed Report: Phase 1 and 2 Stream Geomorphic Assessment Summary

September 25, 2007

DRAFT

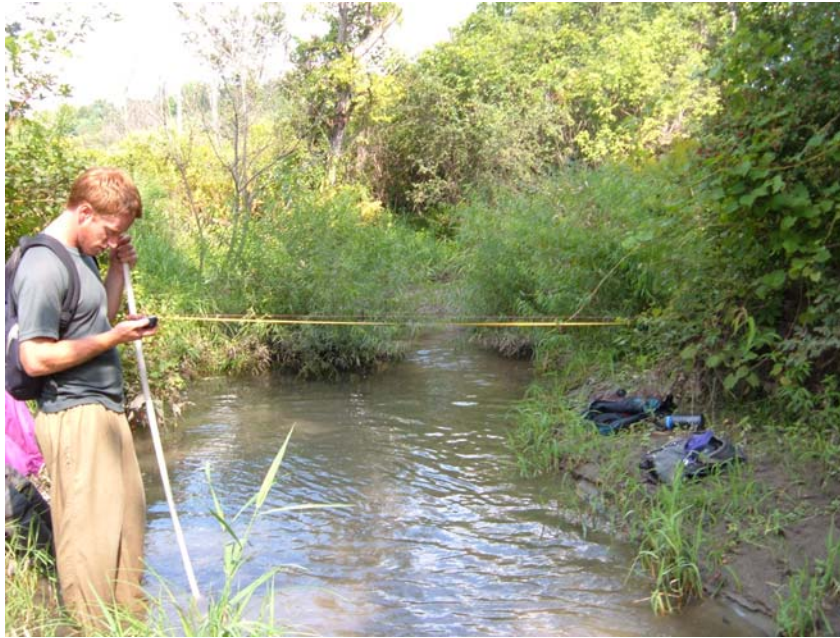
Reach M02 is found from the confluence with a minor tributary entering from the south up to a change in valley slope and confinement approximately 500 feet upstream from the South Brownell Road crossing. This reach has E-type geometry (Rosgen, 1994; Figure 1) with sand substrate, dune-ripple bedform (Montgomery and Buffington, 1997) and a channel slope of 0.2 %. Some ponding was noted in the lower section of the reach due to a large beaver dam in downstream reach M01. The current channel conditions of this reach are relatively stable, with limited evidence of incision from the historic straightening (stage I of channel evolution). Rapid Geomorphic Assessment (RGA) and Rapid Habitat Assessment (RHA) scores were in the good range for this reach. The culvert beneath South Brownell Road (18 feet diameter) represents only a minor constriction of the channel (width of 21 feet), with no aggradation or

Figure 1. Cross-section for Reach M02

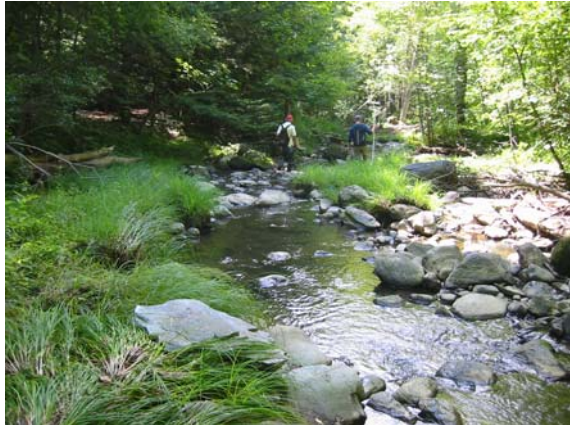
Figure 2. Stable plane bed features in Reach M03

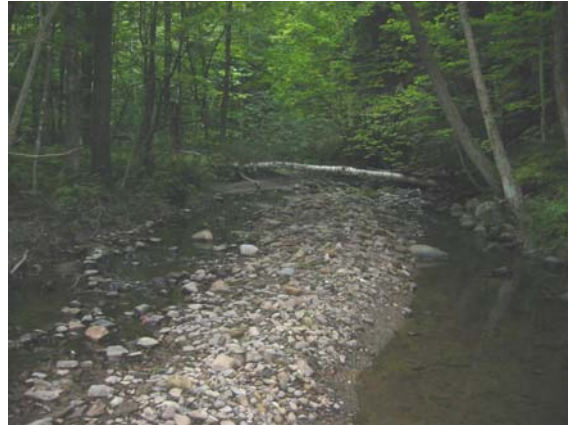
Reach M03 is found from the break in slope up to a change in buffer conditions from forested to herbaceous and shrub-sapling. This reach has a length of 2275 feet with an overall channel slope of 1.3% which supports a stable riffle-pool and planebed system with cobble and gravel substrate (Figure 3). Significant aggradation was noted in the lower section of the reach where a large mid-channel bar has formed prior to a 90 degree bend in the channel. This feature is causing minor widening and bank erosion in this area, but it is isolated to a 200 foot section of the channel. Upstream of this feature, stable riffle-pool and planebed features were observed. Rapid Geomorphic Assessment (RGA) and Rapid Habitat Assessment (RHA) scores were in the good range for this reach, and channel evolution stage was assessed at stage III due to the minor aggradation and widening observed in the lower reach. Due to the limited impacts and channel adjustments observed for this reach, no project identification summaries

Figure 3. Mid-channel bar in lower Reach M03

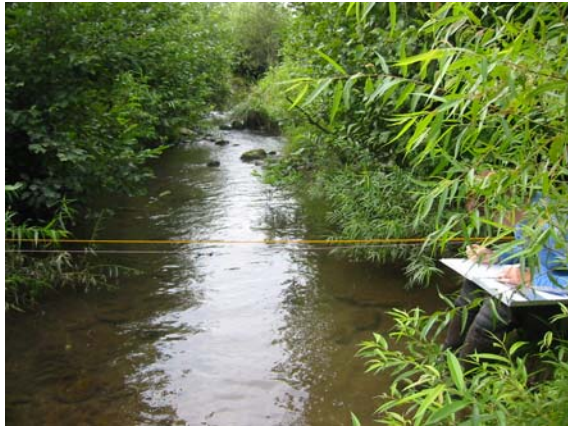
Figure 4. Riffle-pool bed features in Segment M04-A

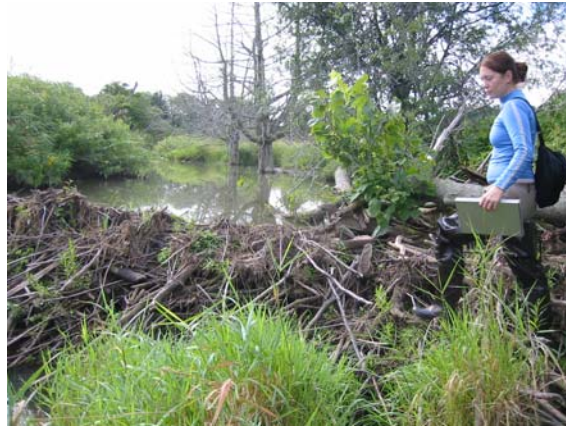
Figure 5. Large beaver dam in Segment M04-B

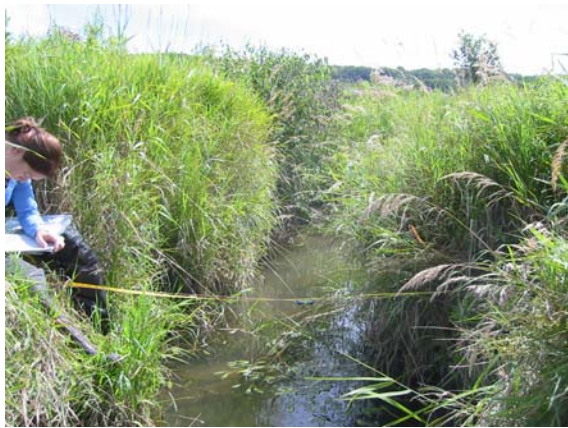
Reach M05 is found from approximately 1000 feet downstream of the mainstem crossing of Route 2A up to where a minor tributary enters from the north. This reach has E-type geometry (Figure 6) with sand substrate, dune-ripple bedform and a channel slope of 0.3%. Some ponding was noted in the lower section of the reach due to a large beaver dam in downstream reach M01. The current channel conditions of this reach are relatively stable, with limited evidence of incision from the historic straightening. These conditions have resulted from an evolution of channel planform and slope, and much of the lower reach is now stable (stage V of channel evolution). Rapid Geomorphic Assessment (RGA) and Rapid Habitat Assessment (RHA) scores for this reach were good and fair, respectively. The culvert beneath South Brownell Road (7 feet diameter) represents only a minor constriction of the channel (width of 8 feet), with only limited scour noted in the vicinity of the structure.

Figure 6. Cross section in M05

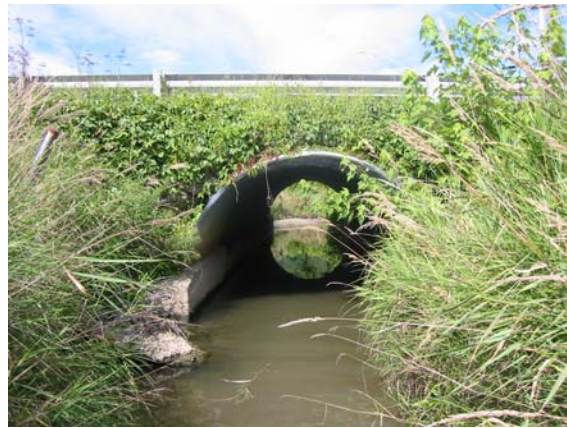
Figure 7. Culvert beneath Route 2A

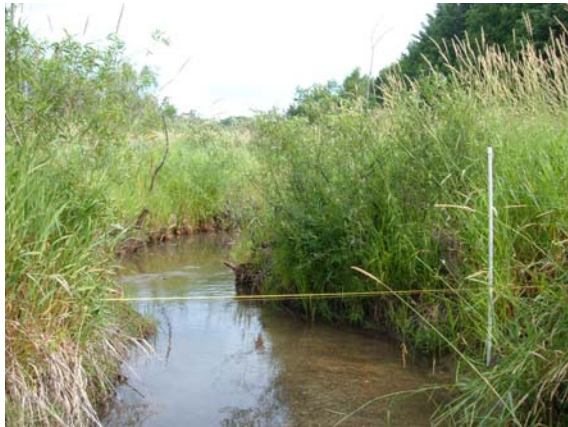
Reach T1.01, the first reach on the north branch tributary, is found from the north branch confluence with the mainstem up to a driveway approximately 1300 ft north of Ridge Rd. This reach has E-type geometry with gravel substrate, riffle-pool bedform and a channel slope of 0.7% (Figure 8). Significant incision was observed in two areas in the reach: 1) in the lower section below the Route 2A crossing where the channel; 2) approximately 500 feet upstream of the Ridge Road crossing. The incision (incision ratio > 1.5) below Route 2A is resulting from an undersized culvert (8.5 feet diameter; channel width = 13 feet) which is restricting the transport of fine gravel through the structure. Upstream of Ridge Rd the channel is downcutting through previously aggraded material (Figure 9) delivered from the avulsion in upstream segment T1.02-B. In between these two areas of incision the channel is in fair condition with limited adjustments, but the overall reach geomorphic stability and habitat conditions have been assessed as fair (channel evolution stage is II).

Figure 8. Cross section in lower T1.01

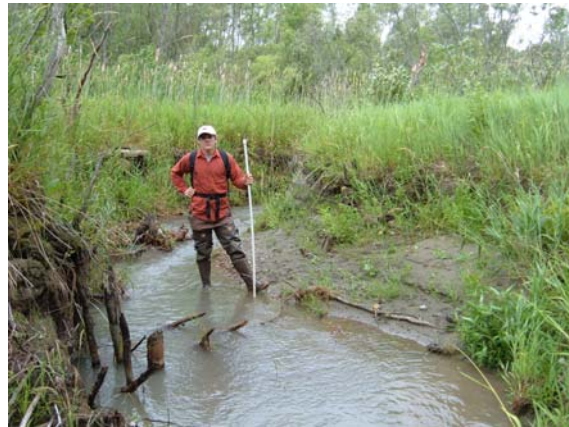
Figure 9. Channel incision in upper T1.01

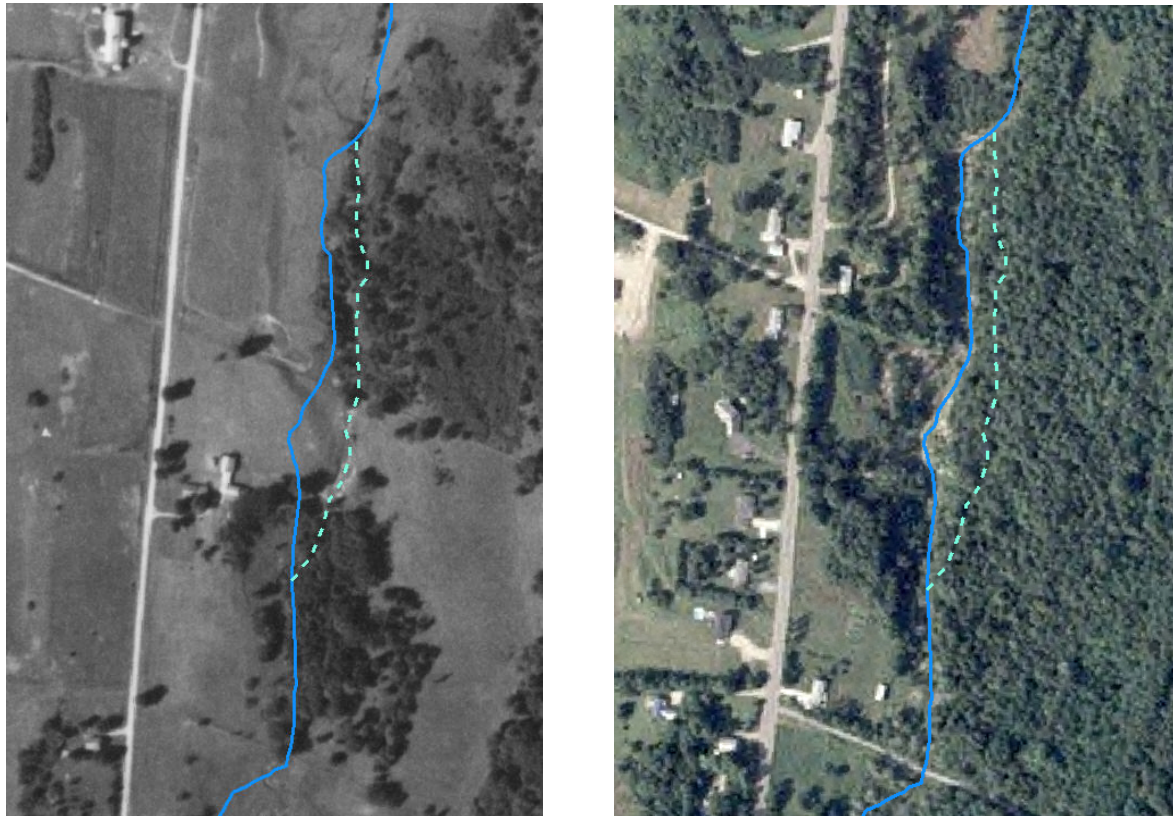
Reach T1.02 was delineated during the Phase 1 analysis to encompass the site of the channel avulsion and subsequent restoration effort. This reach is found from a driveway crossing at the reach break with T1.01 up to approximately 250 feet above LaClair Road. This channel position has shifted to the west by 150 feet in some locations, as seen in Figures 10 and 11. Under reference conditions, this reach had a channel slope of 4.4%, which likely supported a B-type channel with step-pool morphology and cobble substrate. In the 1980's an extreme flood event moved the channel into a new location through an old gravel pit underlain with sands and clays. Since the avulsion, the channel has deepened to form a 40 foot gully, delivering approximately 72,000 cubic yards of material to the downstream reaches. VTANR

considers this one of the worst channel avulsions known to Vermont (Dubois and King, 2007). Today, the gully is the site of an extensive restoration effort to stabilize the channel through the installation of rock weirs and large substrate to control the vertical adjustments.

Figure 10 & 11. Aerial photographs of the channel avulsion site from 1937 (left) and 2003 (right). The current channel location is shown in solid blue, and the 1937 channel location in dashed blue.

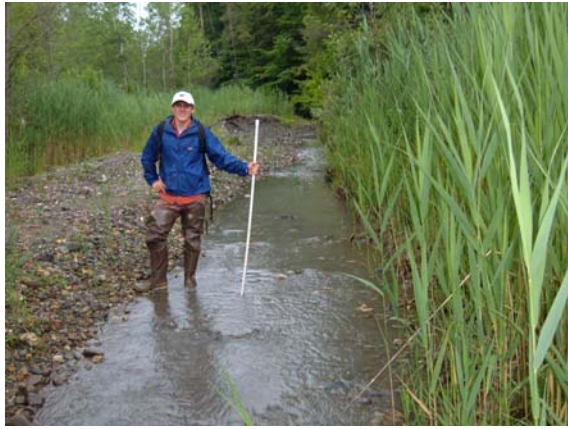
Figure 12. Above 48 inch culvert in lower Reach T1.02

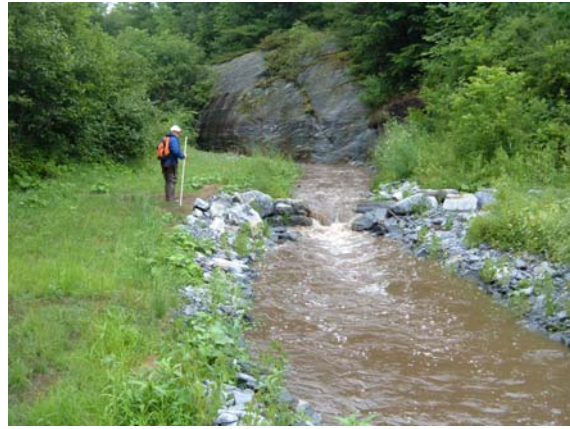
During the Phase 2 assessment of this reach in 2007 by FEA, only the area downstream of the restoration site was accessible for evaluation. The reach was segmented to capture the current channel dimensions below the restoration site, which have undergone a change from B-type channel geometry to C-type geometry due to the aggradation of sediment from above and the redevelopment of a narrow floodplain within the confined valley setting. Segment A is located from the downstream reach break at the driveway crossing up 675 feet to the site of the historic waterfall. This segment is characterized by a C-type stream with riffle-pool bedform and gravel substrate. RGA and RHA scores indicate a reach in fair conditions, with the channel evolution processes reflecting the aggradation and redevelopment of sinuosity (stage IV). Large amounts of coarse material are periodically removed from the channel at the downstream area to avoid flooding at a 48 inch culvert beneath a driveway (Figure 12). Within the channel restoration site, numerous rock weirs are being installed to return the channel to its stable dimensions with B-type geometry and step-pool bedform (Figure 13).

Figure 13. Channel restoration site in upper T1.02

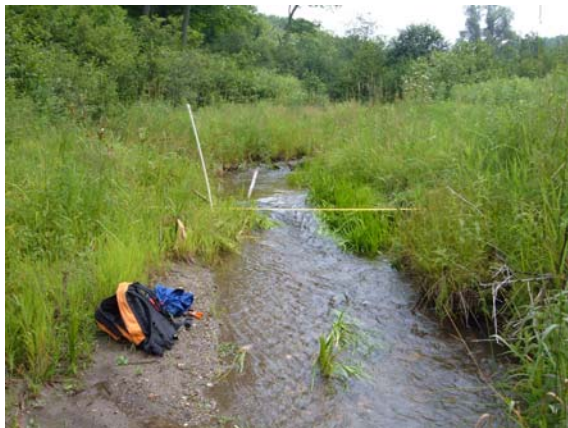
Reach T1.03 is found from the upstream end of the channel restoration site up to a break in slope approximately 600 feet west of the end of Lyman Road. This reach has a channel length of 3170 feet and a slope of 0.95%. It is found in an unconfined valley with limited local impacts from development, and exhibits a stable riffle-pool form with C-type geometry and a sinuous planform (Figure 14). One area of straightening and buffer encroachment in the lower reach has impacted habitat conditions. However, overall the reach has good to excellent stability and geomorphic habitat conditions (channel evolution stage of I).

Figure 14. Cross section in Reach T1.03

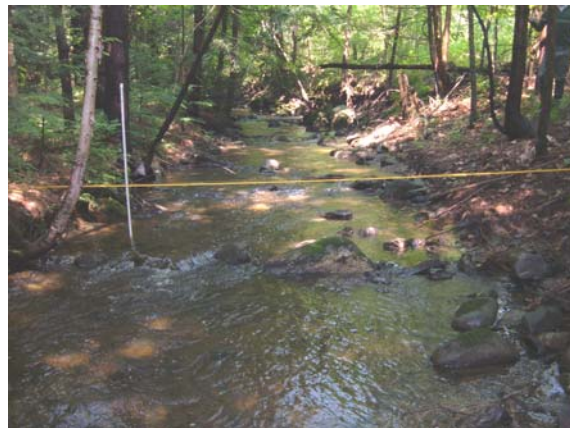
Figure 15. Cross section in lower Segment T1.04-A

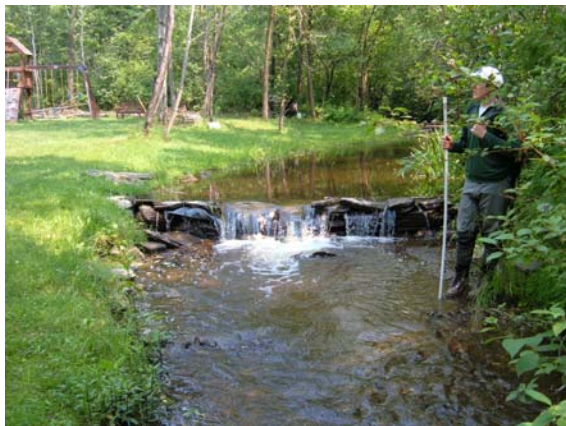
Figure 16. Rock weir in lower Segment T1.04-B

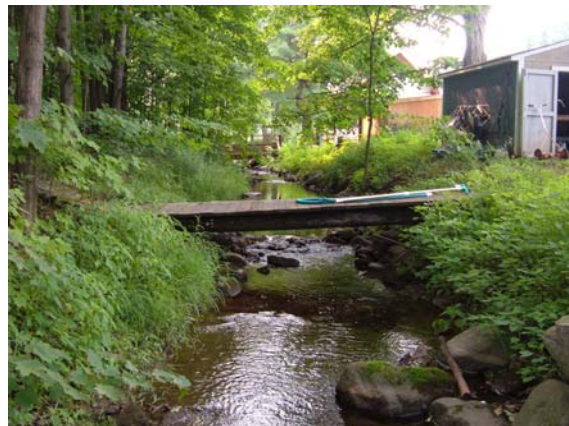
Figure 17. Corridor encroachment in T1.05-A

Segment T1.05-A is found from the crossing at Old Creamery Road up to a change in channel slope 200 feet downstream of the Nob Hill Road crossing. This segment has a length of 1160 feet and C-type channel geometry. The stream channel and corridor have been highly impacted along this segment where the residential land use has altered the buffer and channel boundary conditions (Figure 17). Many areas along this segment lack a woody vegetative

buffer greater than 25 feet, and numerous rock weirs have been placed in the stream for aesthetics, resulting in aggradation above these structures. The depositional features are causing widening upslope, resulting in fair geomorphic stability and habitat conditions. Channel evolution processes have also been assessed in stage III for this segment.

The two segments in between the Old Creamery Road crossings have been highly impacted by historic straightening, residential encroachment on the corridor and unnatural structures placed in the channel. Both have undergone a departure from reference bedform (see Appendix 3), due mainly to a loss of sinuosity. The channel and watershed characteristics in this upper zone are such that little future lateral channel migration is expected; channel straightening combined with bank armoring will hold the channel in place indefinitely. Potential projects in this area include the removal of the in-stream structures causing

aggradation and habitat impacts, as well the revegetation of the buffers with native woody vegetation. Future efforts to identify specific projects in this watershed zone would involve extensive public outreach, given the large number of residential properties found along the channel, especially in segment T1.05-A.

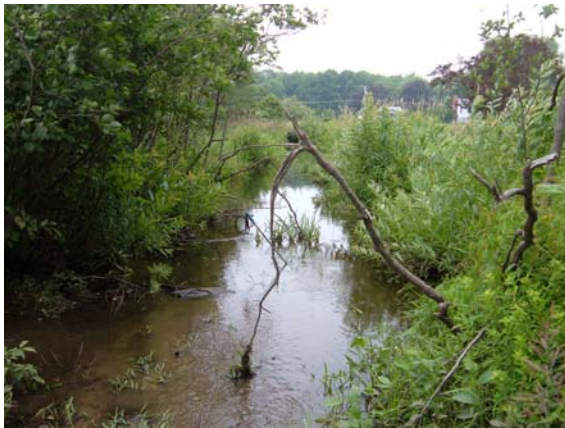
Segment T1.05-B is found from the crossing at Nob Hill Road up to the second Old Creamery Road crossing. This segment has a length of 1955 feet and E-type channel geometry (Figure 18). The stream corridor has also been impacted along this segment where the residential land use has altered the buffer conditions, resulting in a lack a woody vegetative buffer greater than 25 feet. In addition, 28% of the channel length was historically straightened, which has severely impacted the habitat conditions. Despite these impacts, the channel remains relatively stable in stage II of channel evolution due to limited discharge from the upslope watershed, which is likely moderated by the beaver ponding in the upslope segment. The geomorphic stability and habitat conditions have been assessed as fair for this segment.

Figure 18. E-type channel in Segment T1.05-B

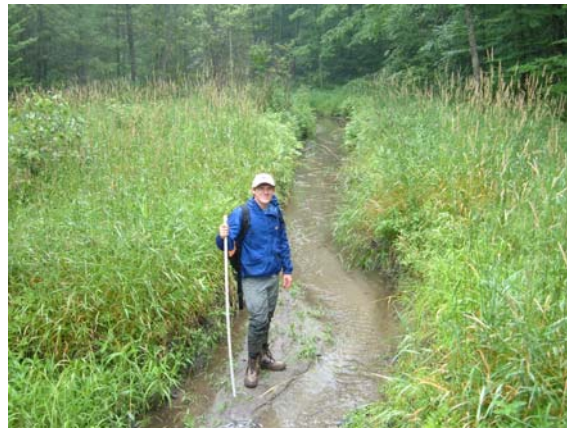
Figure 19. E-type channel in Segment T1.05-C

Segment T1.05-C is found from the crossing at Old Creamery Road up to the north branch source in the vicinity of Oak Hill Road. This segment has a length of 5175 feet and E-type channel geometry throughout (Figure 19). In the lower section of the segment, a large beaver impoundment is found which affects the channel upstream for approximately 1700 feet. Upstream of this area, the channel is unaffected by local-scale residential or agricultural land uses, and maintains a very sinuous planform. Very good habitat conditions for the low-gradient setting were noted in the middle and upper sections of the segment, with excellent buffer conditions and abundant wood debris throughout. The geomorphic stability and habitat conditions have been assessed as good, with stable channel evolution processes (stage I).
