**Slate Roof Replacement Recommendation for the Forgione Barn
National Register Williston Village Historic District, #24**

November 25, 2024

**Ann Cousins, 36CFR61 qualified Architectural Historian,
Working 35 years as a Professional Historic Preservationis**

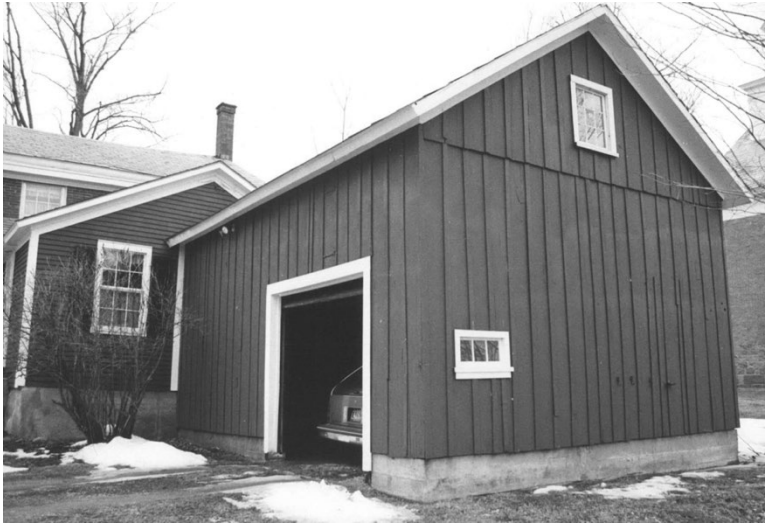
C.1840 Barn, attached to historic c.1840 ell. Wood board and batten siding described as replaced (1992). Poured concrete foundation. Overhead garage door within the original barn opening. View looking southwest.
Williston Village Historic District, Boundary Addition. Entered on the National Register, October 1992. Photo 1991, credit Ann Cousins.

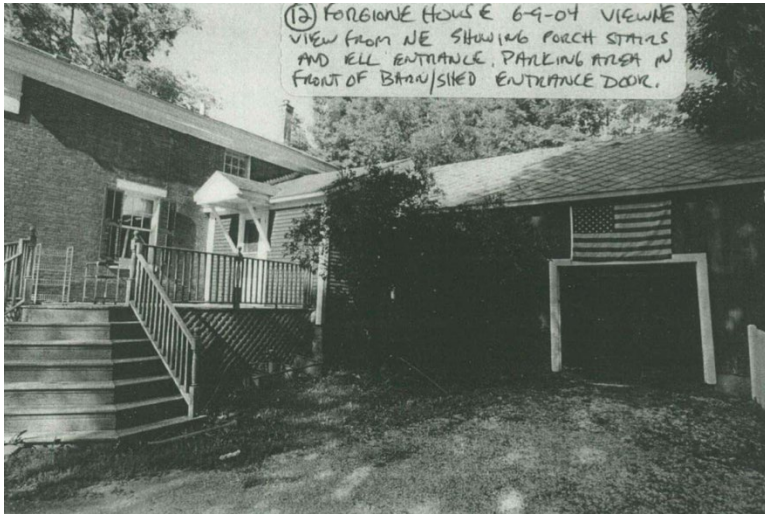
(12) FORGIONE HOUSE 6-9-04 VIEWING VIEW FROM NE SHOWING PORCH STAIRS AND ELL ENTRANCE. PARKING AREA IN FRONT OF BARN/SIDED ENTRANCE DOOR.

RITC application, Part 1 (Photo 2002)
Barn, ell and house are c.1840. Original ell spans half the width of the house. The barn sits approx. 3 feet lower than the ell.
View looking west-southwest

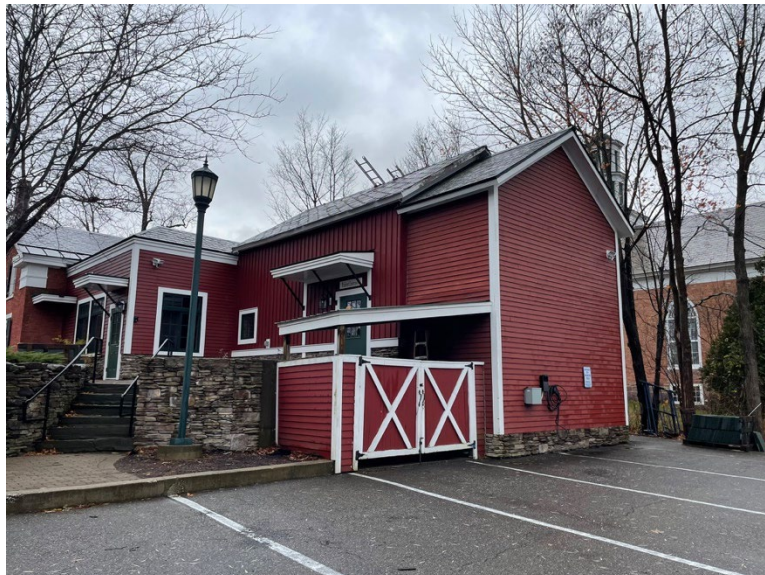
Photo: November 2024
2004-06 renovations included a new hipped roof "link" replacing original 1840 ell adding approx. 300 sq. ft. Barn is elevated and relocated. Renovated barn has new window and pedestrian door on east side; north gable end windows removed and two story stair tower added (2004-06 building project).

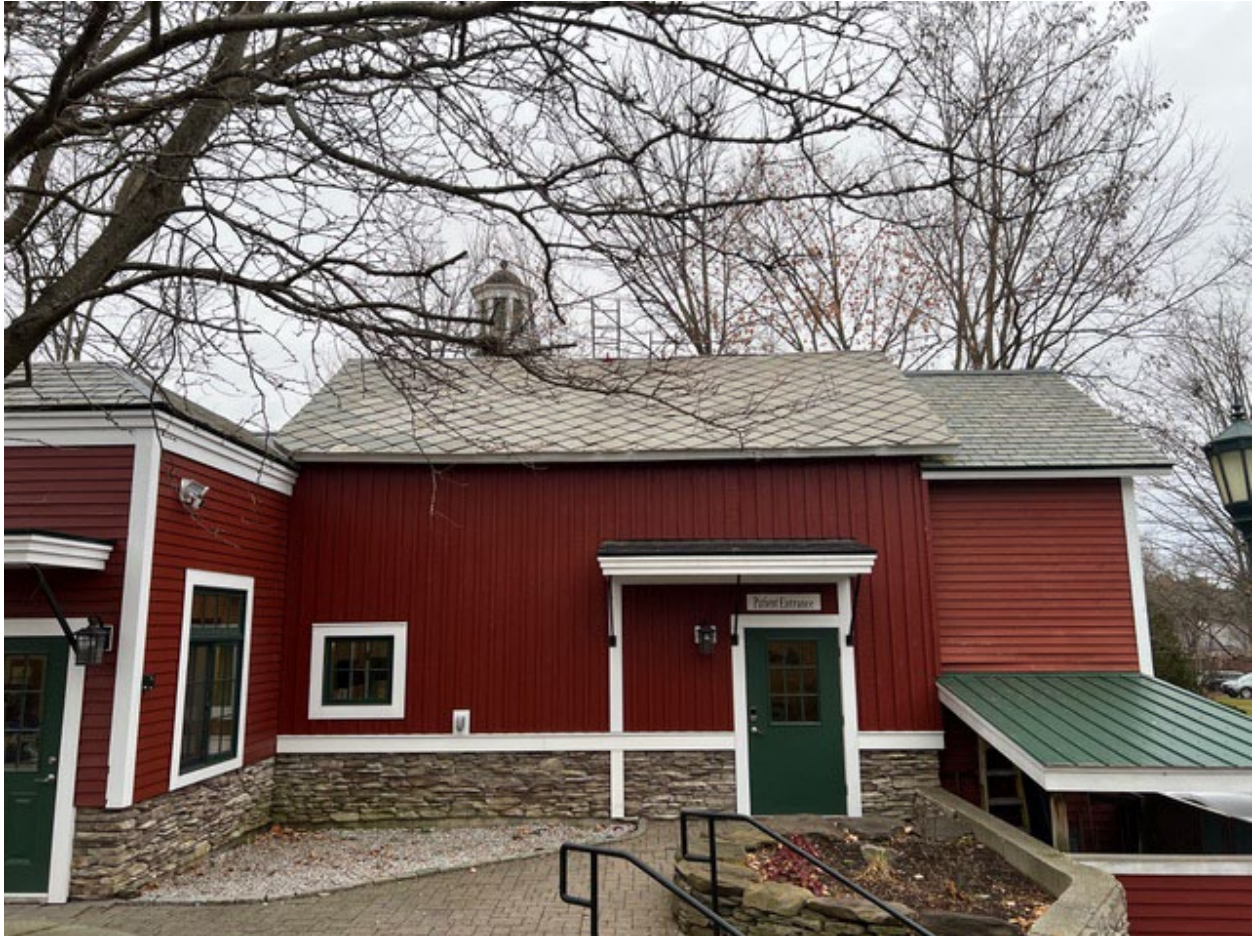
2024 Photograph of the c.2006 ell, attached c.1840 barn, c.2006 wing attachment

With the extensive 2004-2006 changes to the ell and barn, the integrity of the barn is compromised. The changes were appropriate and approved by the National Park Service in part because the extensive exterior changes were at the rear of the building. The restaurant use brought new life to the historic building, just as the current use as a dental office continues to use the historic property in an appropriate way.
