Allen Brook Watershed Departure Analysis and Project Identification Summary

April 11, 2008

Fitzgerald Environmental Associates, LLC.

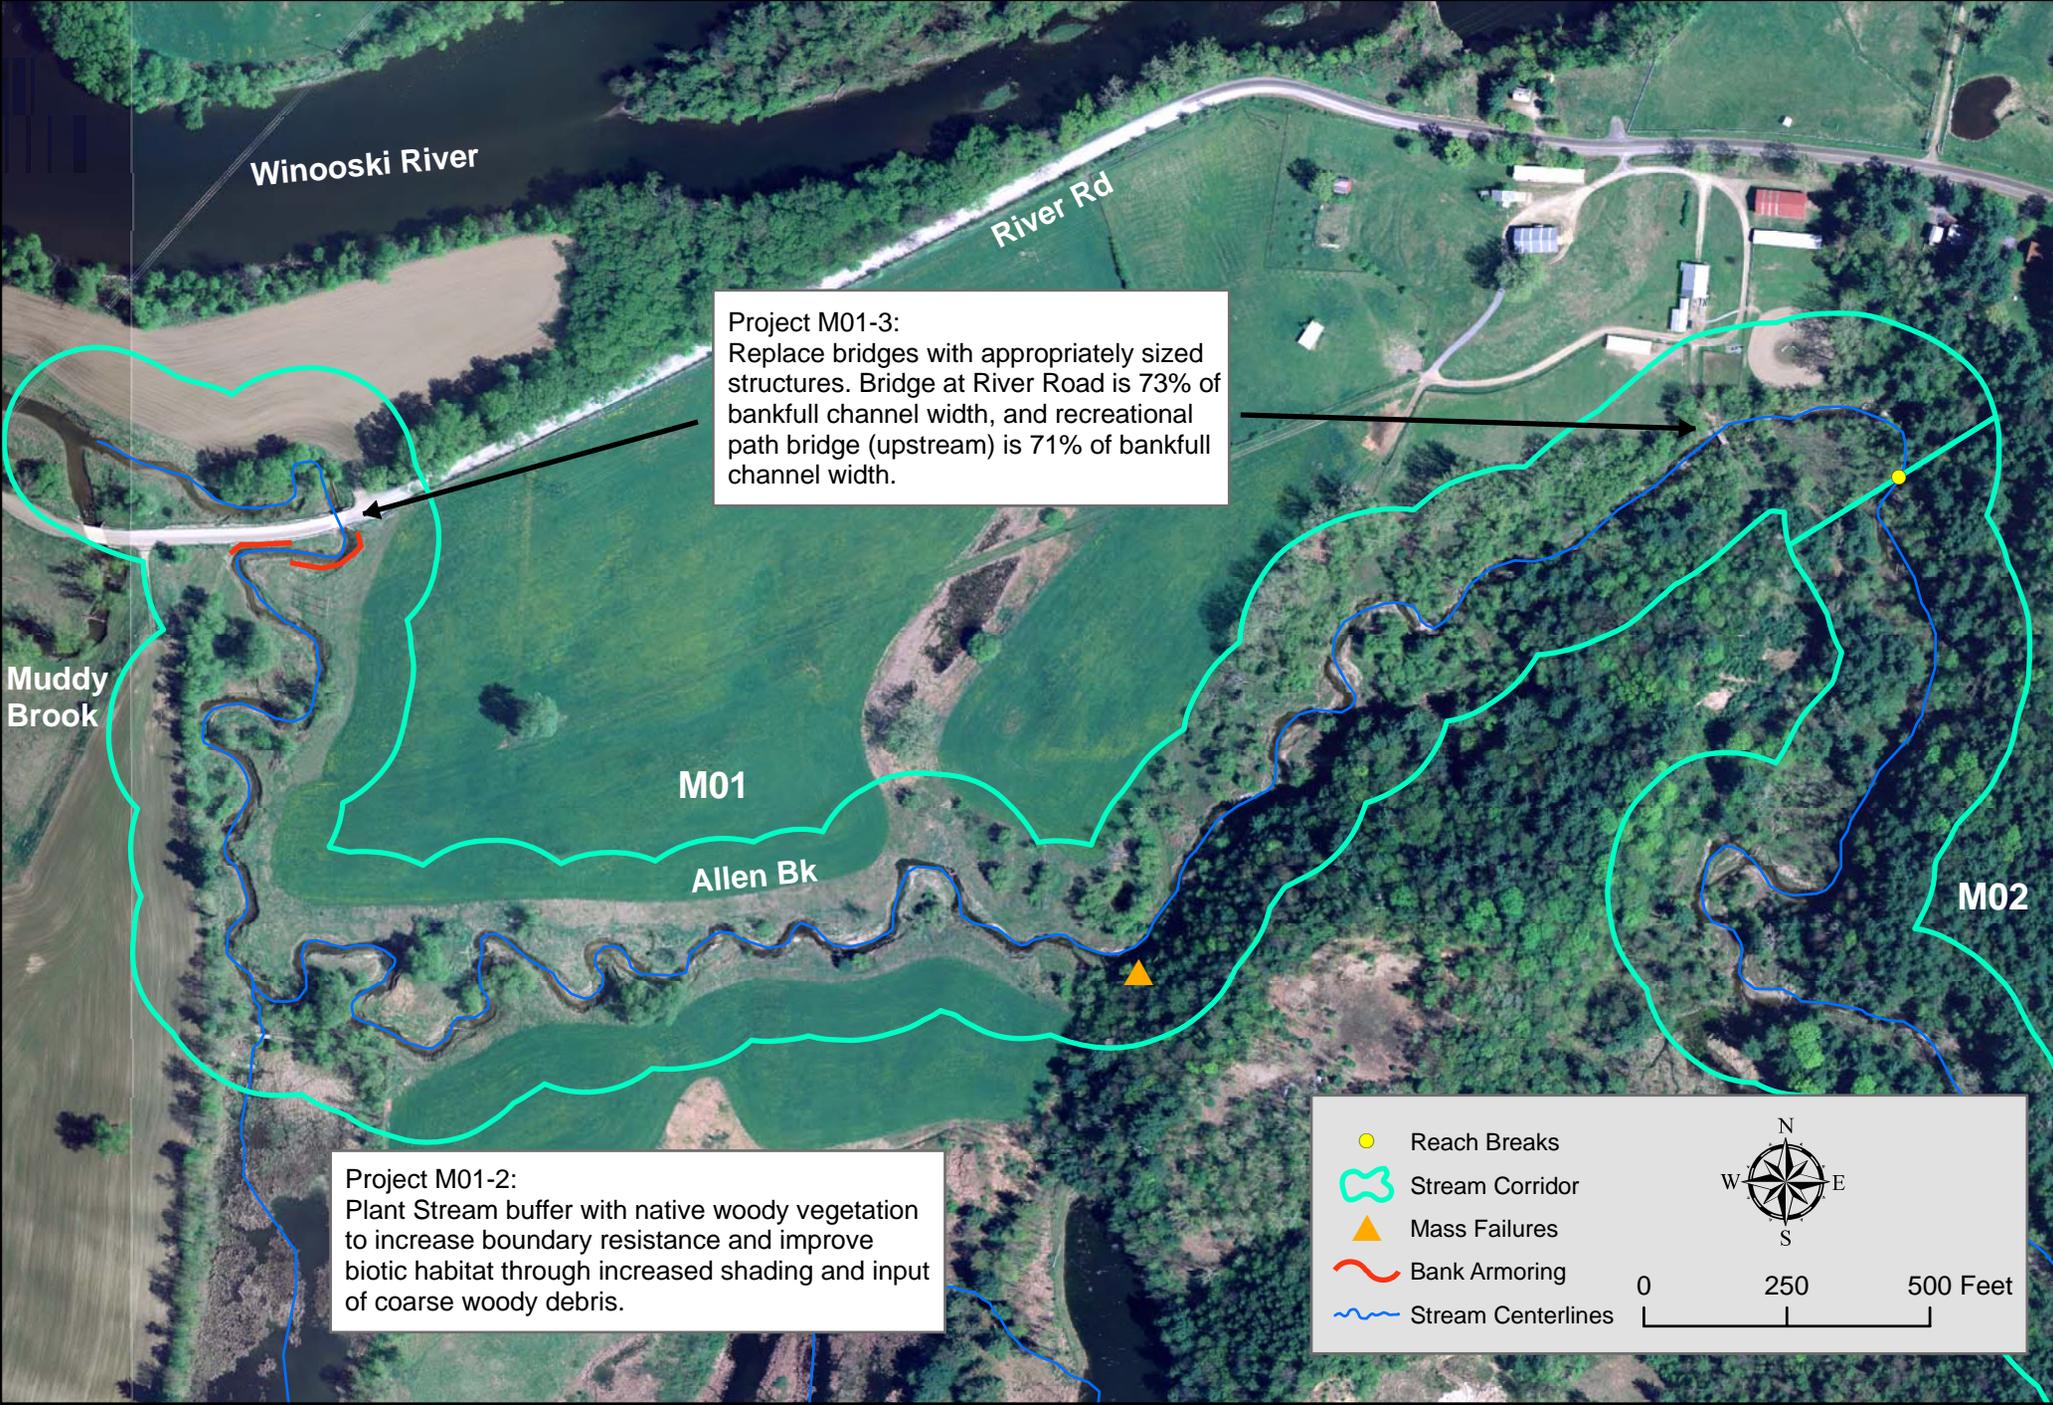
Figure 11
Reach M01 Project Locations

1. M01-2: Plant buffer with native woody vegetation in the middle and lower reach. Detailed site mapping is provided in Figure 11 (high priority).
2. M01-3: Replace bridges with appropriately sized structures. Follow new RMP guidelines to accommodate 100% of equilibrium channel width. Detailed site mapping is provided in Figure 11 (medium priority).

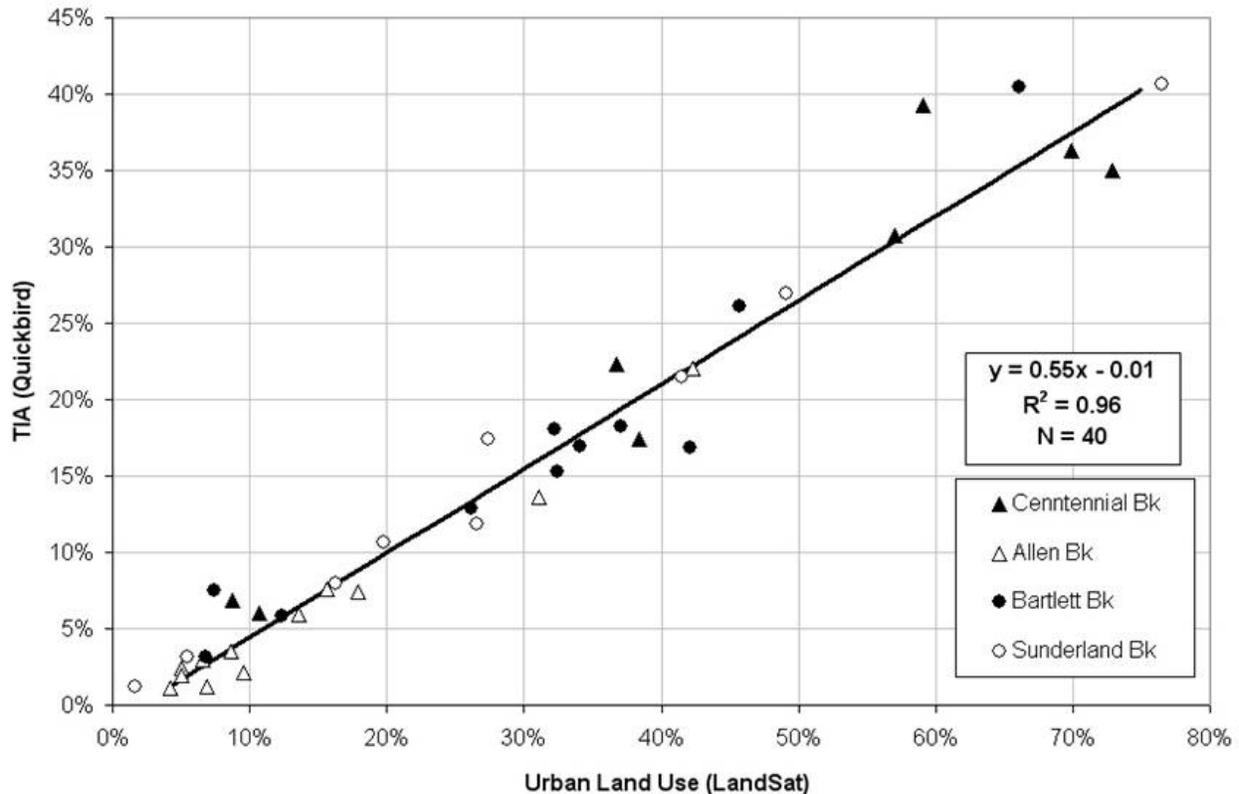
Plot of relationship between Urban Land Cover and TIA for 40 independent subwatershed areas from 4 of the study watersheds.

Quickbird-derived TIA data was only available for a select group of watersheds during the time of this analysis. Given this limitation, a correlation analysis was performed using the Landsat-derived urban class and the Quickbird-derived TIA class for 4 of the 16 study watersheds. The dataset used for the correlation analysis included 40 independent subwatersheds with a wide distribution of drainage areas (ranging from 0.07 km² to 3.8km²) and TIA percentages (ranging from 1.2% to 40.6%). The analysis resulted in a robust linear relationship that was used to calculate TIA for all study watersheds at each spatial scale.
