**Mountain View Road
Improvements Update,
Williston, VT**

Prepared for:
CCRPC and Town of Williston

Prepared by:
Greg Edwards, PE

May 8, 2017

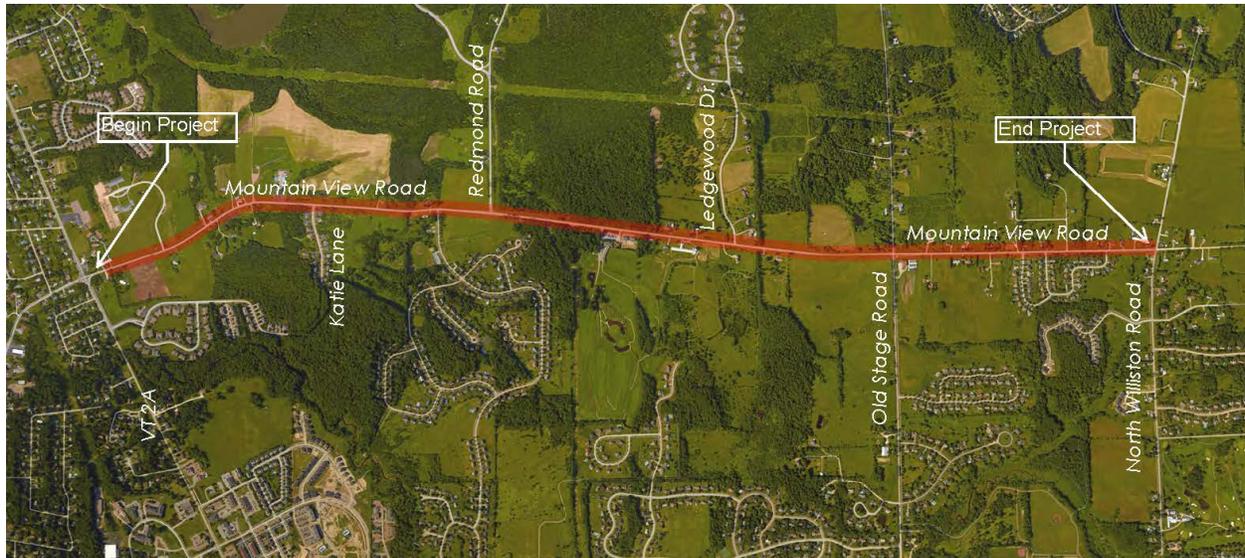
Figure 1: Project Area Plan

The purpose of this report is to expand the detail and information developed by the previous Mountain View Road Bicycle/Pedestrian Facilities Feasibility Study, dated February 4, 2014. The project area begins just east of the VT Route 2A/Industrial Avenue/Mountain View Road intersection and extends easterly approximately 13,000 feet (2.5 miles) along Mountain View Road to the Mountain View Road/North Williston Road intersection. The project area is shown below.

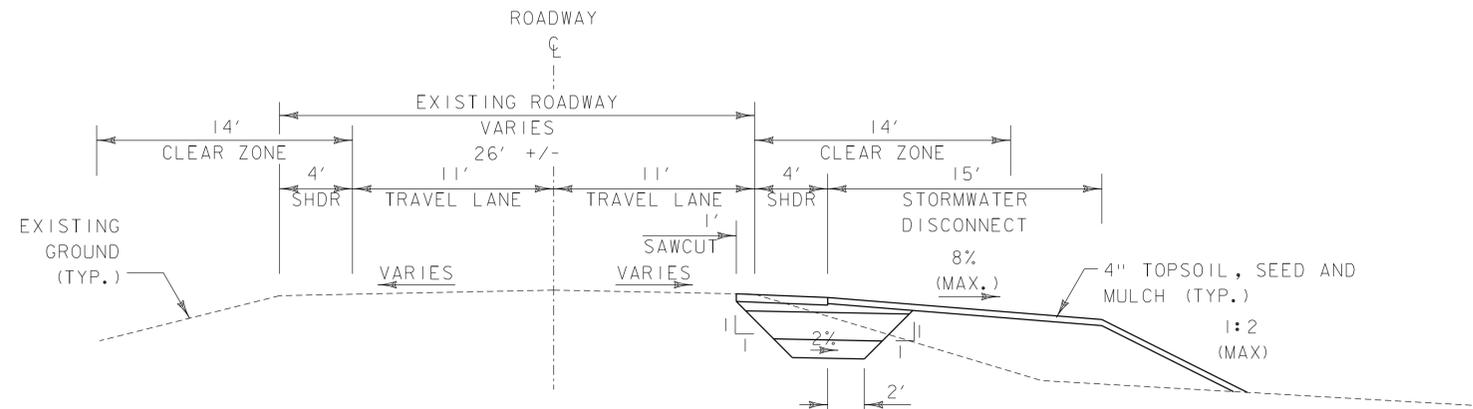
ROADWAY WIDENING, FILL SECTION
 N. T. S.

ROADWAY WIDENING CONSTRUCTION:
 2" SUPERPAVE BITUMINOUS CONCRETE PAVEMENT (1 LIFT - TYPE IIIIS)
 3" SUPERPAVE BITUMINOUS CONCRETE PAVEMENT (1 LIFT - TYPE IS)
 6" SUBBASE OF CRUSHED GRAVEL, FINE GRADED
 18" SUBBASE OF DENSE GRADED CRUSHED STONE
 12" SAND BORROW
 (MATCH EXISTING)

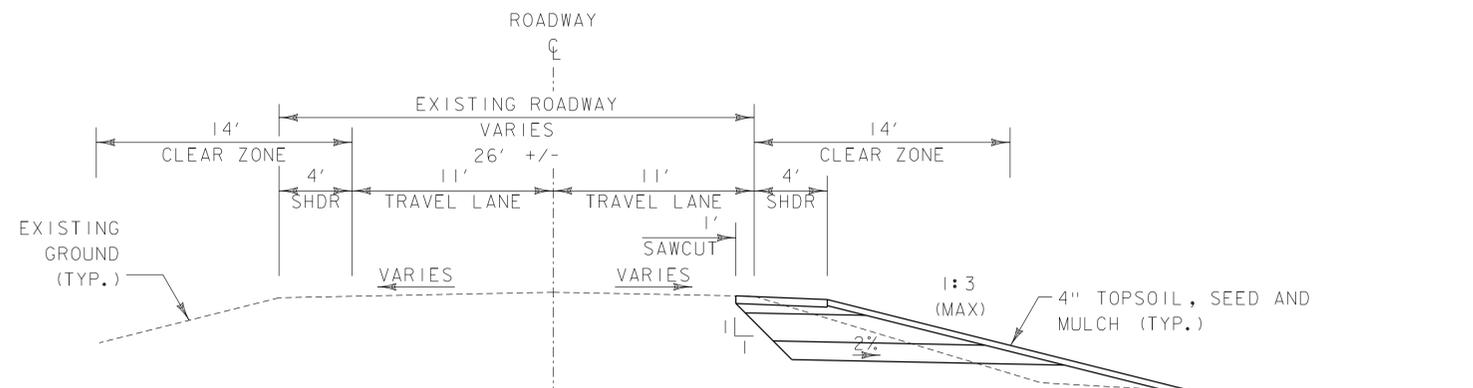
ROADWAY WIDENING, FILL SECTION
 N. T. S.

DISCONNECT AREA, RIGHT
 STA. 6+75 TO STA. 12+50
 STA. 13+75 TO STA. 16+00
 STA. 88+50 TO STA. 96+75
 STA. 101+00 TO STA. 114+50

ROADWAY WIDENING CONSTRUCTION:
 2" SUPERPAVE BITUMINOUS CONCRETE PAVEMENT (1 LIFT - TYPE IIIIS)
 3" SUPERPAVE BITUMINOUS CONCRETE PAVEMENT (1 LIFT - TYPE IS)
 6" SUBBASE OF CRUSHED GRAVEL, FINE GRADED
 18" SUBBASE OF DENSE GRADED CRUSHED STONE
 12" SAND BORROW
 (MATCH EXISTING)

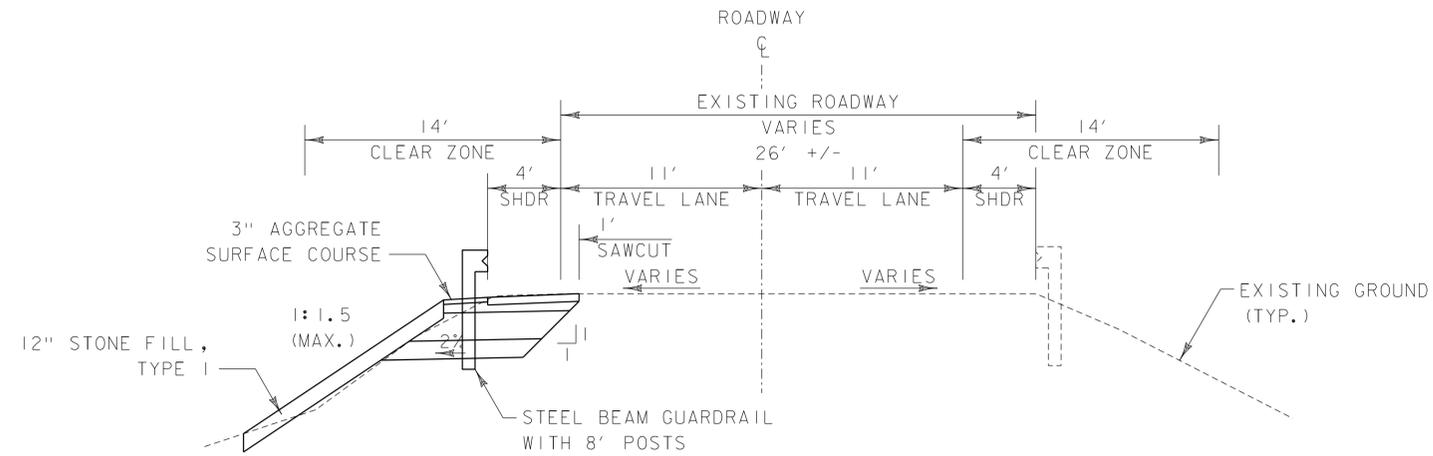
ROADWAY WIDENING, GUARDRAIL SECTION
 N. T. S.

ROADWAY WIDENING CONSTRUCTION:
 2" SUPERPAVE BITUMINOUS CONCRETE PAVEMENT (1 LIFT - TYPE IIIIS)
 3" SUPERPAVE BITUMINOUS CONCRETE PAVEMENT (1 LIFT - TYPE IS)
 6" SUBBASE OF CRUSHED GRAVEL, FINE GRADED
 18" SUBBASE OF DENSE GRADED CRUSHED STONE
 12" SAND BORROW
 (MATCH EXISTING)

GUARDRAIL SECTION, LEFT
 STA. 21+00 TO STA. 23+25

The project is not proposing to directly affect any streams and a stream alteration permit is not required. There is a stream crossing with a 48" culvert at station 22+00 and a cross section was developed to determine the construction limits. By using guardrail with 8 foot posts and 1.5:1 stone fill slopes, the existing culvert length will accommodate the 4 feet of widening. Therefore, no culvert lengthening/replacement or stream alteration permit is required.

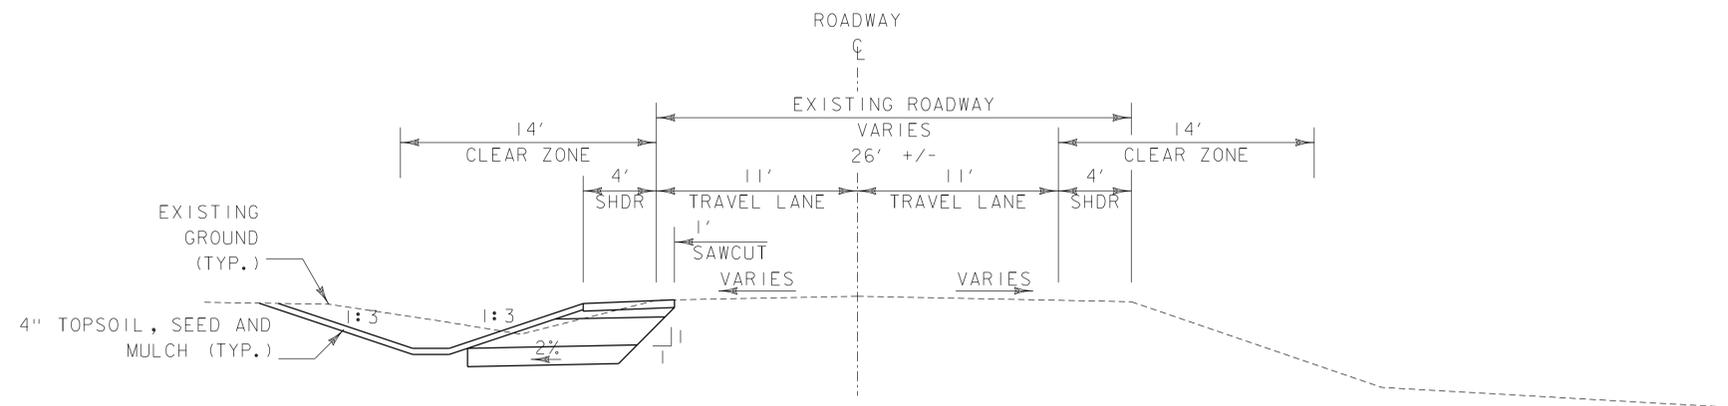
ROADWAY WIDENING CONSTRUCTION:
 2" SUPERPAVE BITUMINOUS CONCRETE PAVEMENT (1 LIFT - TYPE IIIIS)
 3" SUPERPAVE BITUMINOUS CONCRETE PAVEMENT (1 LIFT - TYPE IS)
 6" SUBBASE OF CRUSHED GRAVEL, FINE GRADED
 18" SUBBASE OF DENSE GRADED CRUSHED STONE
 12" SAND BORROW
 (MATCH EXISTING)

SWALE SECTION, LEFT
 STA. 29+00 TO STA. 32+50
 STA. 43+50 TO STA. 52+25
 STA. 76+75 TO STA. 88+00
 STA. 136+75 TO STA. 139+25
 STA. 143+00 TO STA. 147+50
 STA. 150+00 TO STA. 151+50

- The project could construct roadside swales in areas adjacent to houses or any location where the Town find it is more advantageous.
- Anywhere a new swale crosses an existing driveway, the existing drive pipe will need to be removed and replaced. Given the condition of the existing pipe, it may be able to be reused and replaced.

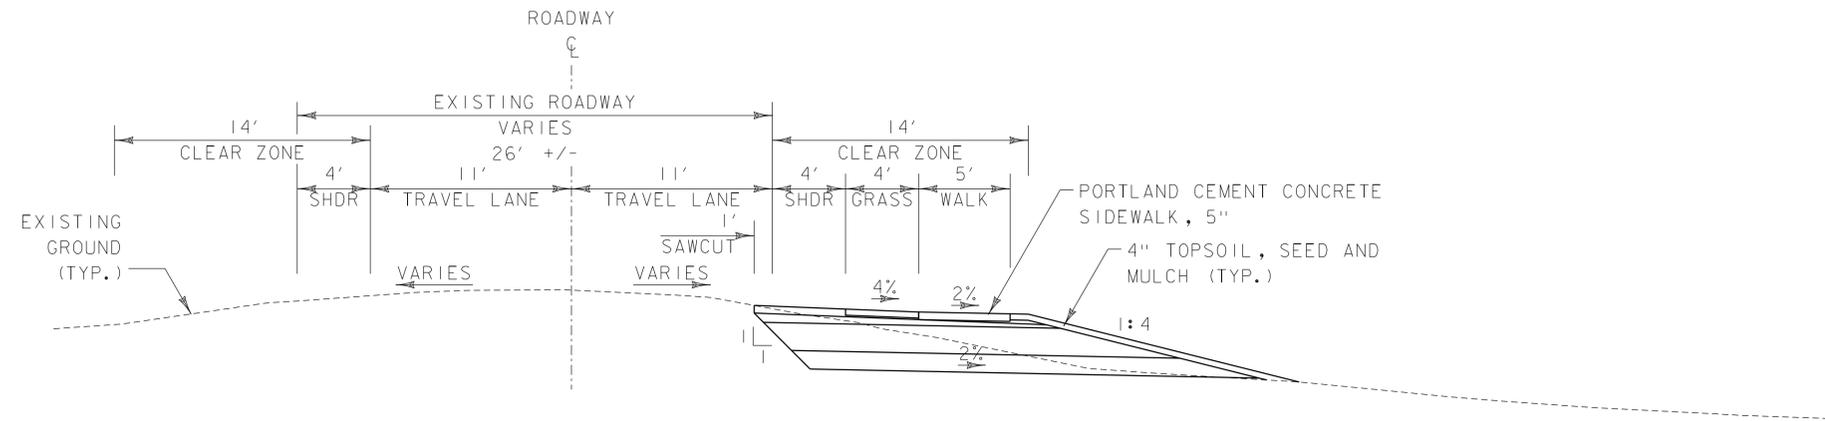
ROADWAY WIDENING CONSTRUCTION:
 2" SUPERPAVE BITUMINOUS CONCRETE PAVEMENT (1 LIFT - TYPE 111S)
 3" SUPERPAVE BITUMINOUS CONCRETE PAVEMENT (1 LIFT - TYPE 1S)
 6" SUBBASE OF CRUSHED GRAVEL, FINE GRADED
 18" SUBBASE OF DENSE GRADED CRUSHED STONE
 12" SAND BORROW
 (MATCH EXISTING)

SIDEWALK AREA, RIGHT
 STA. 118+75 TO STA. 128+25

The widening has not changed since the feasibility study. We have now included a section of sidewalk reconstruction to the east of Adams Apple Orchard & Farm Market. The widening in this area is on the southern side of the road and the existing sidewalk is close to the roadway. To provide a 4-foot grass strip between the new edge of road and sidewalk, the sidewalk must shift farther to the south. An existing fence will need to be replaced south of the edge of the sidewalk.

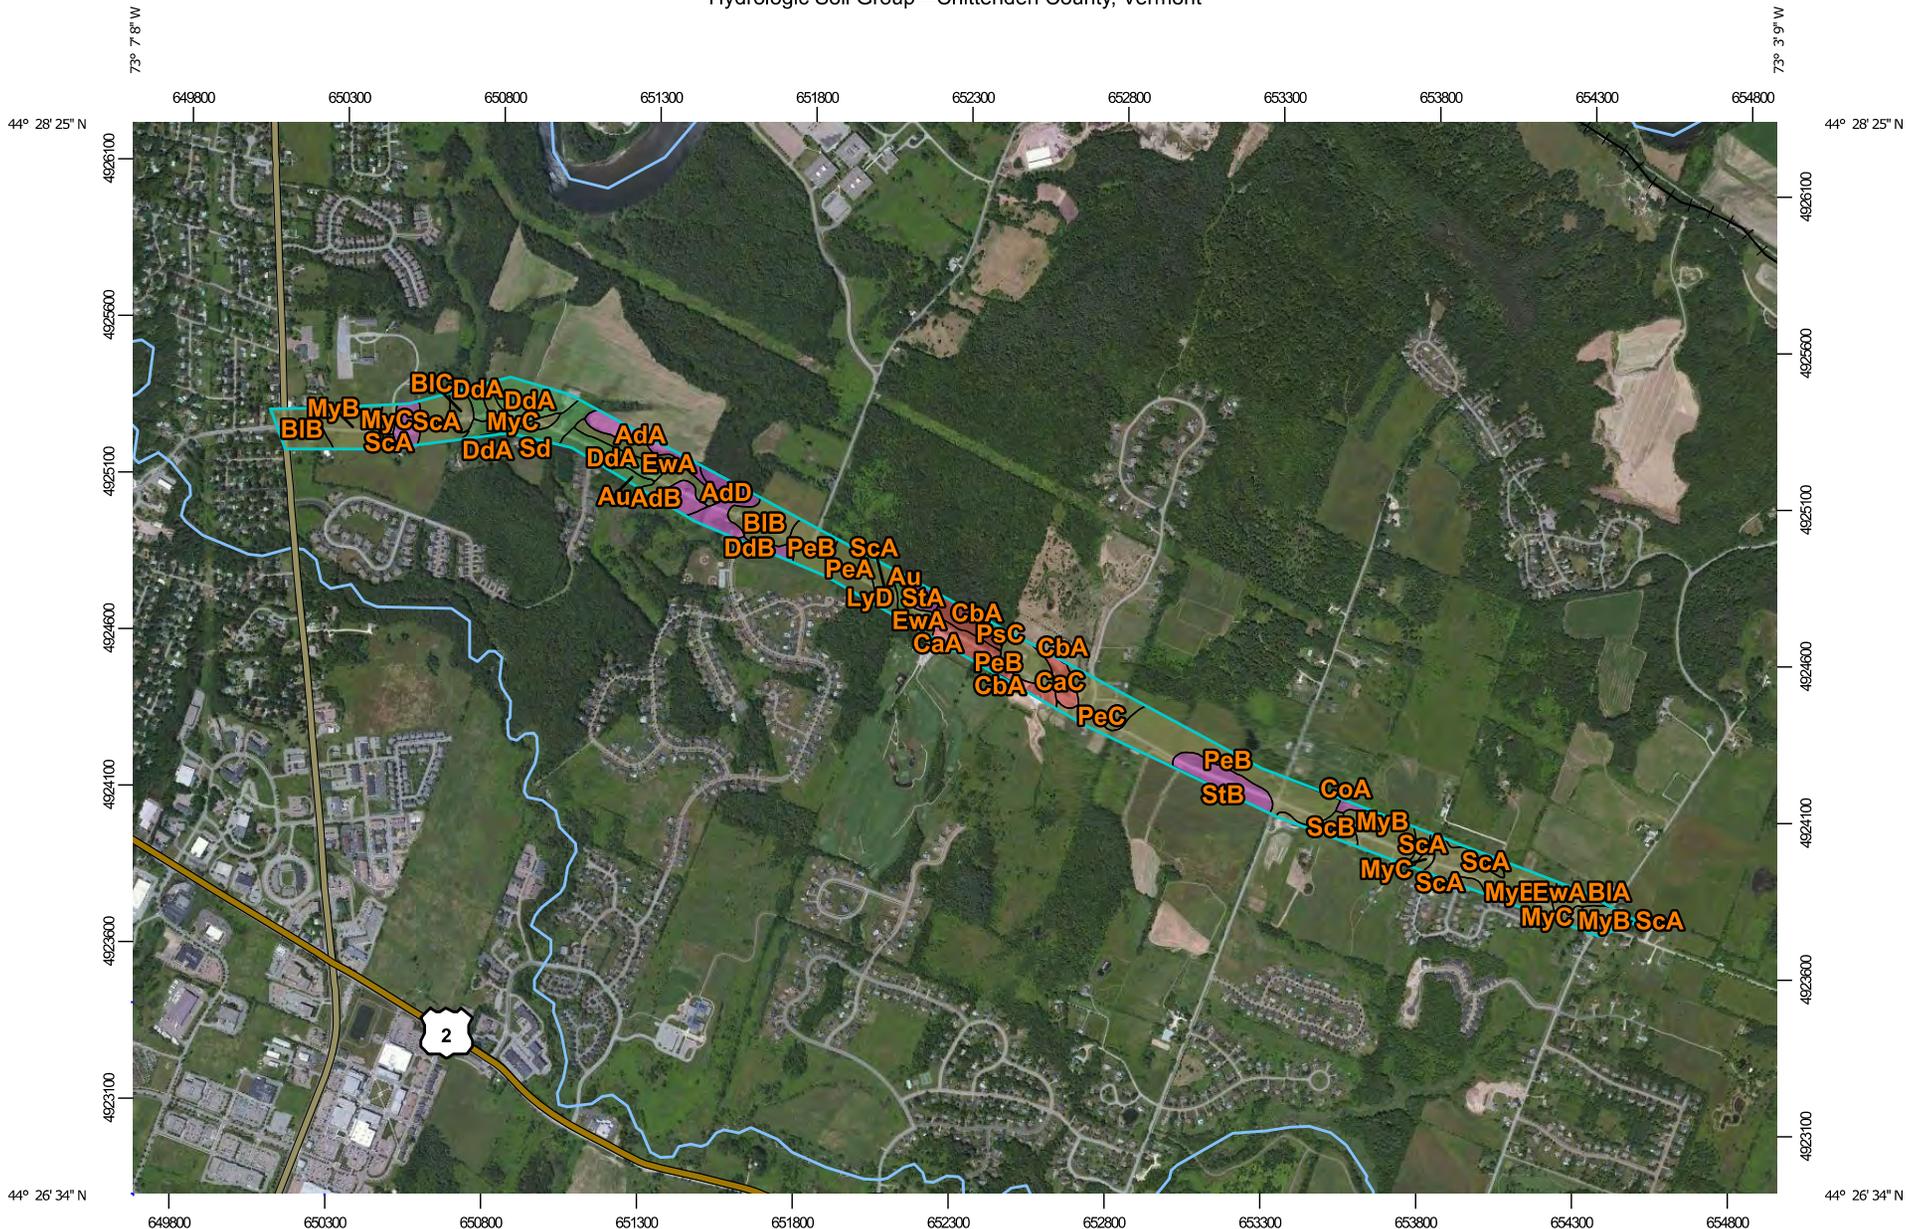
Hydrologic Soil Group—Chittenden County, Vermont

Hydrologic soil groups are based on estimates of runoff potential. Soils are assigned to one of four groups according to the rate of water infiltration when the soils are not protected by vegetation, are thoroughly wet, and receive precipitation from long-duration storms.

If a soil is assigned to a dual hydrologic group (A/D, B/D, or C/D), the first letter is for drained areas and the second is for undrained areas. Only the soils that in their natural condition are in group D are assigned to dual classes.

- Based on NRCS Soil Survey Hydrologic Soil Group, approximately 75% of the existing soils in the project area are C/D soils; therefore, during the design phase of the project, the infiltration rates should be confirmed for the corridor.

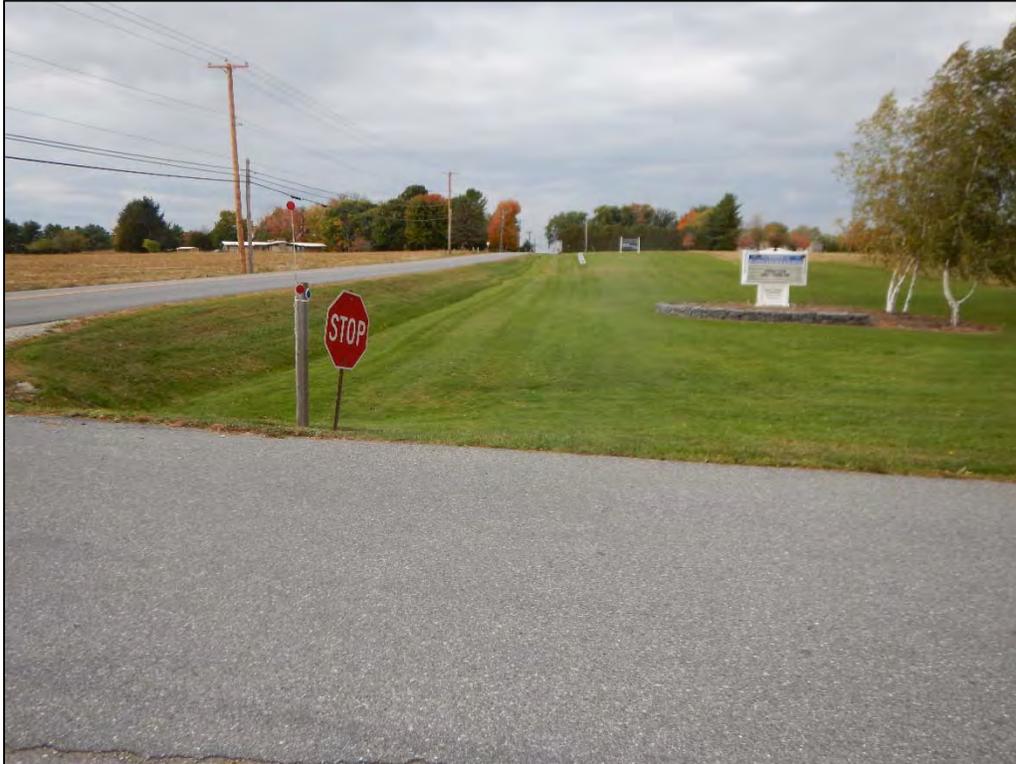
Photo 1. Western end of the project APE at Station 10+30 from entrance to Trinity Baptist Church (Str. 5). Note drainage ditch and road embankment. View to the west.

The existing conditions along the project alignment consist of a combination of suburban lawn, undeveloped margins of fields and a few wooded areas (Photos 1 to 6). There are roadside ditches and road embankments along much of the APE. A sidewalk constructed c. 2010 is present along the south side of the road extending from Old Stage Road east to North Williston Road. Underground utilities along the alignment consist of water and gas lines from Essex Road to Redmond Road with a gas line on the north side of the APE extending a short distance past Redmond Road.

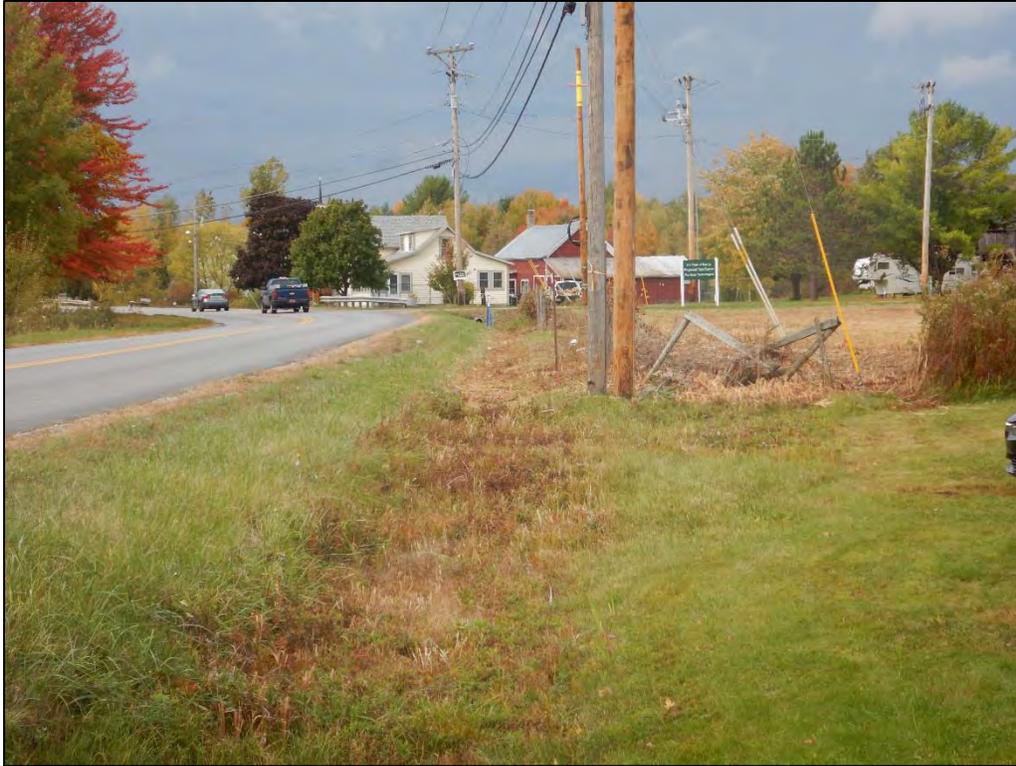
Photo 2. Project APE at Station 25+60 and Structure 12. Note drainage ditch and road embankment. View to the west/northwest.

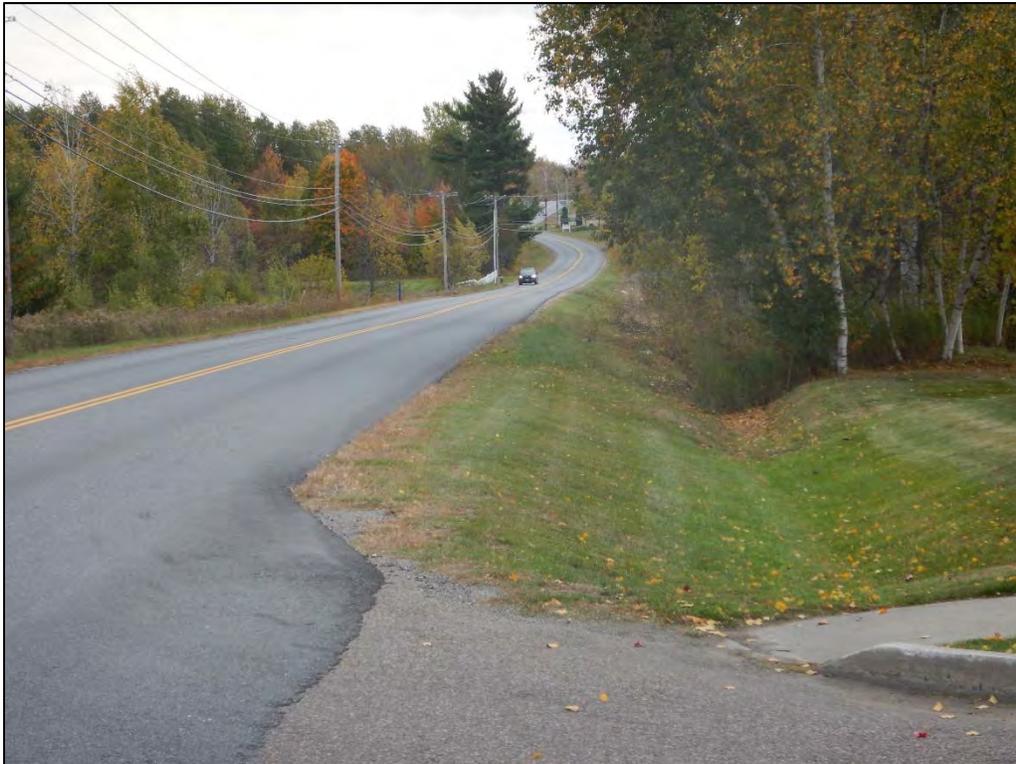
Photo 3. Project APE at Station 34+80 from Katie Lane. Note drainage ditch and road embankment. View to the southeast.

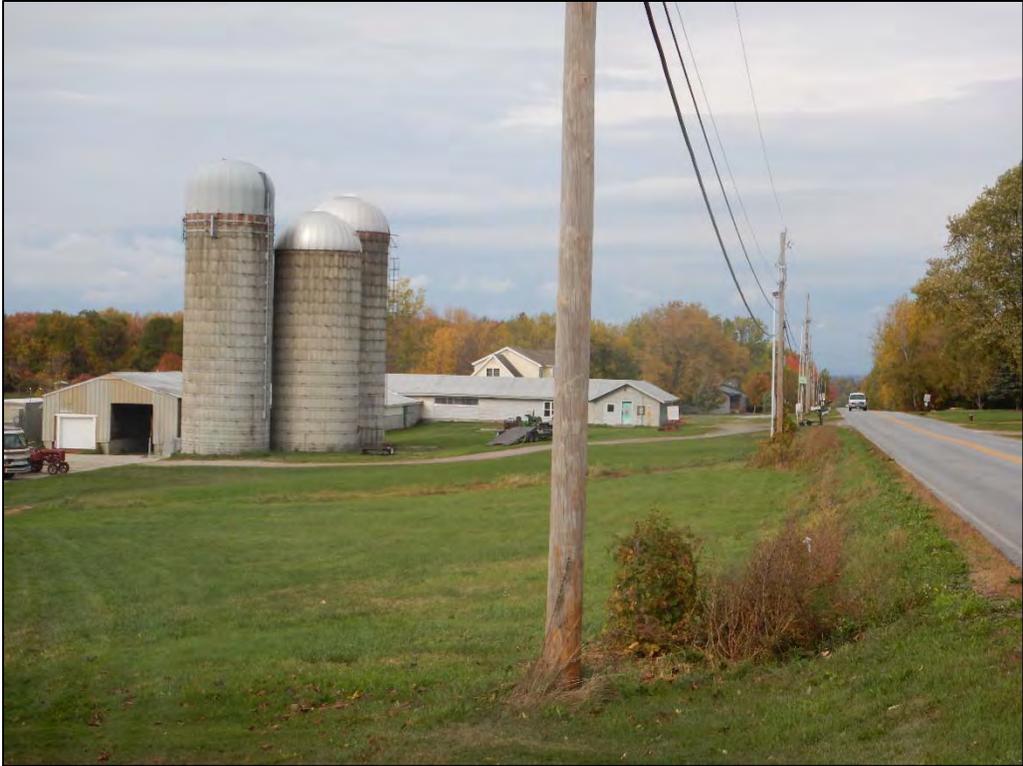
Photo 4. Project alignment at Station 89+75 at Structure 27, west of Ledgewood Drive. Note road embankment. View to the northwest.

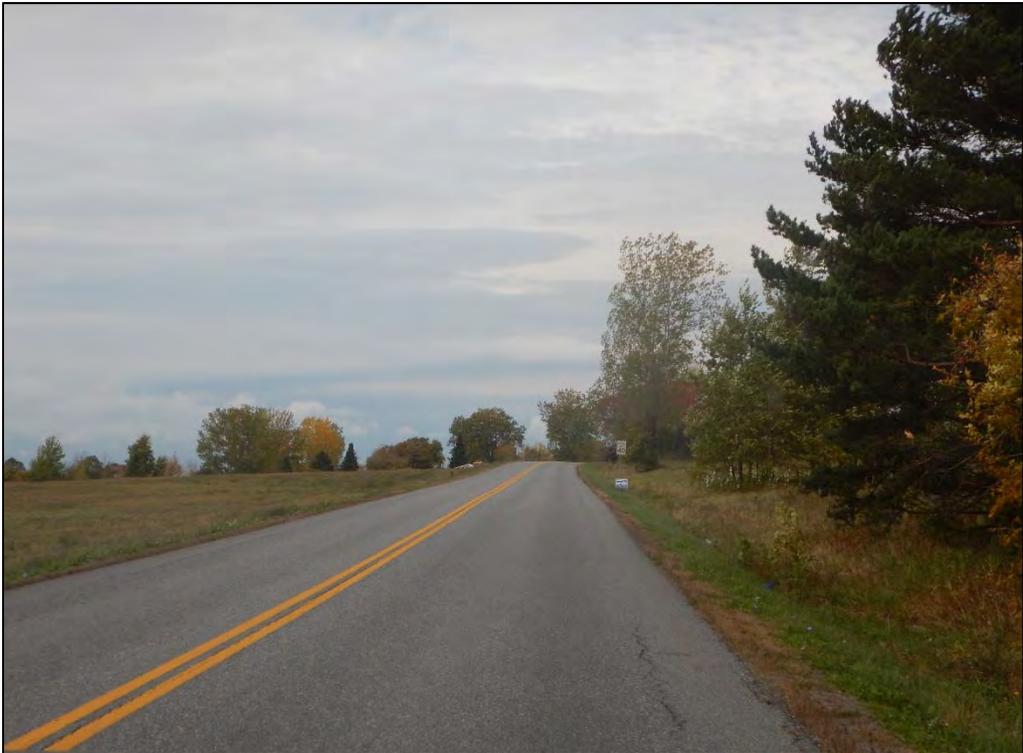
Photo 5. Project APE at Station 114+80 from Old Stage Road. Note open fields on either side and road embankment and drainage ditch. View to the northwest.

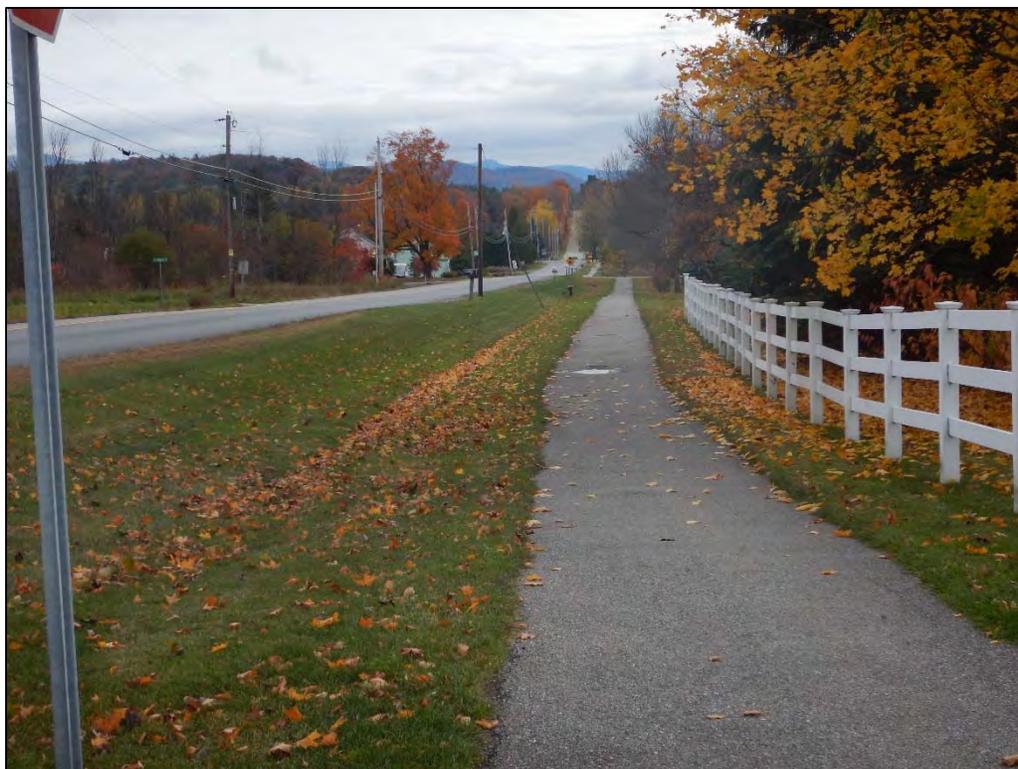
Photo 6. Project alignment at Station 135+20. Note road embankment, drainage ditch and existing sidewalk. View to the southeast.
