TOWN OF WILLISTON

TOWN-WIDE WATERSHED IMPROVEMENT PLAN - PHASE 1

FINAL REPORT

Stone Project ID 12-055

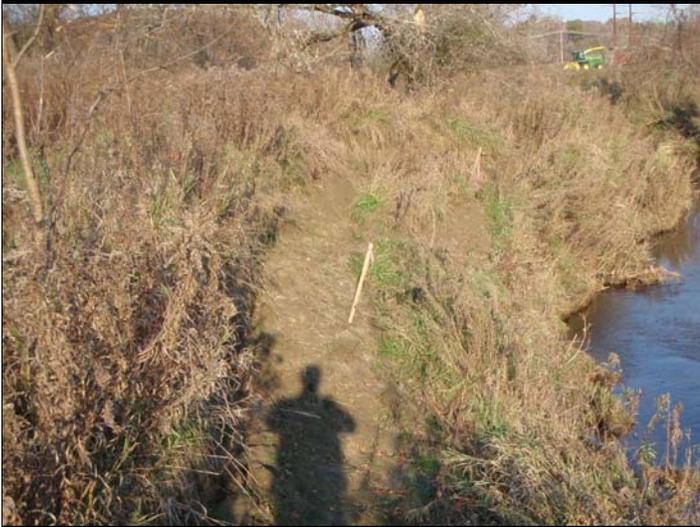
Photo 1.

Historical straightening of Allen Brook channel as part of the adjacent agricultural operation led to channel incision and increased bed and bank erosion that continues today. Numerous instances of eroding channels banks and tall adjacent terraces that are actively eroding into the channel. Several corrective measures have been implemented, but more work remains to be done.

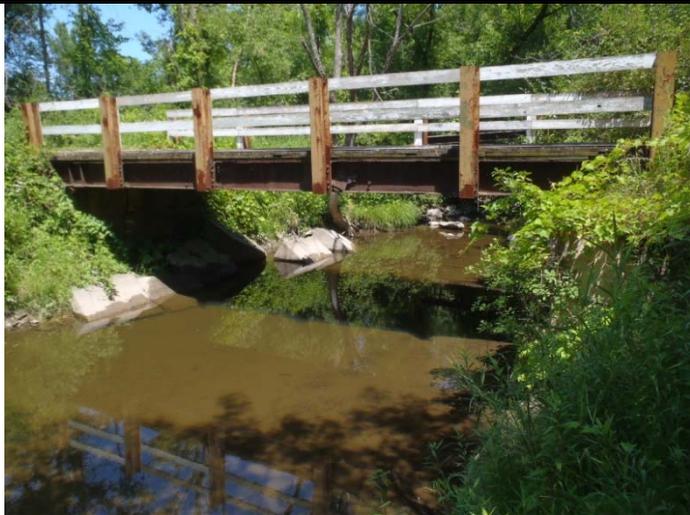
Description of Observed Conditions:
 Concrete support blocks on North side of bridge have failed and collapsed into brook. Bridge does not appear to be causing a mid-channel deposition in brook as was noted in the SGA.

Photo 1. Support blocks in stream channel

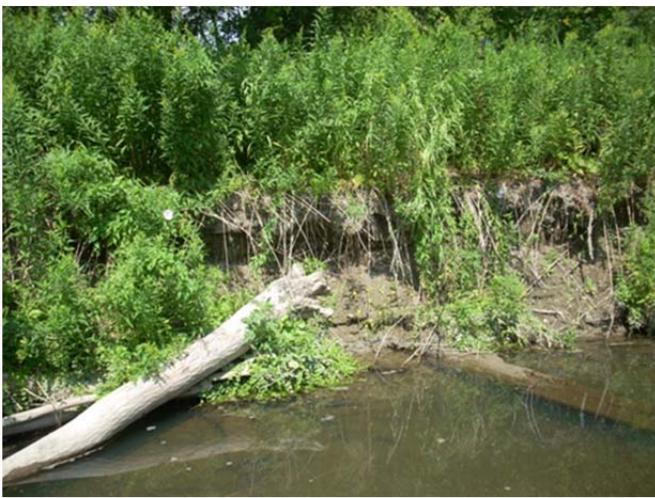
Aggradation has caused new (braided) channel to form; visible erosion on outer bank. Large riparian buffer zone, including some woody vegetation, present.

Photo 1. Visible erosion/undercutting of bank

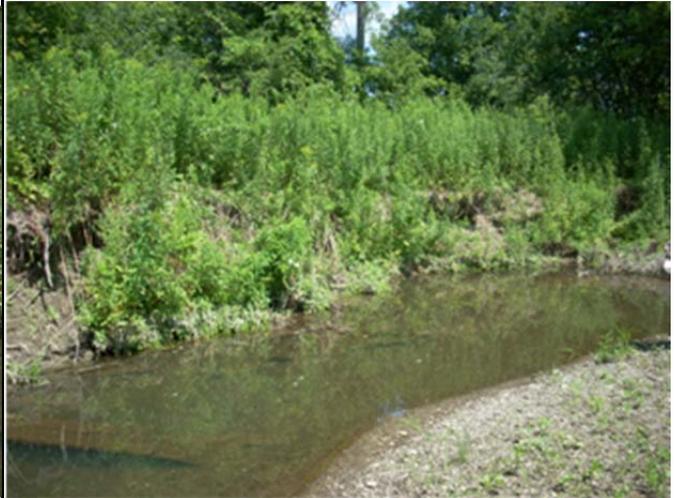
Photo 2. Evidence of aggradation

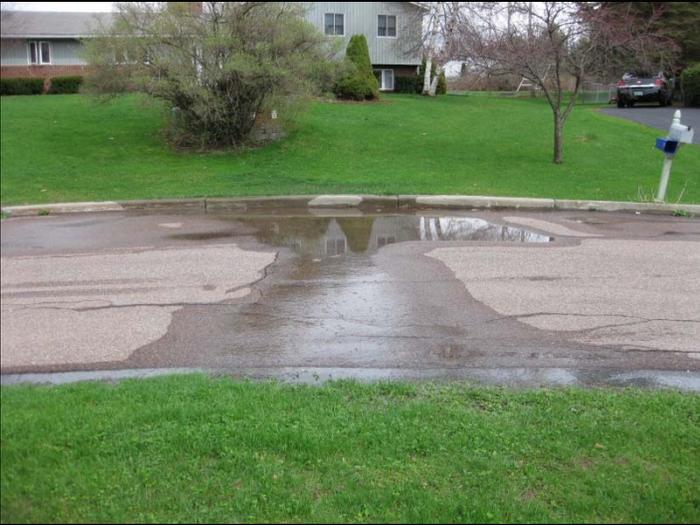
Lawns on east-side of circle all slope towards road, and water reaching the road has no place to drain to. No catch basins or other stormwater collection devices (such as rain gardens) in area. Catch basins in road seem to have house drains flowing into them. Lawns drain to cul-de-sac with no stormwater facilities to collect runoff.

Photo 1. Stormwater runoff flowing into the cul-de-sac from surrounding residential properties.

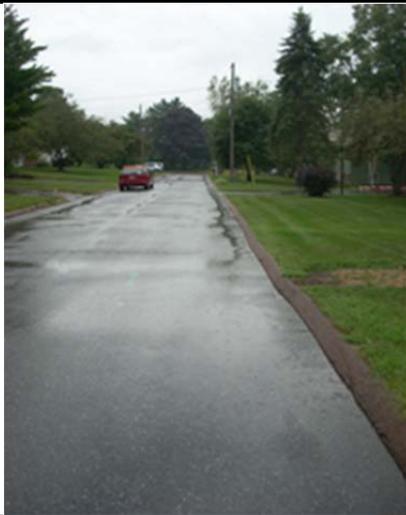
Water is apparently coming from Sundown Dr; there are no catch basins or other drainage infrastructure on Fawn Pl. A curb cut was poorly repaired leading to water running on road to jump curb and flow through the lawns on Fawn Pl, into driveways and then being homes on Fawn Place. Residents indicated runoff eventually reaches the backyard to house on 264 Hillside Dr. Owners have installed a French drain to protect house and foundation from flooding. Owner at 55 Fawn Place is very concerned about flooding and damage to driveway.

Photo 1. Looking south along Fawn Place

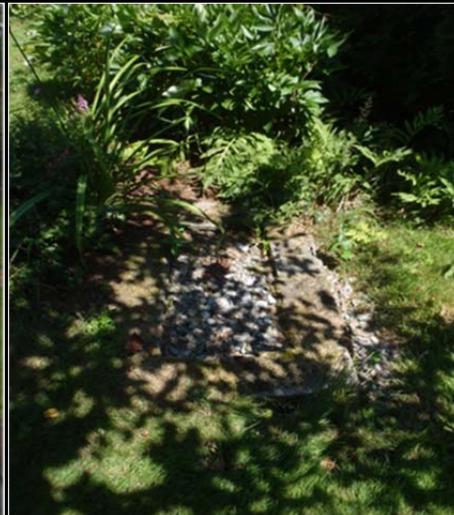
Photo 2. Owner installed catch basin/leach field at 264 Hillside

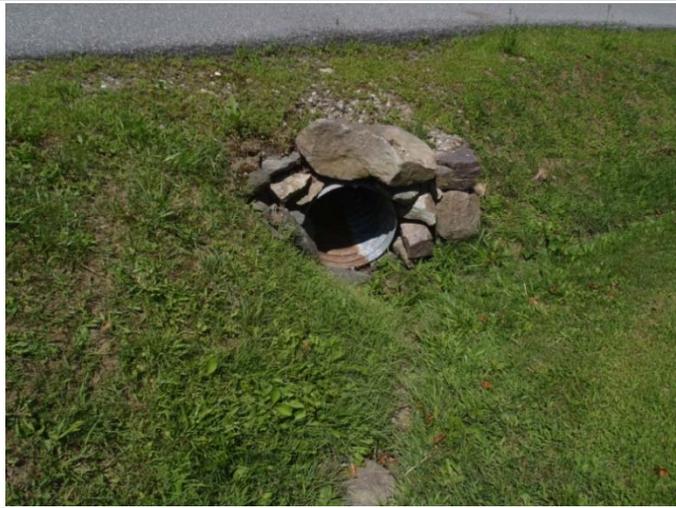
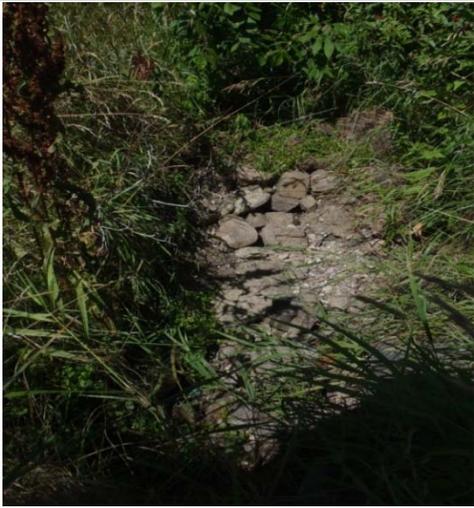
Stormwater from Pamela Ct, Lea Dr, and N. Gail Terr all flows to culvert at intersection of Pamela and Lea (photo 1). Culvert is 18" corrugated metal pipe. At outfall, some sediment is building up; may contribute to localized road flooding reported by residents. Gail Terr catch basins are clear or debris. At 92 Gail, basin in yard is full of debris. No catch basins present on Pamela Ct, ditch drainage through culverts under driveways - most are 12" pipes.

Photo 1. Culvert at intersection of Gail/Pamela	Photo 2. Culvert outfall

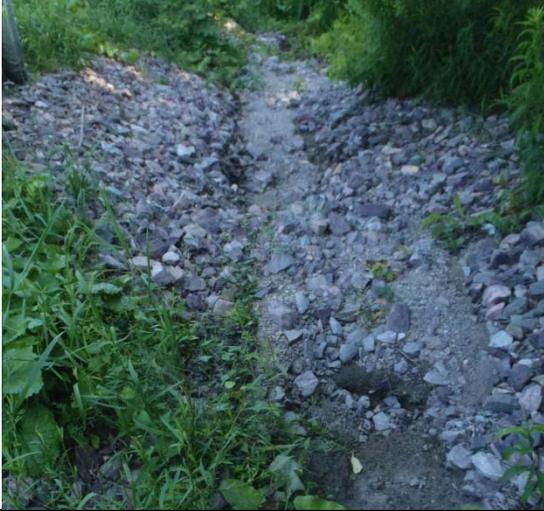
Rip rap has been placed in the ditch/gully alongside road. Small headcut (<1') and channeling in lower half of rip rap. Some sediment deposition, presumably carried from road is present, where the rip rap ends (Photo 1).

Photo 1. Looking down riprap

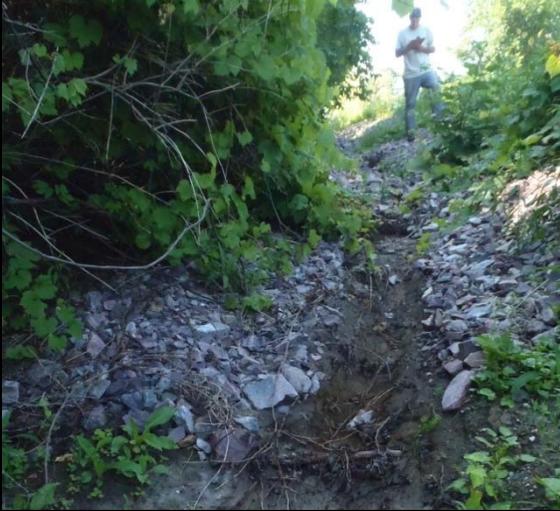
Photo 2. Looking up riprap, channeling

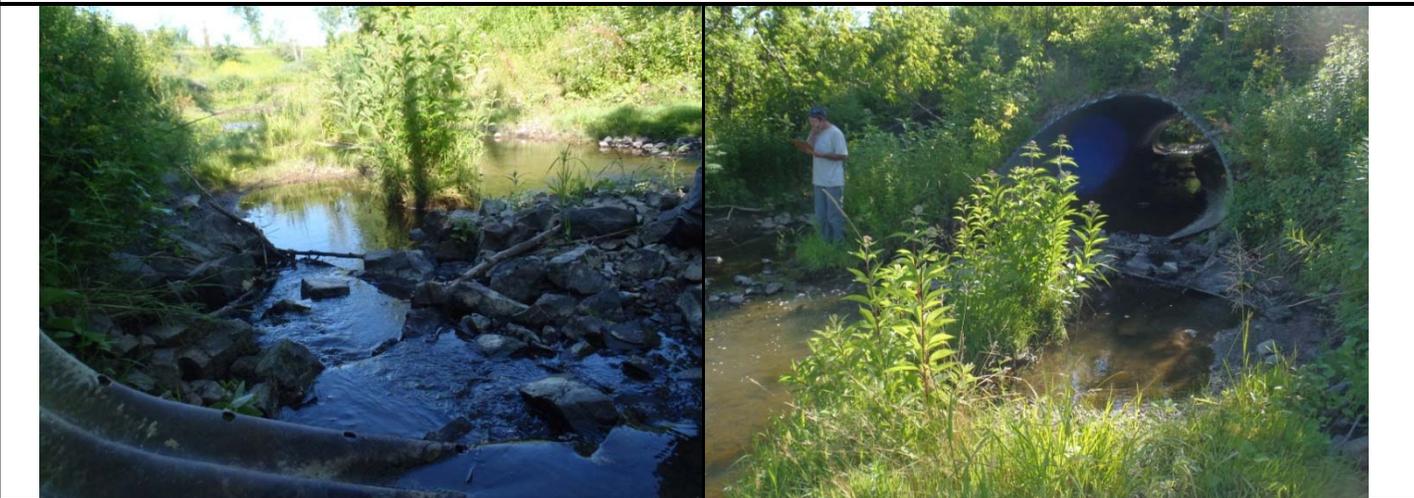
Culvert is significantly less than bankfull width. Signs of channel scour just below culvert (Photo 2). Rock, sediment and debris are being deposited at outfall.

Photo 1. Debris deposits

Photo 2. Scour pool

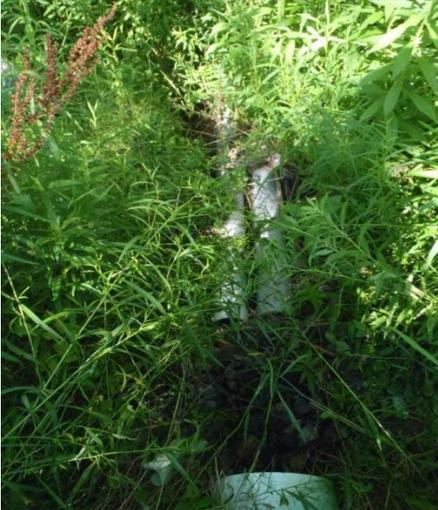
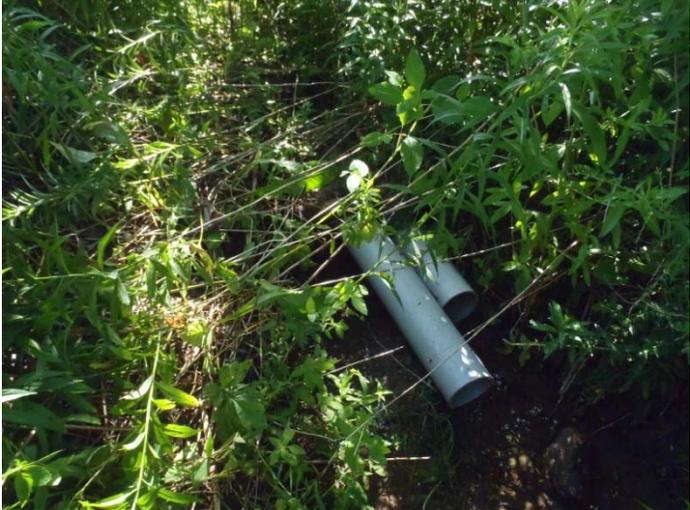
12" plastic pipe outfalls to two- 6" pipes that appear to help direct flow of water. Pipes appear to have been buried at one point, but erosion has caused them to be exposed. Scour pool and channelization has formed at outfall of two 6" pipes. Water leads to a wet bank buffer zone before flowing into Allen Brook.

Photo 1. "Intersection" of 12" and 6" pipes	Photo 2. Scour at outfall of 6" pipes

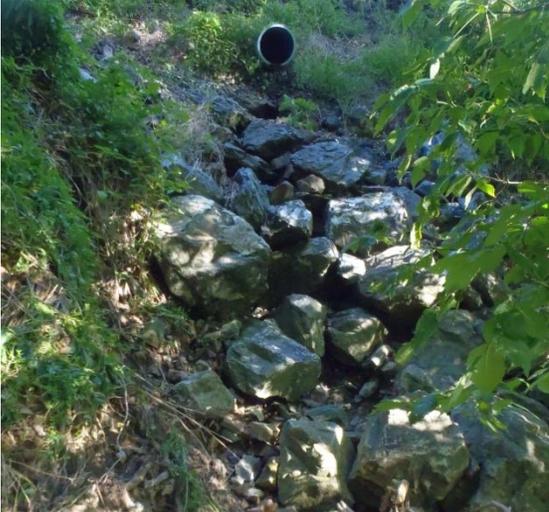
Description of Observed Conditions:
 12" plastic outfall; riprap has been placed below outfall - outfall drop is ~1'. Erosion is present in a few areas around riprap. Major sediment build up at intersection with Allen Brook. Large amounts of storm debris evident in brook.

Photo 1. Erosion left of riprap

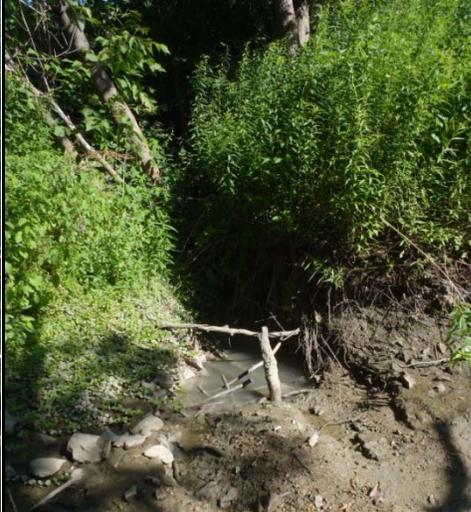
Photo 2. Sediment in Allen Brook

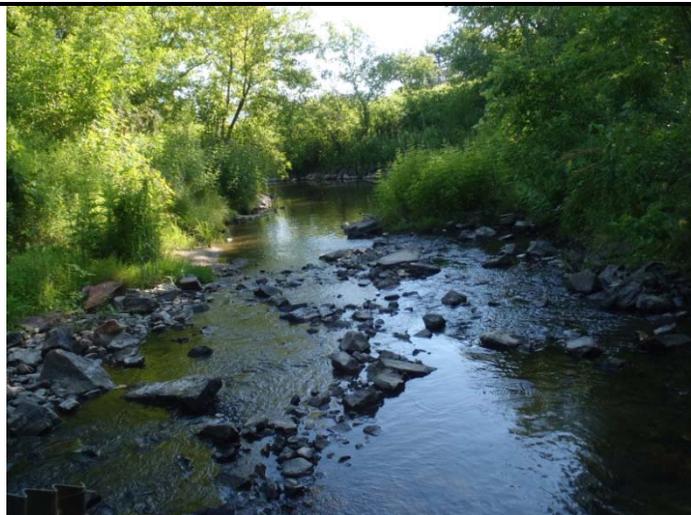
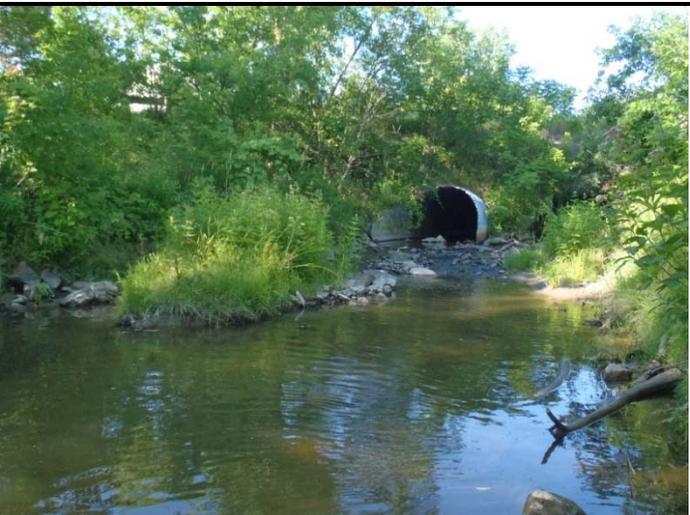
Description of Observed Conditions:
Sediment “delta” and scour pool forming at outfall of double-barrel culverts. Scour pool is developing at outfall. Culvert is less than bankfull width.

Photo 1. Looking downstream from culvert outfall	Photo 2. Culvert outfall

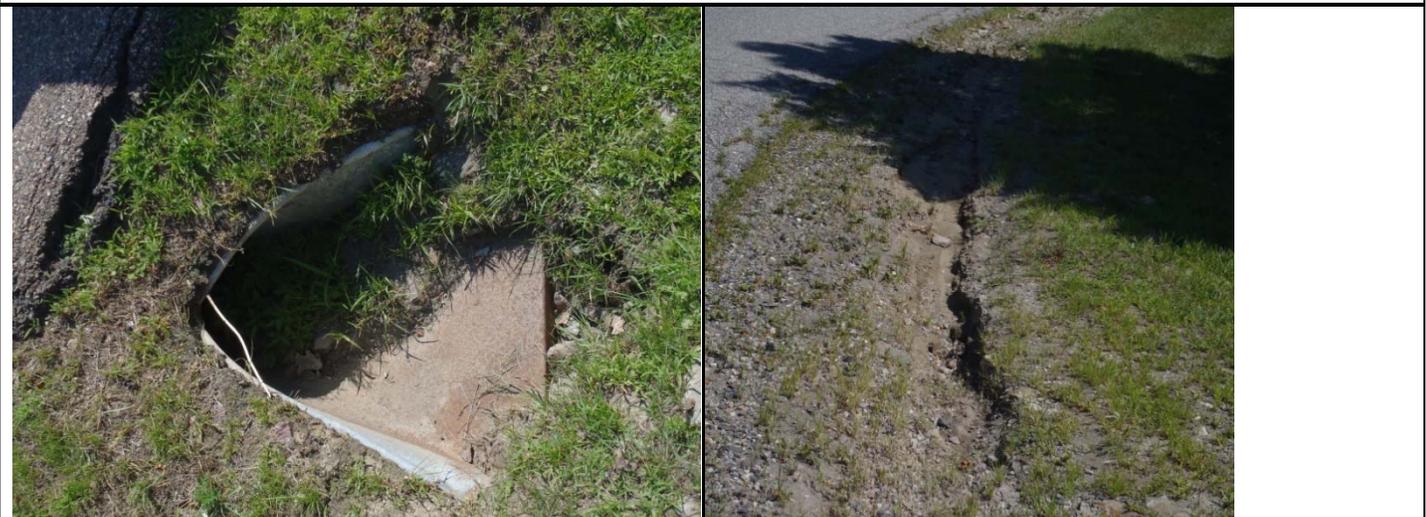
Erosion in drainage ditches on west side of Avenue D; excess flows have begun to undermine. Check dams have been installed to slow water rate as it approaches culvert. Gullying present on the east side of road at bend in Avenue D. Some evidence of hillside cutting and erosion on bank from parking lot run-off at Production Advantage.

Photo 1. Culvert, beginning to be undermined

Photo 2. Curve side trenching

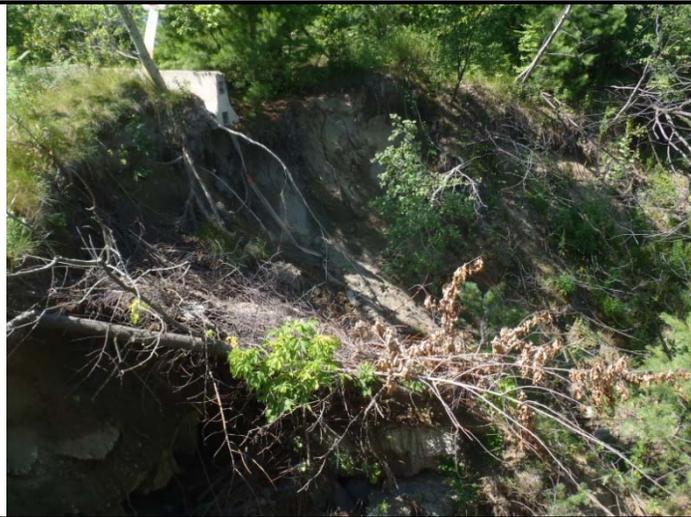
Major erosion and bank failure. Landslide extends several hundred feet down into old sand pit. Run-off from road could be contributing to erosion around outfall.

Photo 1. View from top of slide

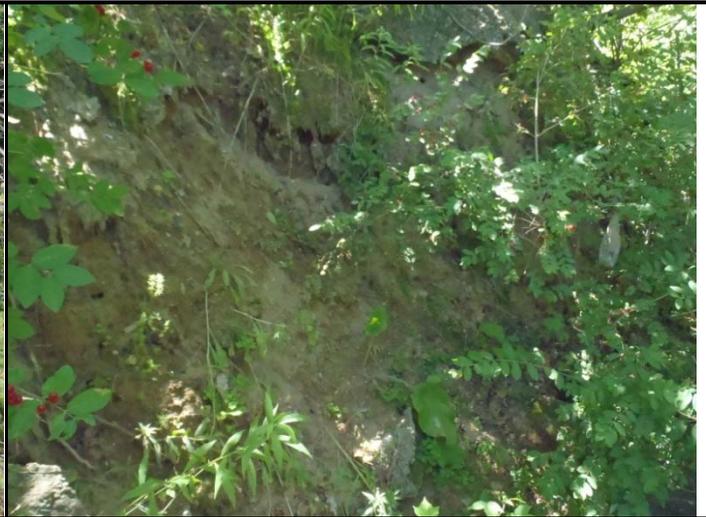
Photo 2. Further down in slide

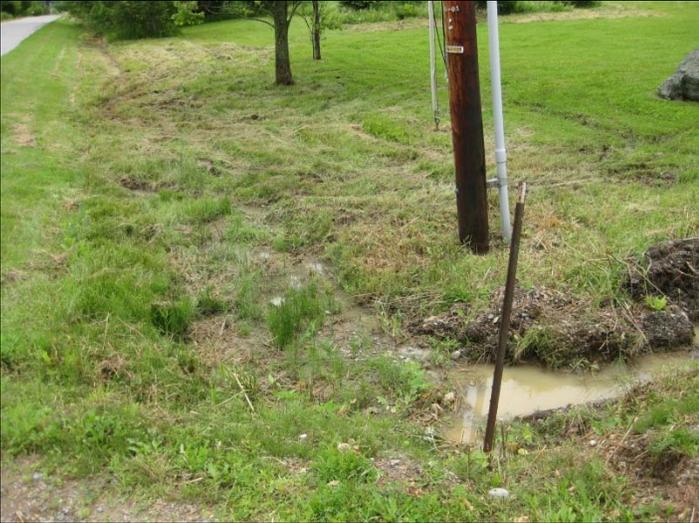
Black 12" corrugated plastic culvert under Amber Ln. Sediment accumulating at outfall of culvert. Area is high point on Stage Rd where it appears that water may have no place to flow. Ditches are level, no gradient to them.

Photo 1. Water ponding along Old Stage Road at the intersection with Amber Lane

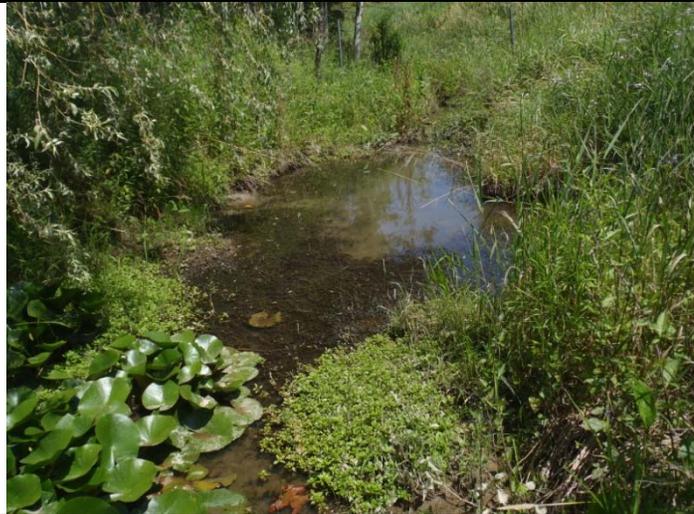
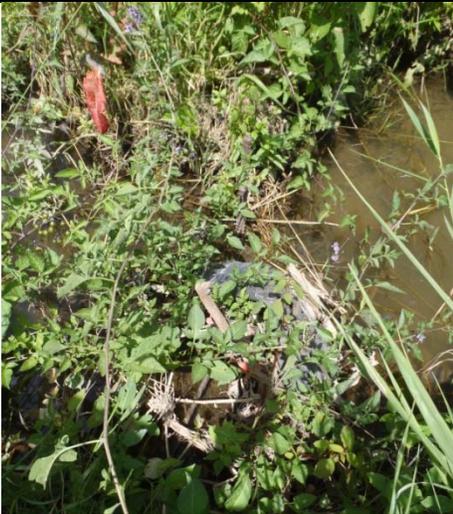
Description of Observed Conditions:
 Ponding of water before entering marsh area. Pond is 8' by 12' about 8" deep. Signs of small dam/blockage at one point with rebar in stream; obstruction has been breached.

Photo 1. Ponding of water	Photo 2. Remnants of blockage

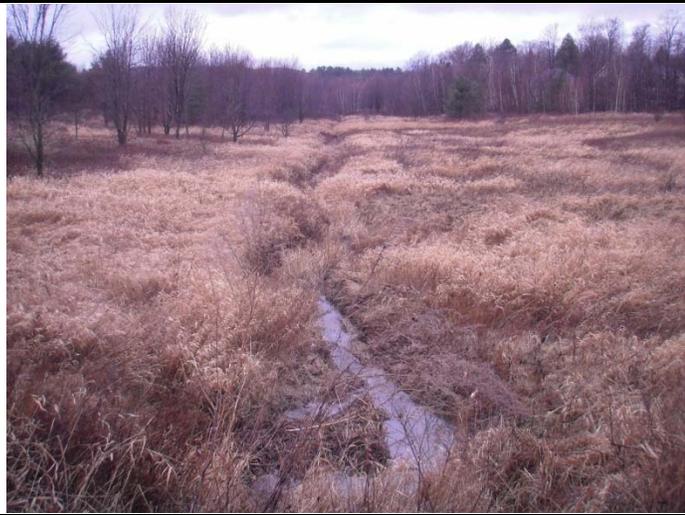
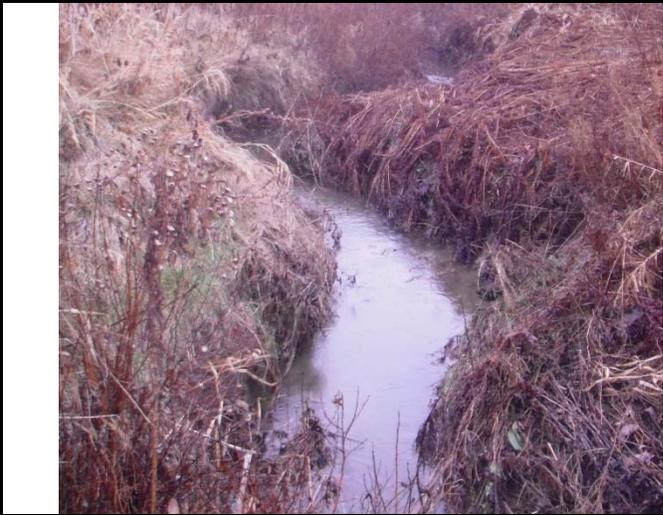
Description of Observed Conditions:
 Incised banks are constantly failing. Conditions worsen as stream progresses down channel. Large amount of development in the watershed.

Photo 1. Stream in wetland area	Photo 2. Erosion of stream banks.

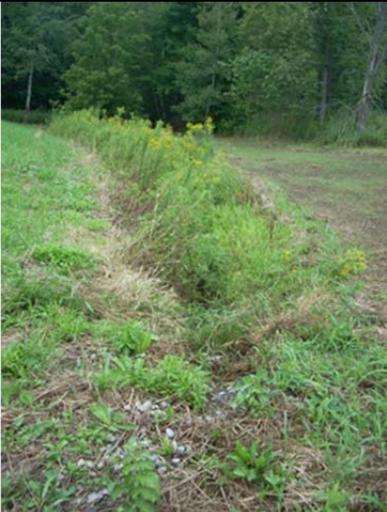
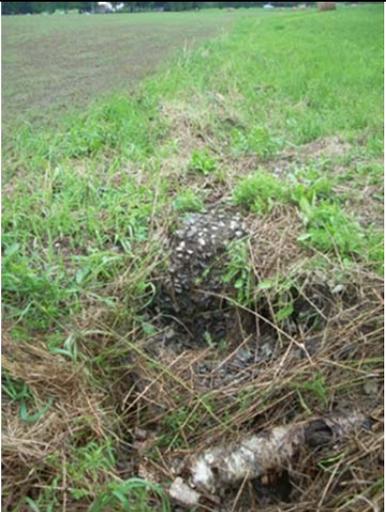
Photo 1.	Photo 2.

Loose gravel around underground pipe is eroding. Pipe end is filling in with material and channelization occurring immediately after outfall. Pipe appears to drain field and house area upstream. Problem caused by piping and burying the natural drainage which conveys runoff from the golf course.

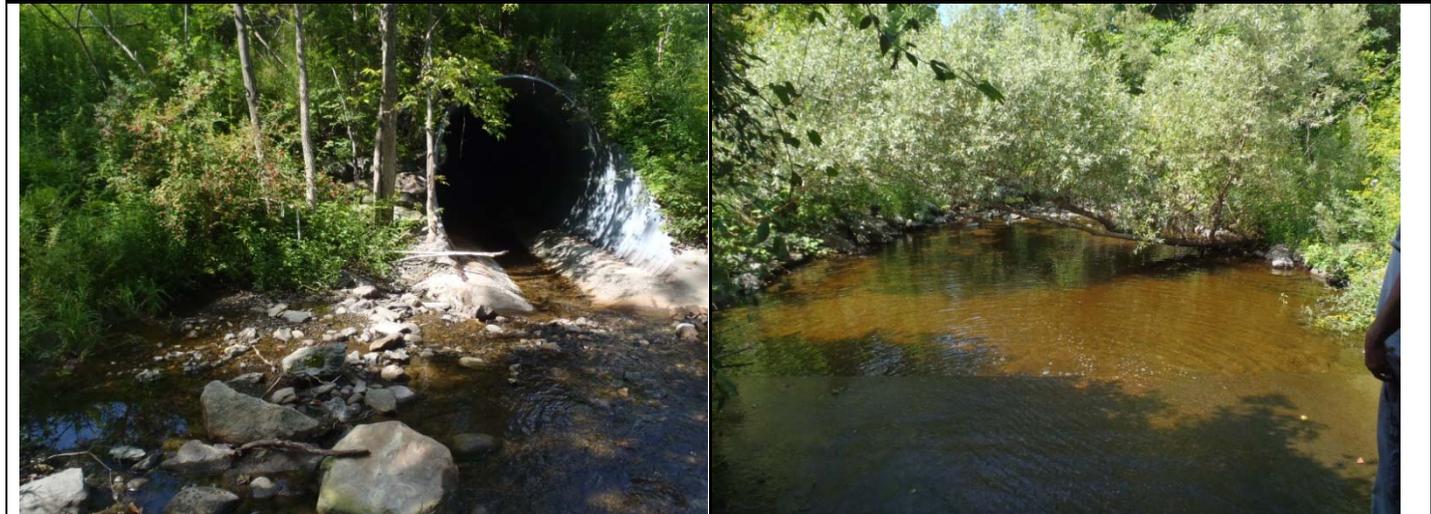
Photo 1. **Photo 2.**

Description of Observed Conditions:
 Upstream, brook makes an “S” as it approaches culverts. Bank scouring at the entrance to culvert. Between N/S lanes of 89 small scour pool is present. Scour pool at North bound outfall with 6” headcut from concrete box culvert.

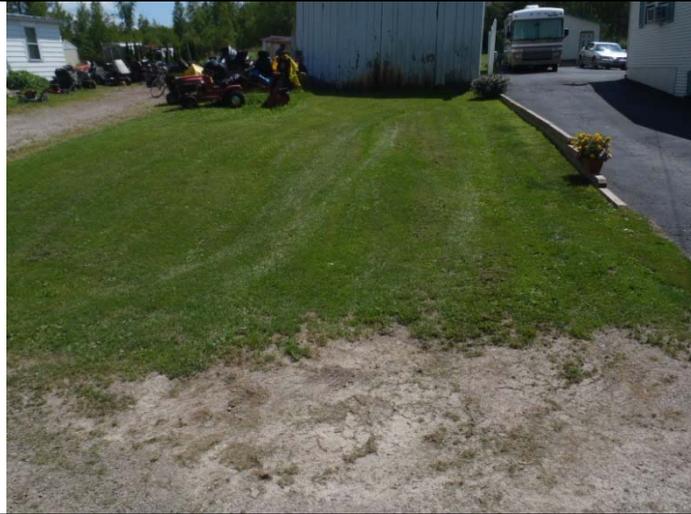
Photo 1.

There is a lawn swale that runs from under barn to edge of property and sidewalk. Some signs of standing water and localized erosion in private drive.

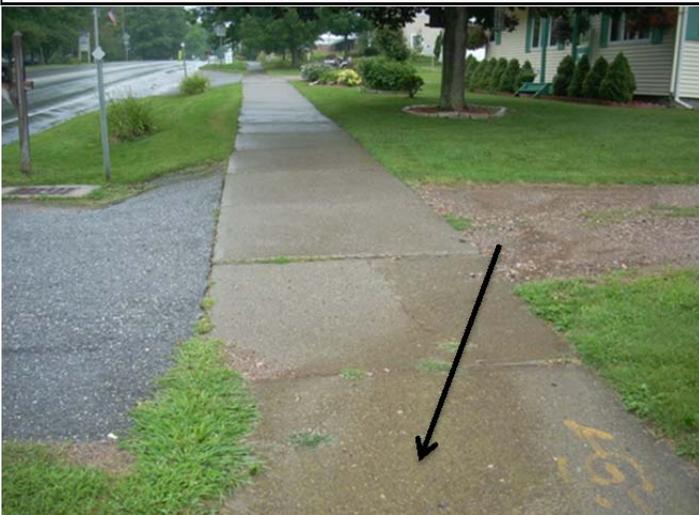
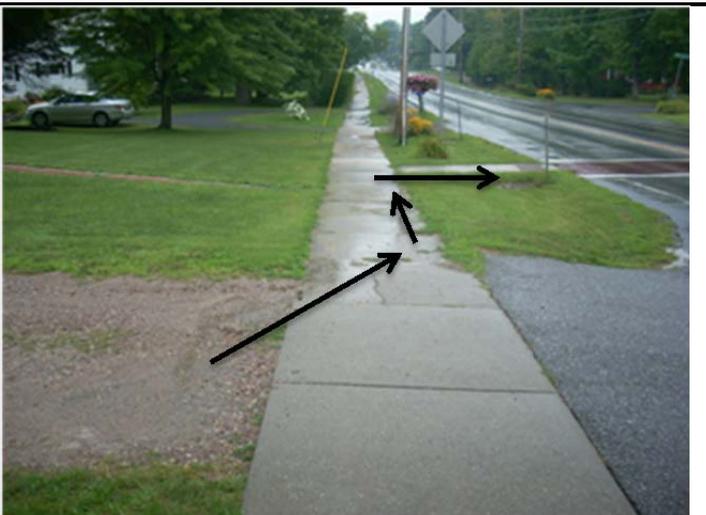
Description of Observed Conditions:
Stormwater pipe flows from French drain underground to catch basin. French drain is a 6" plastic pipe and stormwater pipe is 12". Signs of erosion and water bypass at French drain outlet causing water to flow into driveway and onto sidewalk and street.

Photo 1.	Photo 2. Looking down to street

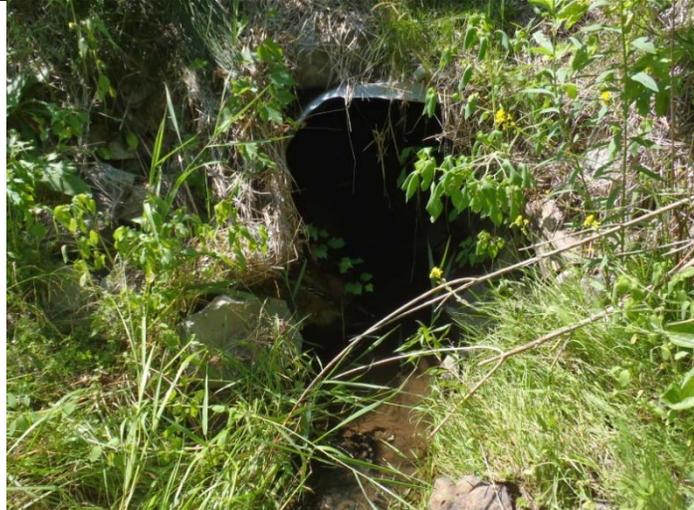
Description of Observed Conditions:
 3' corrugated metal culvert; bottom has deteriorated. Culvert is ~50% of bank width; scour is evident at outfall and channel is incising.

Photo 1. Inlet, grass on sides matted down	Photo 2. Deteriorated culvert

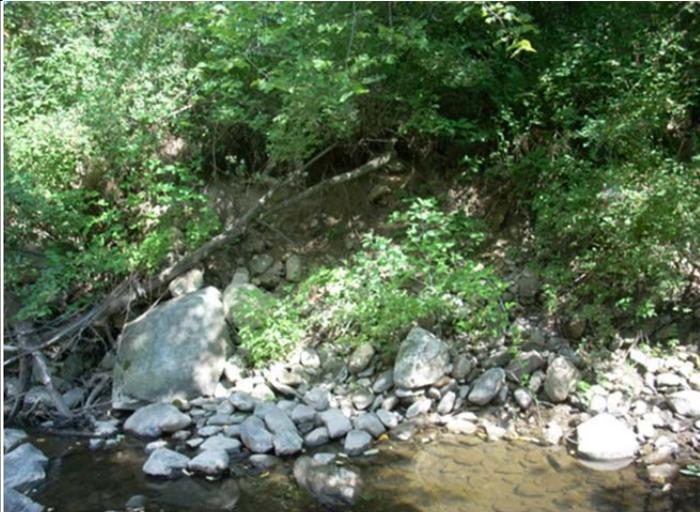
Photo 1.

Description of Observed Conditions:
 Mass wasting and erosion on outer bank of stream; streambanks are undercut. Local, sandy soils may be particularly sensitive to unraveling.

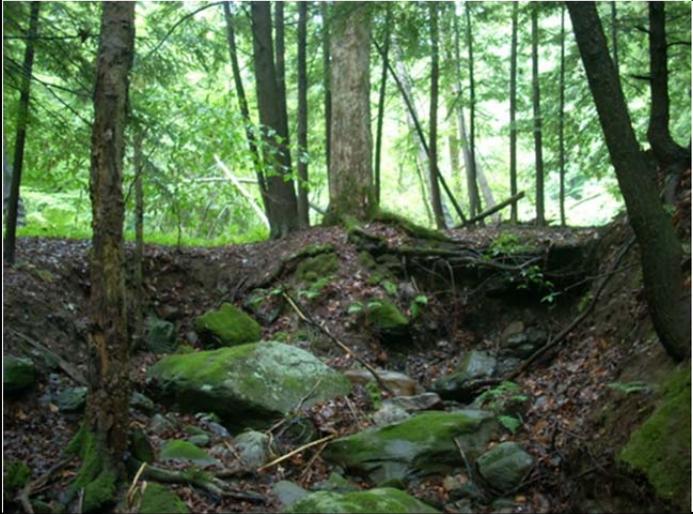
Description of Observed Conditions:
Areas of streambank erosion and small undercuts and bank collapses were observed. One area where water has jumped bank was also noted.

Photo 1. Streambank has been undermined	Photo 2. Localized bank collapses

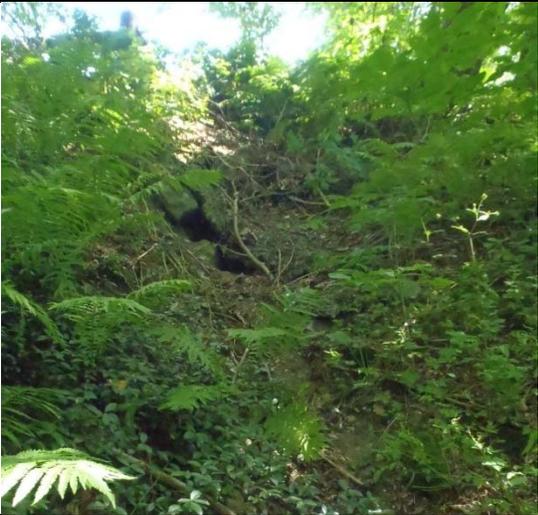
Gully has formed in northwest corner of parking lot, where land slopes down to the woods line. Gully is not deep, but has potential to increase in size. Gully stops about 30 ft down into woods.

Photo 1. Looking up gully

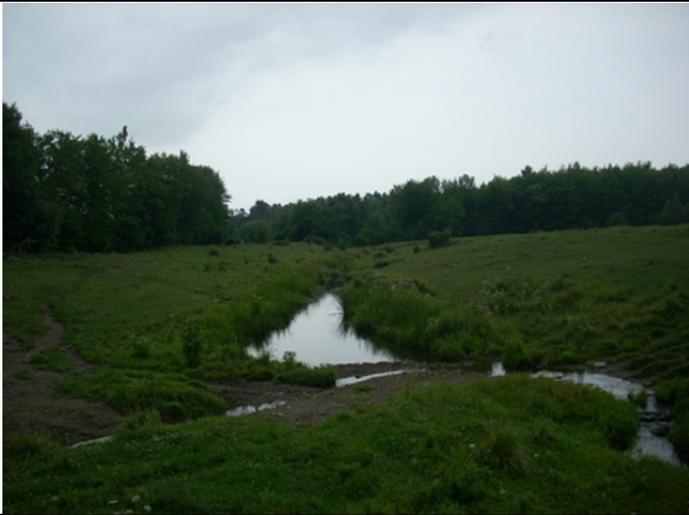
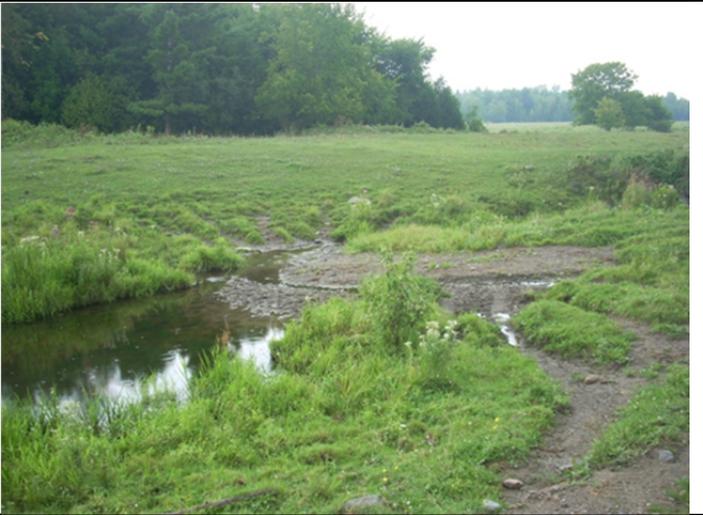
Photo 1.	Photo 2.

Description of Observed Conditions:
No buffer or fence between cattle grazing and stream. Evidence of direct animal access to the stream (Photo 2).

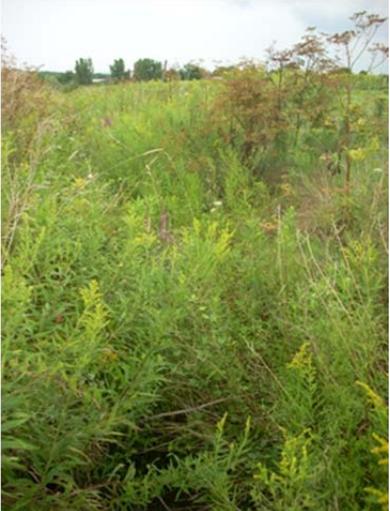
Description of Observed Conditions:
Roadside ditch is eroding/deepening over time; mostly stable now.

Photo 1. Ditch is mostly well-vegetated	Photo 2. Bank erosion/sloughing

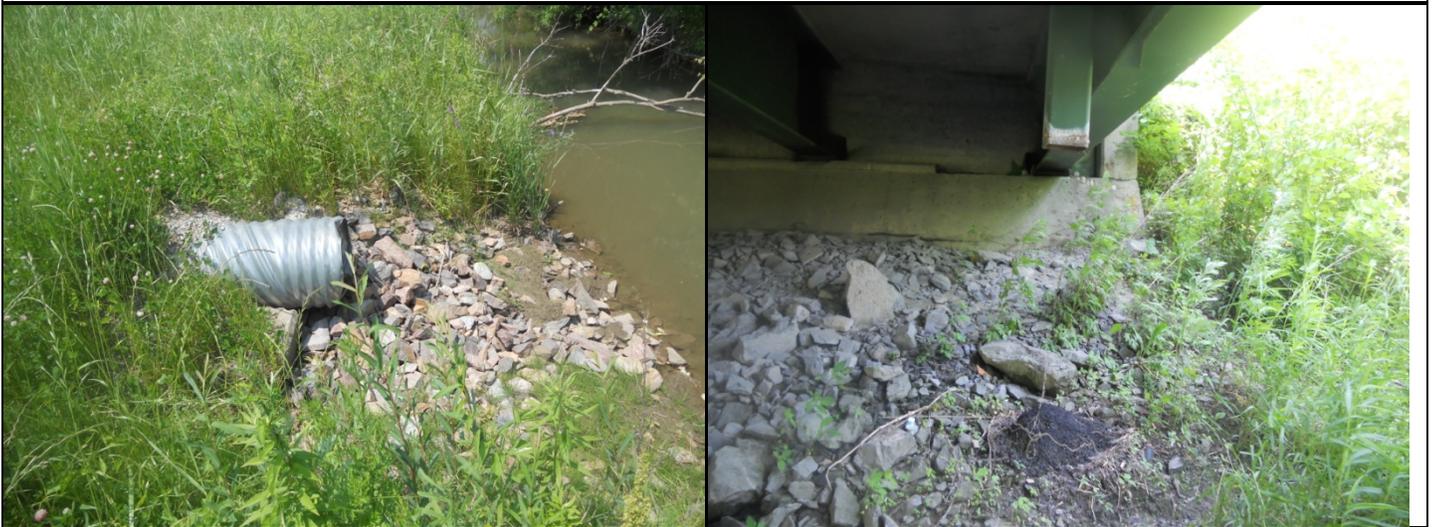
Six drains from northbound lanes and three pipes from southbound lanes of I-89 discharge directly into Muddy Brook. Southbound drains causing erosion and trenching into Muddy Brook. New riprap was recently placed around culvert in question

Photo 1. Recent riprap around culvert

Photo 2. Highway drainage

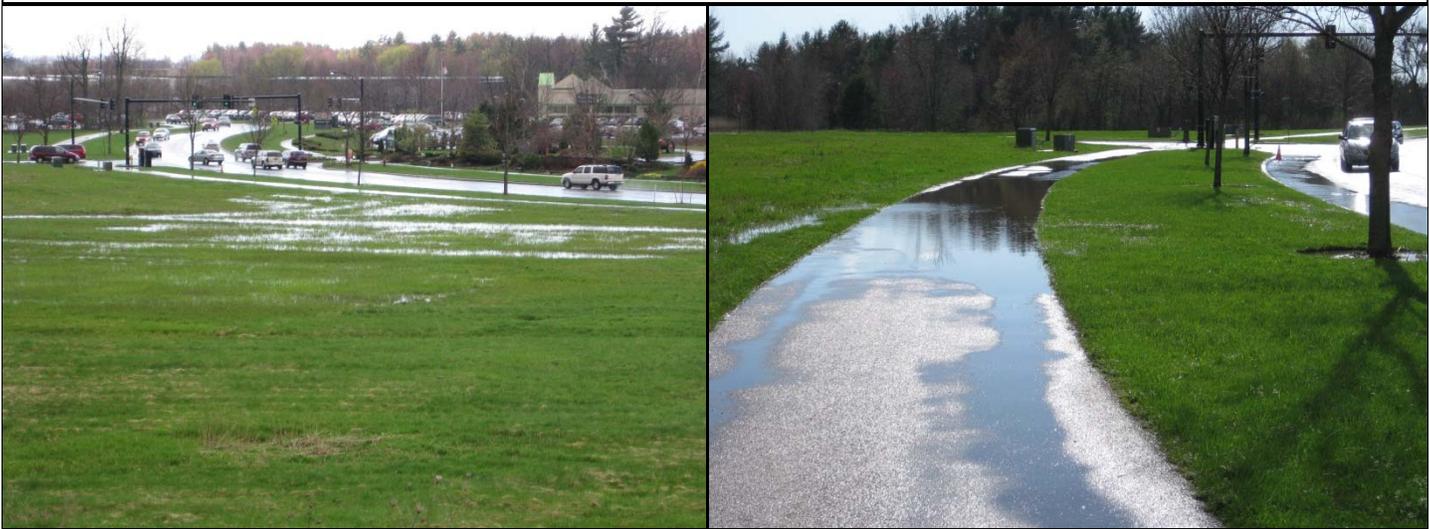
Marshall Avenue and the adjacent sidewalk flood as the Muddy Brook floodplain overflows across private property. Town Public Works Department contacted the developer who cleaned the culvert; more observations are needed to ensure problem has been fully addressed.

Photo 1. Evidence of poor drainage

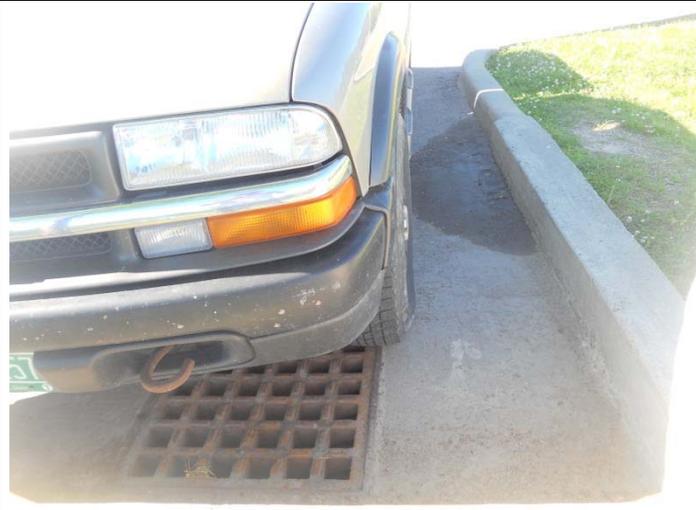
Catch basin is slightly elevated or pavement/ground around the basin has settled and sunk in corner of parking lot. Water is flowing next to basin straight into the curb and then over and down the bank towards the Wal-Mart drive. Trenching is visible on west side of drive where water flows to. Water is seeping from hillside between two basins, unsure of this source as it had been dry for a few days before observations.

Photo 1. Water seeping from ground	Photo 2. Bank damage

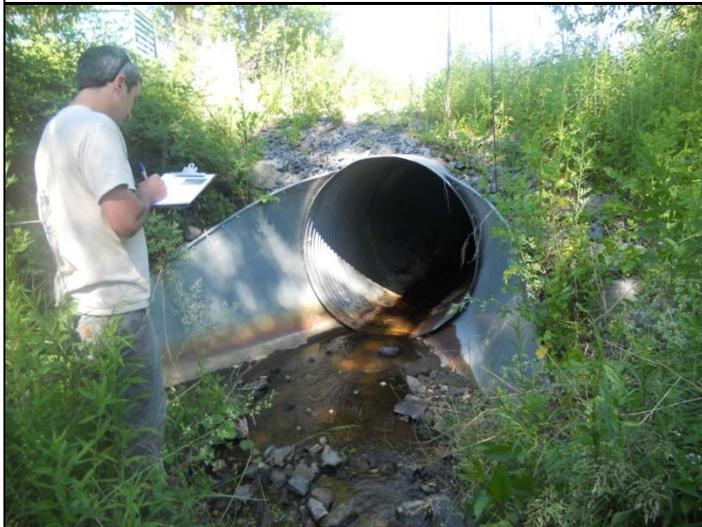
Photo 1. Looking downstream

Description of Observed Conditions:
 Sediment built up at outfall of culvert, which is causing pooling in the culvert and very slow moving water at outfall. Large amounts of sediment downstream of culvert altering flow of water. Town Public Works Department contacted the developer who cleaned the culvert; more observations are needed to ensure problem has been fully addressed.

Prioritization Ranking Factors							
Relative Impact	Frequency	Current Condition	Urgency	Impact to public infrastructure?	Realistic to fix?	Impacts beyond water resources?	Part of larger systemic problem?
2	2	2	1	Yes	Yes	Yes	Yes
Relative Impact: Upstream erosion from Home Depot site (see MB-15) causing sediment to build up near/in culvert.

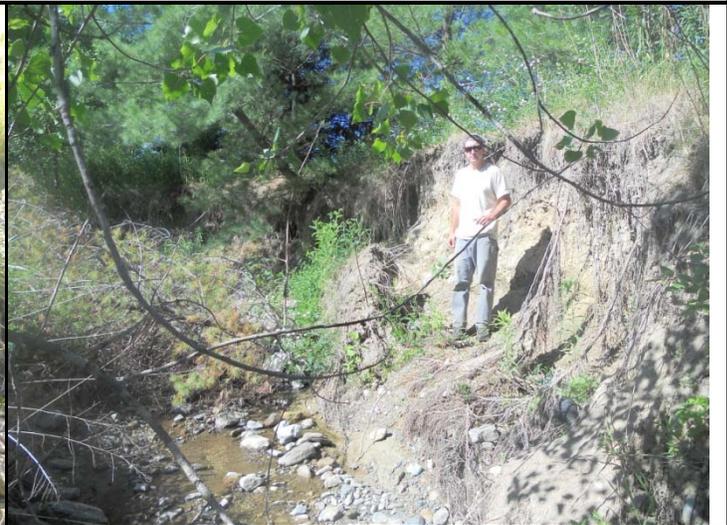
Description of Observed Conditions:
 Severe bank erosion is present along most bends of reach. Major bank under cutting occurring, particularly along the bank that separates stream from Home Depot parking lot, only about 6' of bank left. Could be cause of sediment build up in MB 14, as it is just upstream of culvert.

Photo 2. Bank between Home Depot and Stream

Relative Impact: Large amounts of erosion in stream causing downstream sediment build up and possible complete bank failure to Home Depot parking lot. Bank between stream and parking lot is severely eroded.

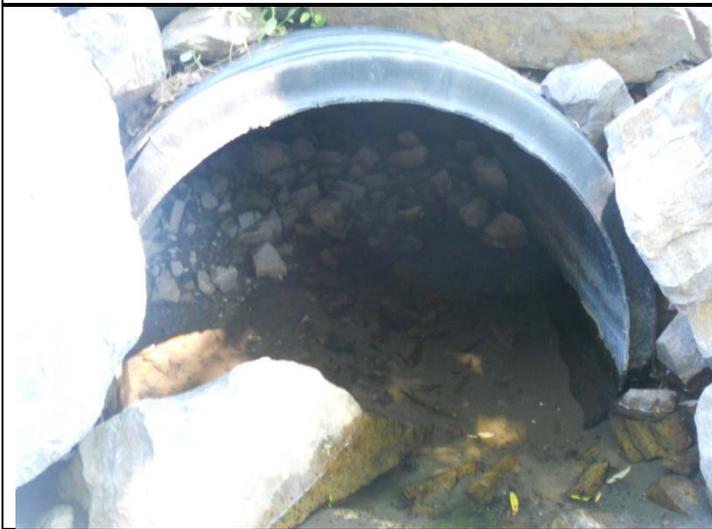
Majority of the issues appear to be on the southeast side of 2A; road-side ditches are eroding road shoulders. Drainage ditch crosses 2A at #3283 with 24" plastic culvert. Culvert is ½ full of sediment and debris. Hydraulic capacity of culvert decreased from aggraded material.

Photo 1. Aggradation in culvert.

Relative Impact: Drainage ditches along road needs repair; culvert needs to be cleaned out. Slope of culvert or source of backwater should be investigated to determine reason for aggradation.

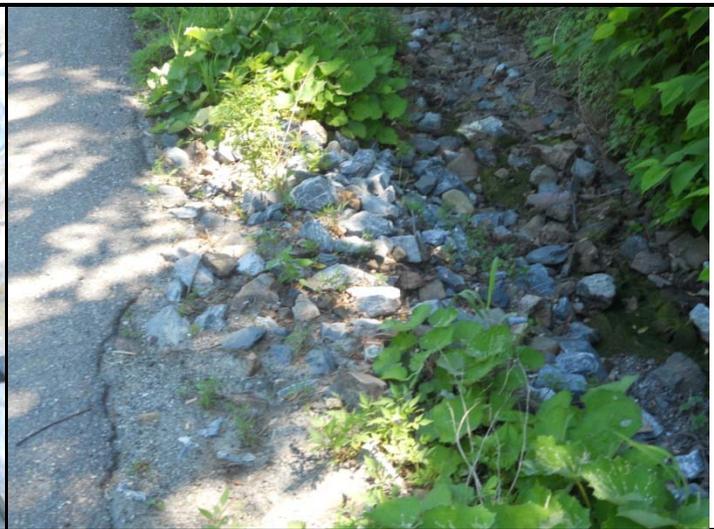
Photo 2. Road side erosion

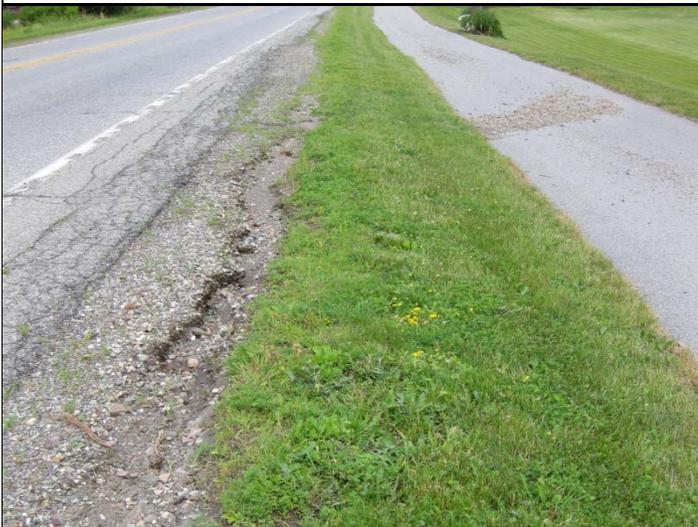
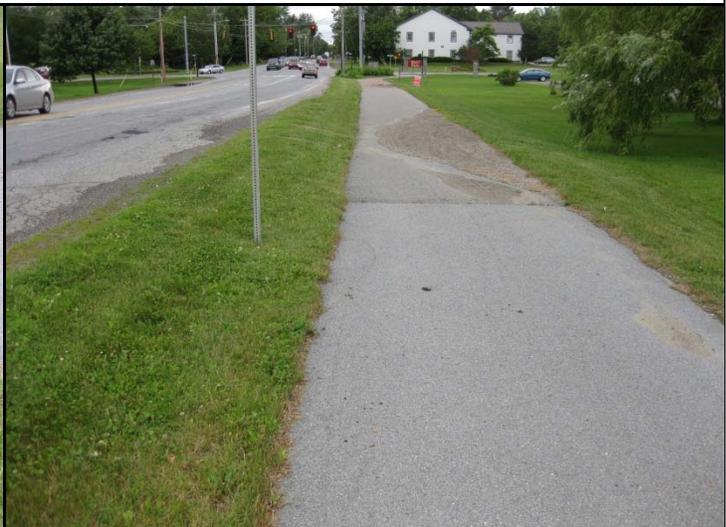
Evidence of road run-off is present on sidewalk. Trenching has formed between road and green belt.

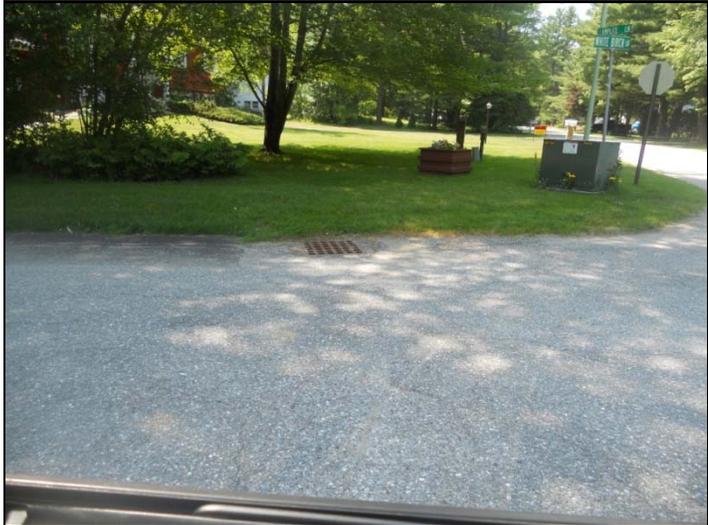
Photo 1.

Description of Observed Conditions:
 Catch basin appears to be clear of debris, difficult to determine exact cause of flooding.

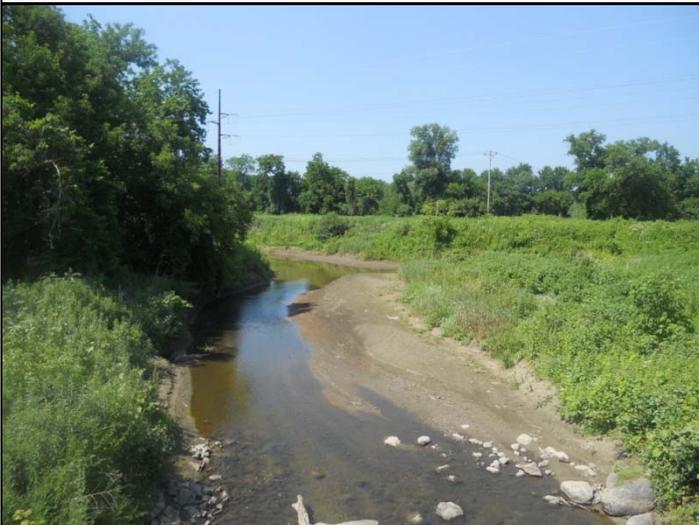
Description of Observed Conditions:
 Sediment build up occurring downstream of bridge. Small, 1' head cut just upstream of bridge. Signs of bank erosion on both upstream and downstream edges, majority is on west side. Existing bridge is causing significant upstream and downstream erosion; existing bridge is 52% of bankfull width.

Photo 1. Looking downstream	Photo 2. Upstream

Prioritization Ranking Factors							
Relative Impact	Frequency	Current Condition	Urgency	Impact to public infrastructure?	Realistic to fix?	Impacts beyond water resources?	Part of larger systemic problem?
1	1	2	1	Yes	No	No	No
Relative Impact: On-going in channel erosion as brook continues to adjust to increased stormwater flows and constriction caused by undersized bridge.

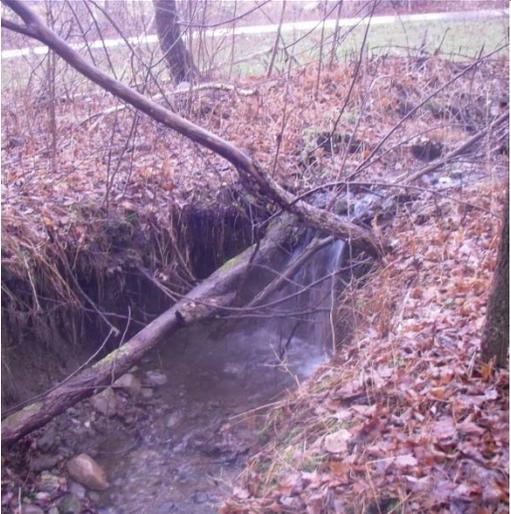
Description of Observed Conditions:
 4-5-foot headcut forming downstream from culvert under Blackberry Ridge; streambank is actively eroding.

Photo 1. Looking upstream	Photo 2. Downstream

Prioritization Ranking Factors							
Relative Impact	Frequency	Current Condition	Urgency	Impact to public infrastructure?	Realistic to fix?	Impacts beyond water resources?	Part of larger systemic problem?
3	2	2	3	No	Yes	No	Yes
Relative Impact: Headcut will eventually move up to culvert, endangering bank stability.

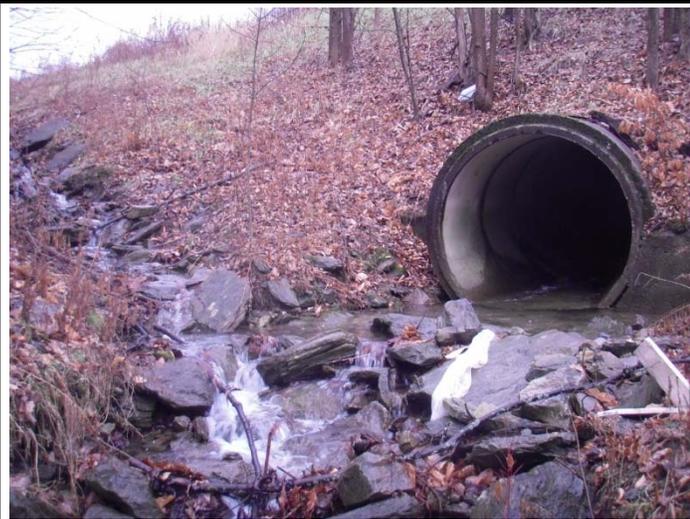
Description of Observed Conditions:
 Streambank erosion downstream of culvert. Access to floodplain ~100ft downstream.

Photo 1. Looking upstream at culvert under I-89 N.Bound

Prioritization Ranking Factors							
Relative Impact	Frequency	Current Condition	Urgency	Impact to public infrastructure?	Realistic to fix?	Impacts beyond water resources?	Part of larger systemic problem?
2	1	2	2	No	No	No	Yes
Relative Impact: Some stabilization measures have been implemented. Rip-rap has failed in places and bank erosion continues.

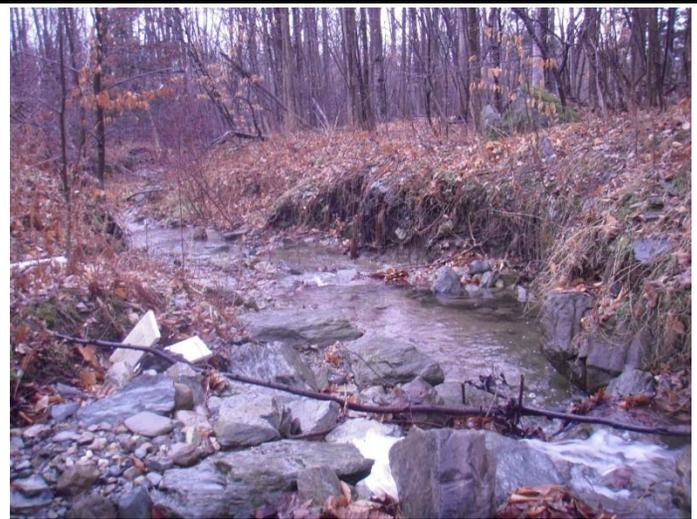
Photo 2. Looking downstream from culvert under I-89.
