TOWN OF WILLISTON

TOWN-WIDE WATERSHED IMPROVEMENT PLAN - PHASE 1

FINAL REPORT

Stone Project ID 12-055

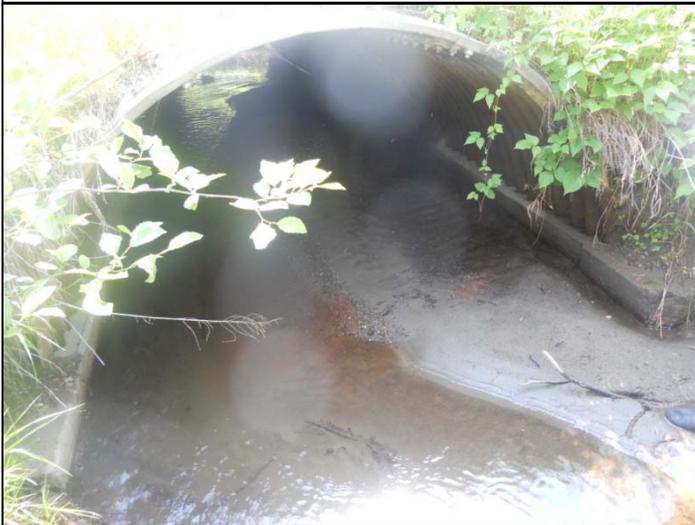
A series of small headcuts (6-10" in height) and scour pools are visible in this section of Sucker Brook. As was noted in the 2007 SGA, and reconfirmed during this process, the culverts found in this reach are all undersized, especially the two which take the stream under Ridge Road (5.5') and the driveway crossing at the reach break (4.5'). Channel width through this area ranges between 13 and 15 feet.

Photo 1. Culvert under Ridge Road

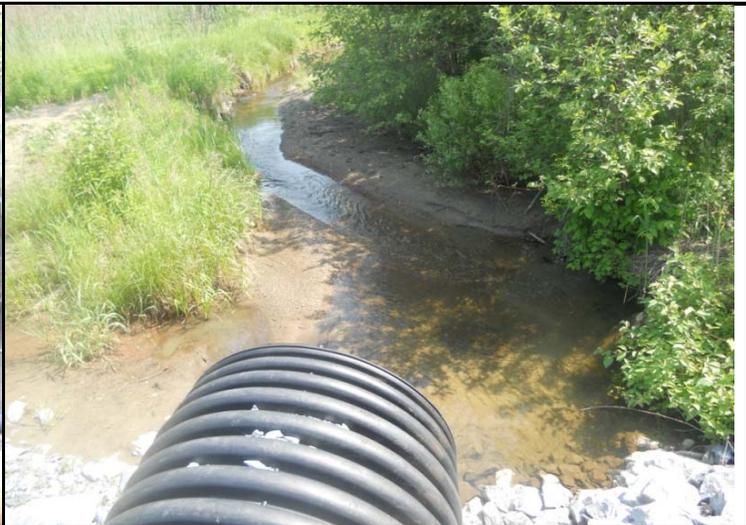
Photo 2. Culvert under private drive

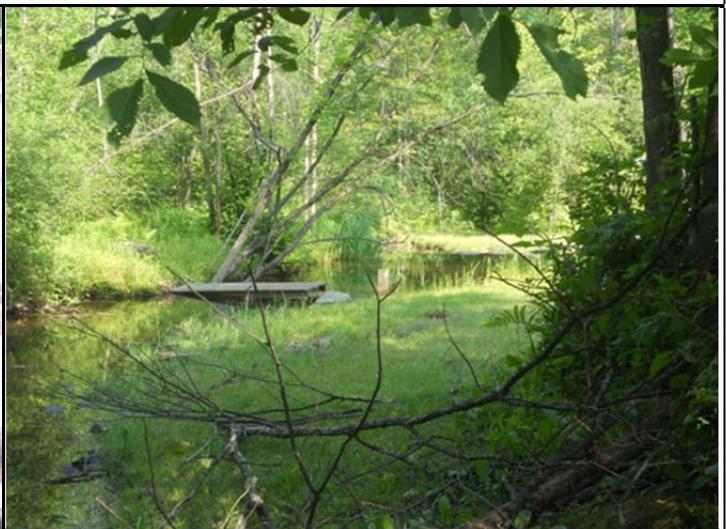
In this area, Sucker Brook is being impacted by residential encroachment (and the attendant stormwater runoff) and unnatural structures placed in and across the channel. Specific observed problems include eroding streambanks and channel incision.

Photo 2. Foot bridge and "abutment"

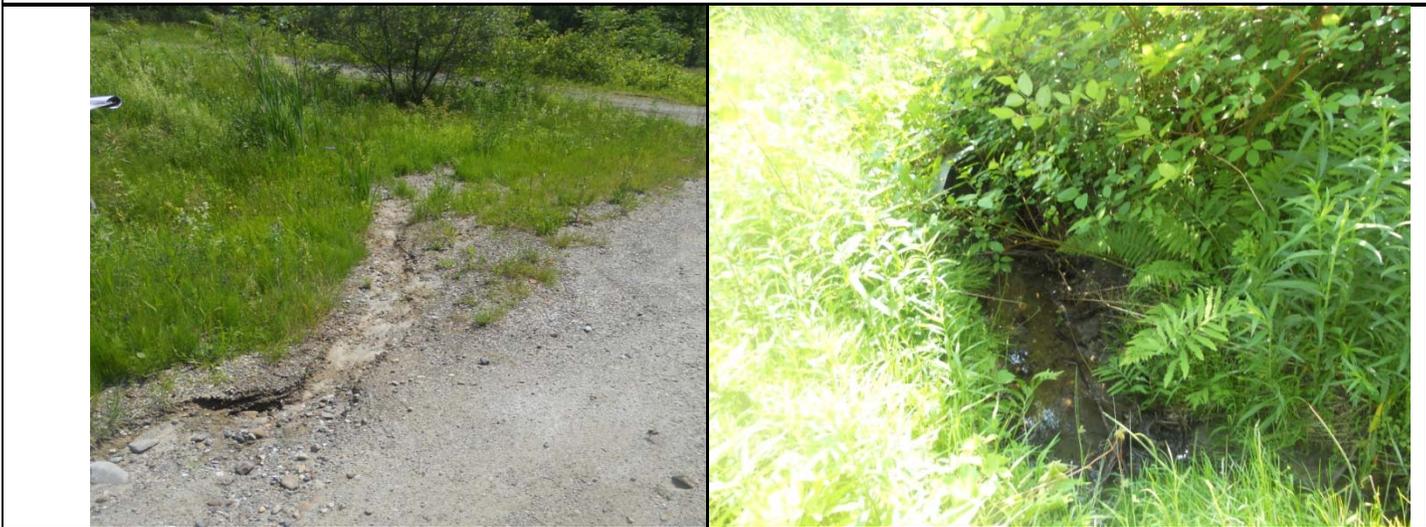
Culverts running under Chaloux Ln and private drive are significantly overgrown. Some sediment build up is present at outfalls. Northeast corner of intersection showing signs of erosion related to road run-off. Southern edge of Lincoln Road also showing signs of run-off and trenching.

Photo 1. Road erosion

Photo 2. Culvert under Chaloux Lane

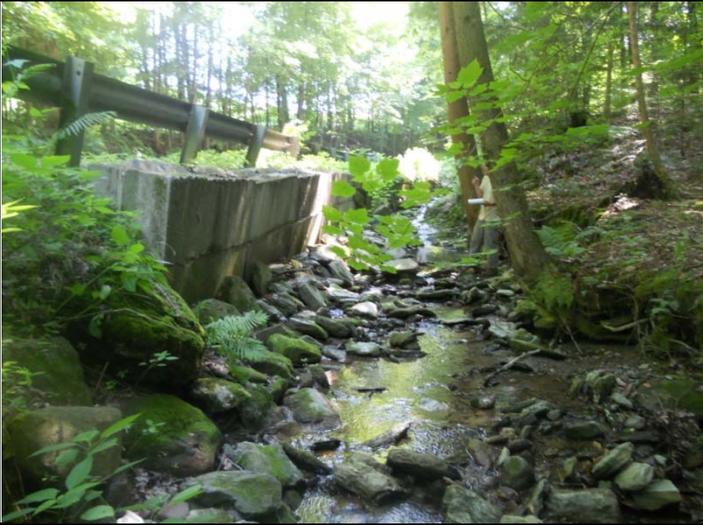
Retaining wall is collapsing; guardrails are leaning as well. Wall is made of 2'x5' concrete blocks, stacked two high, running 17 columns long. Public Works is aware of the concern and has indicated plans to reinstall the retaining wall in 2013. Depending on where things stand in the design and funding of the fix, may have an opportunity to consider a less structural solution.

Photo 1. Retaining wall (looking upstream)

Prioritization Ranking Factors							
Relative Impact	Frequency	Current Condition	Urgency	Impact to public infrastructure?	Realistic to fix?	Impacts beyond water resources?	Part of a larger or systemic problem?
1	2	3	3	Yes	Yes	Yes	No
Relative Impact: Failing retaining wall is impacting road surface and exacerbating erosion along road.

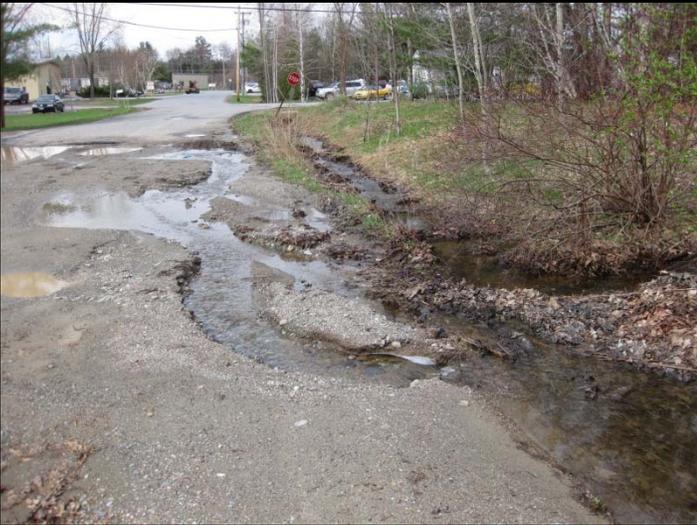
Heavy erosion, significant ruts and mud holes forming in road. Run off from neighboring lots on Shirley Circle and James Brown Dr exceeds the capacity of the ditch beside Shirley Circle and washes out the roadway. Private section of road that is over utilized by large vehicles from Town Garage located at end of public road.

Photo 1. Roadway washout.

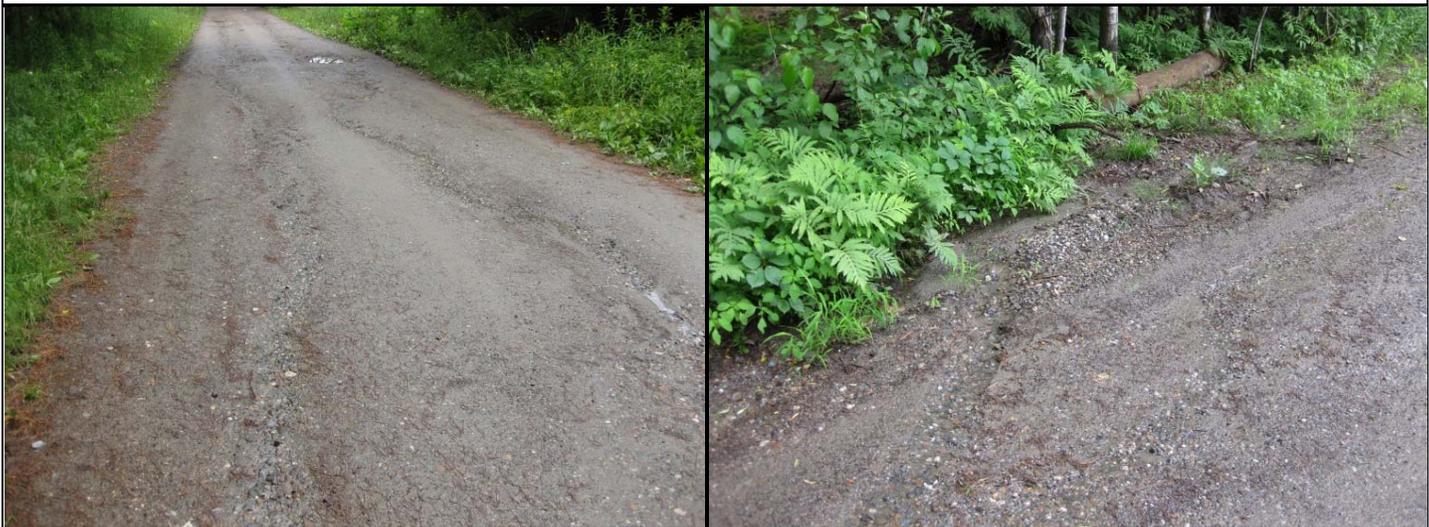
Class 4 road closed Nov 1-May1. Lack of roadside conveyance facilities and proper road crown/cross slope is causing runoff to erode the dirt/gravel roadway. Multiple in-road gullies beginning to form, as road is not crowned/sloped so as to reliably shed water. Undermining of tree and roots along north-side of road.

Photo 1. Erosion in the roadway.

Photo 2. Sediment discharge along road shoulder.

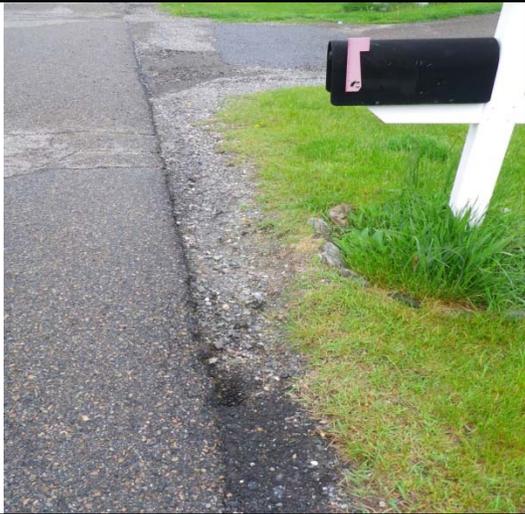
Catch basins positioned in lawns away from road. Storm water flows down edge of road causing gullying and road decay. Town remedy of rubber, semi permeable asphalt working in areas it was installed but it appears that the material was not extended all of the way downhill. All storm water flows to catch basin at center of circle, causing some road damage. Water drains from the catch basin via an 8" corrugated metal pipe which discharges to a drainage ditch in the back of development.

Photo 1. End of town remedy, beginning of erosion
