**Slate Roof Replacement Recommendation for the Forgione Barn
National Register Williston Village Historic District, #24**

November 25, 2024

**Ann Cousins, 36CFR61 qualified Architectural Historian,
Working 35 years as a Professional Historic Preservationis**

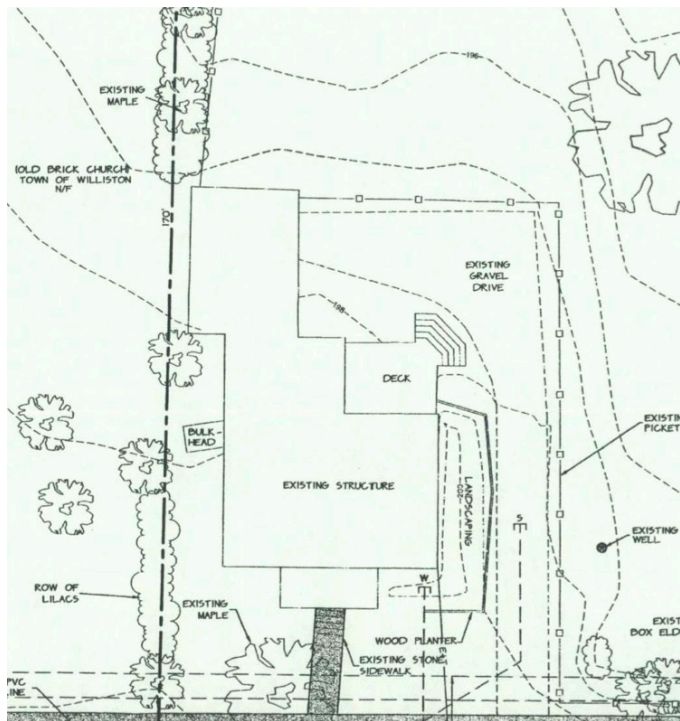
Photo: November 2024
2004-06 renovations included a new hipped roof "link" replacing original 1840 ell adding approx. 300 sq. ft. Barn is elevated and relocated. Renovated barn has new window and pedestrian door on east side; north gable end windows removed and two story stair tower added (2004-06 building project).

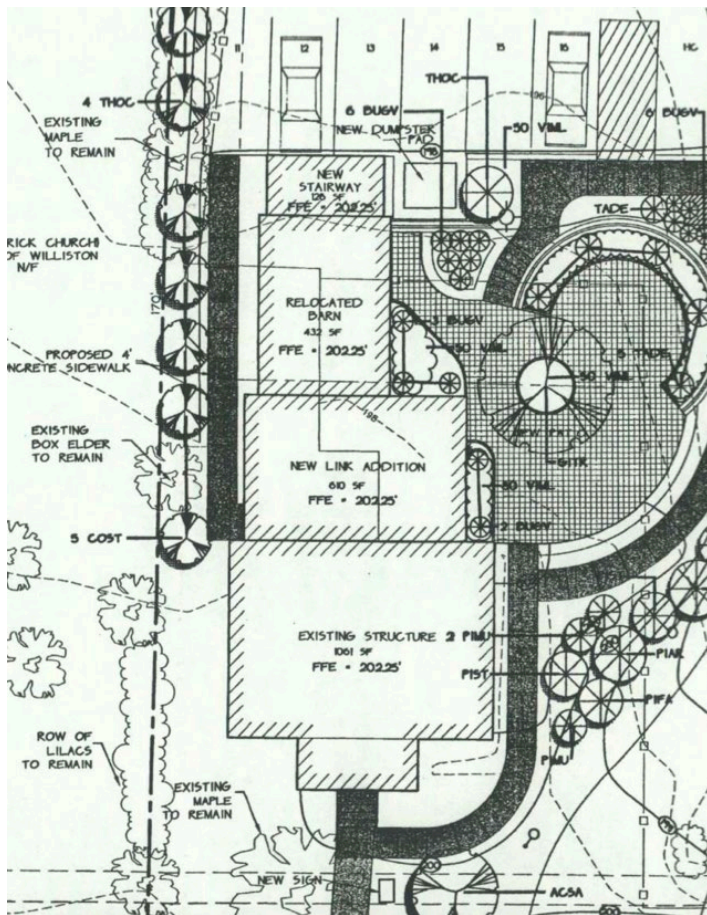
2004 Landscape Plan by O'Leary-Burke Civil Engineers illustrating "New Link Addition," "Relocated Barn" and "New Stairway."
