Appendix A

Reach Mapping

**Muddy Brook Phase 2 Mapping
Reaches M01, M02, M03 &
T1.01 (Allen Brook)**

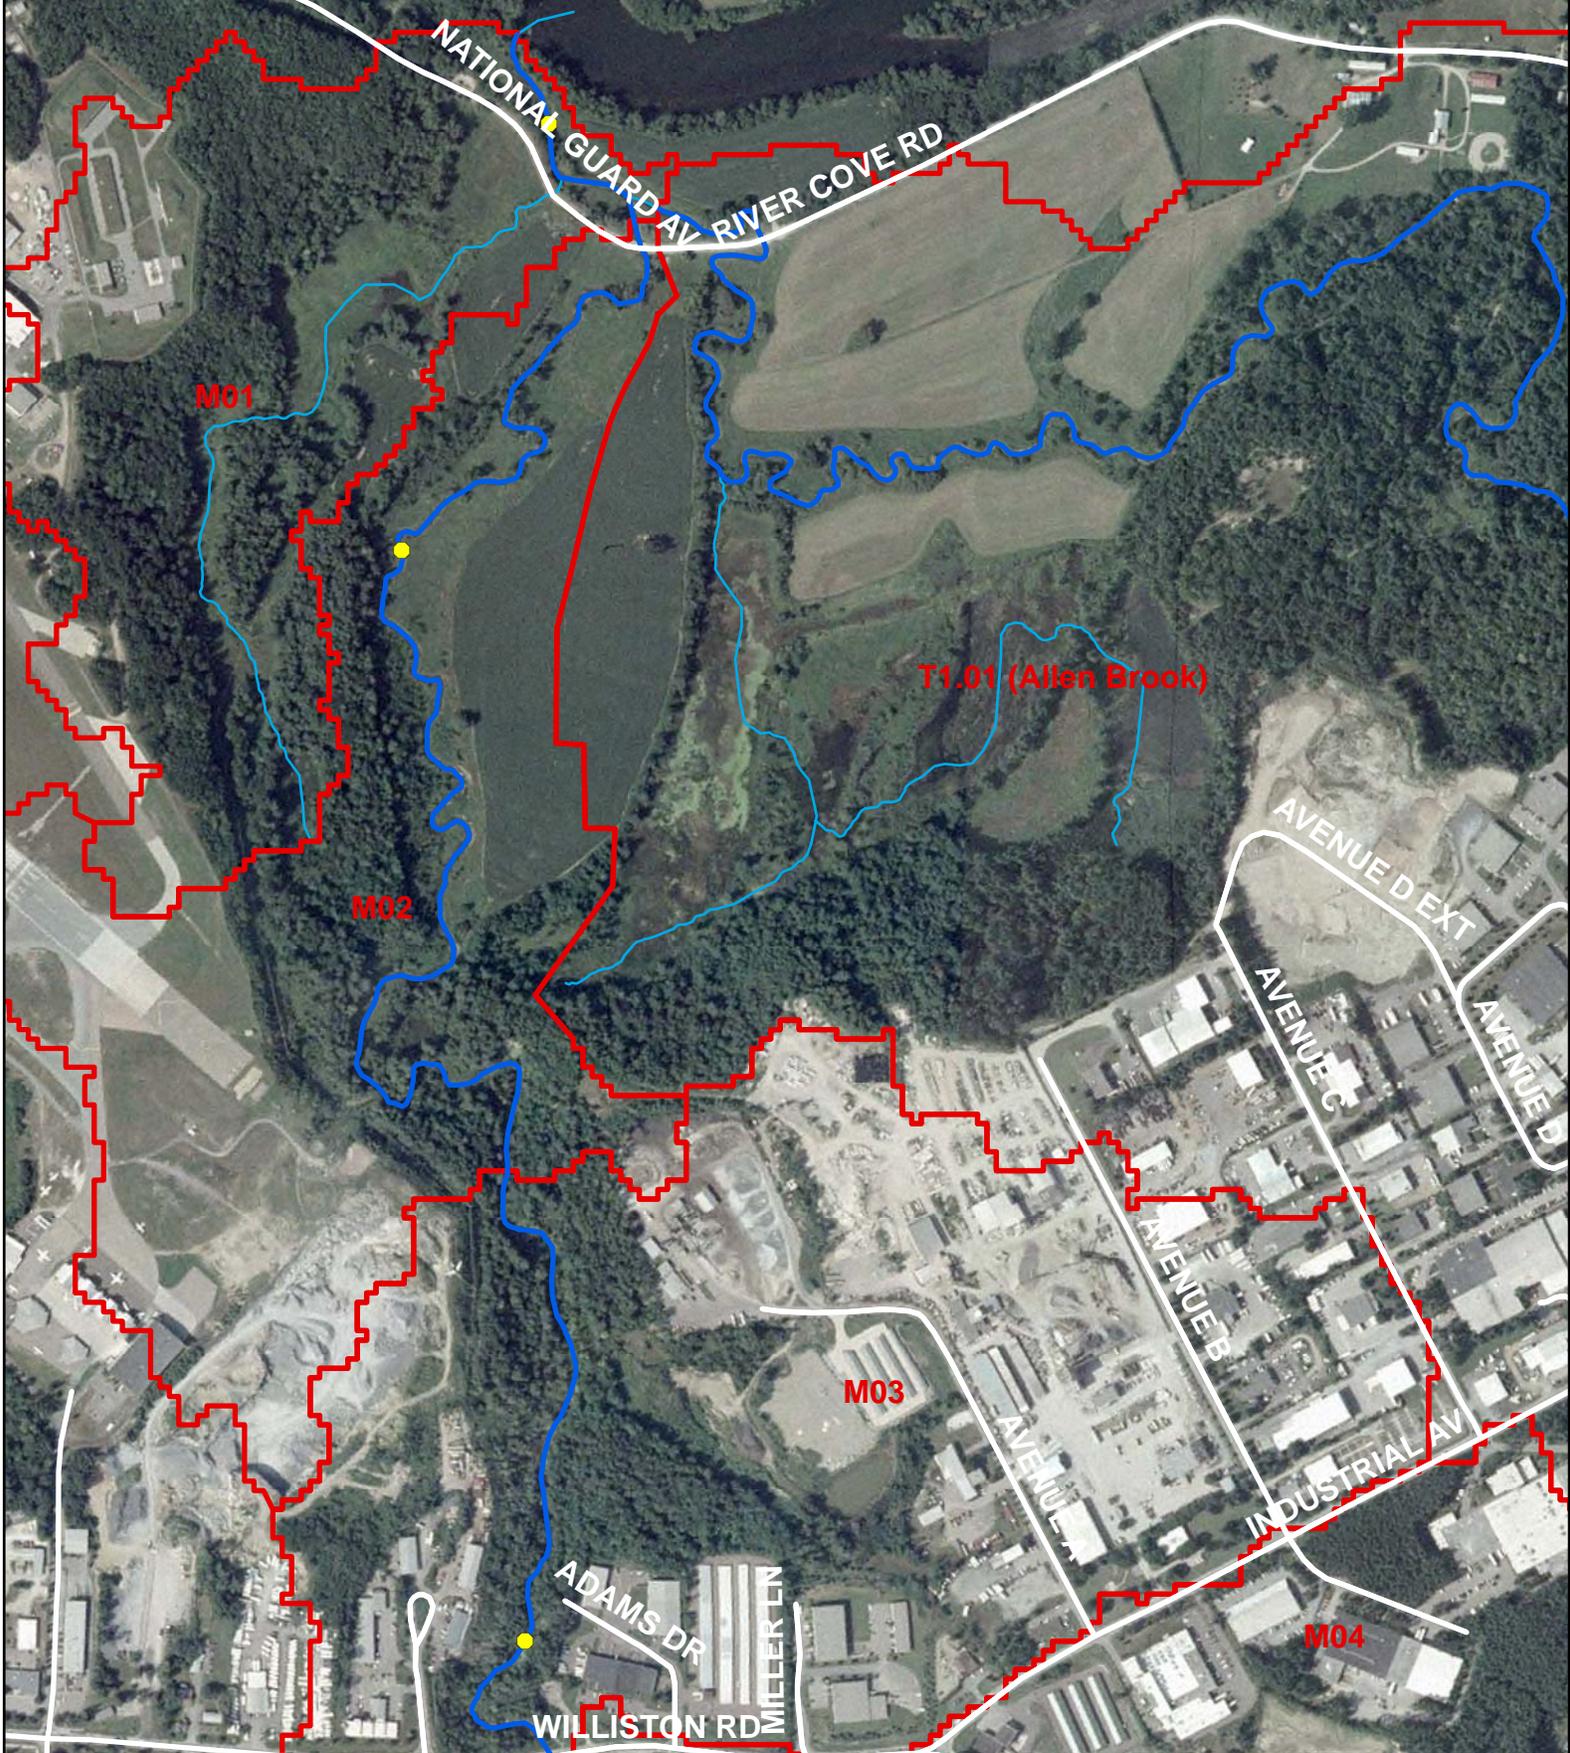
Cross-Section Locations
-

Segment Breaks
-

Subwatershed Boundaries
-

Muddy Bk Surface Waters
-

Minor Tributaries

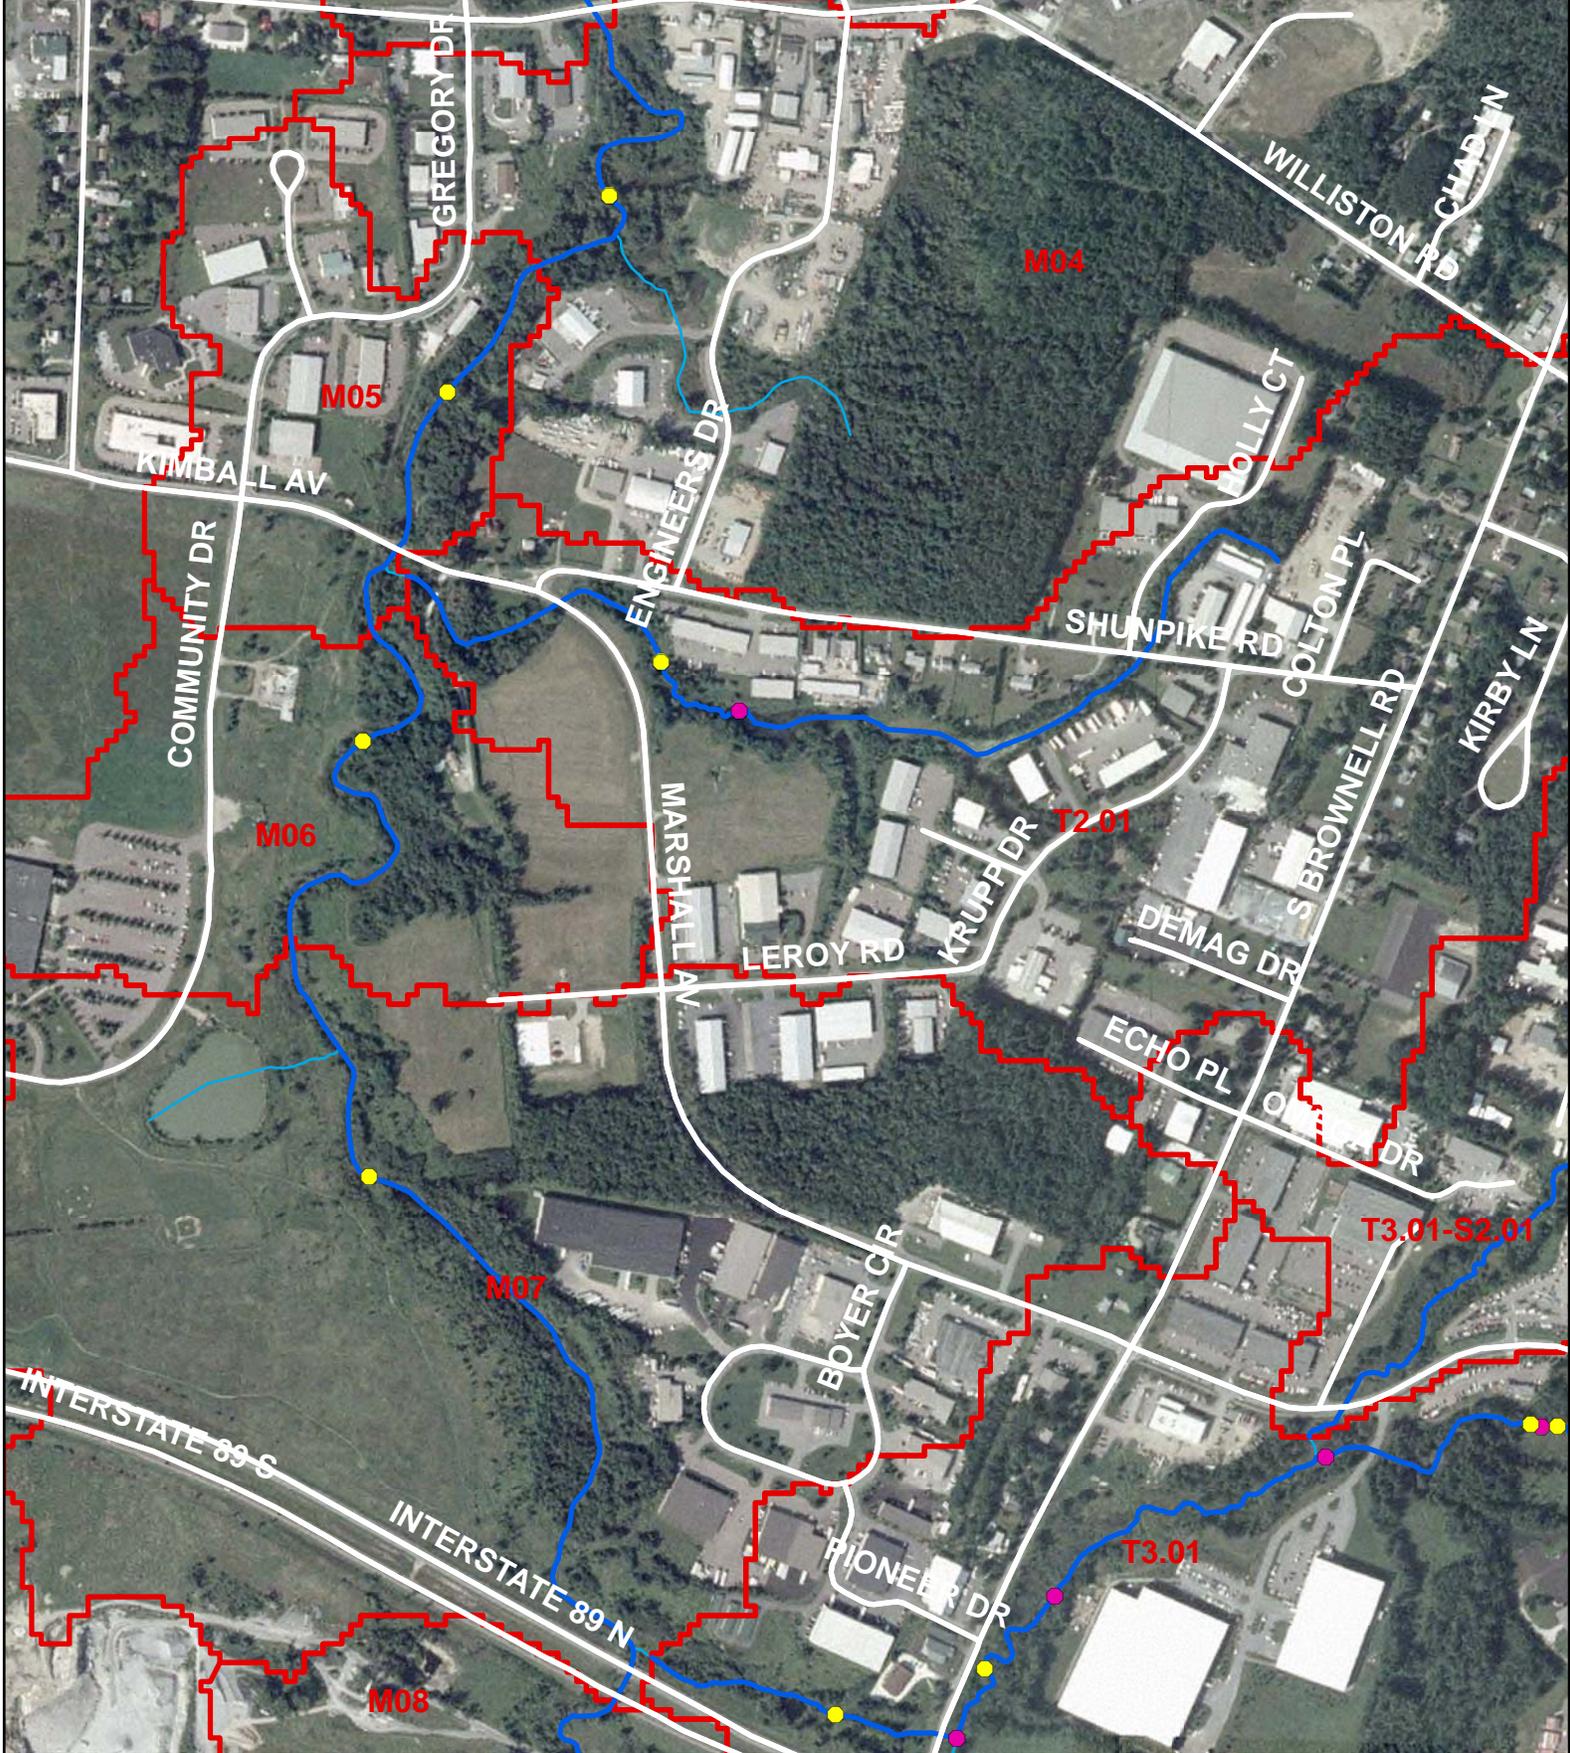
**Muddy Brook Phase 2 Mapping
Reaches M04, M05, M06,
M07 & T2.01**

Cross-Section Locations
-

Segment Breaks
-

Subwatershed Boundaries
-

Muddy Bk Surface Waters
-

Minor Tributaries

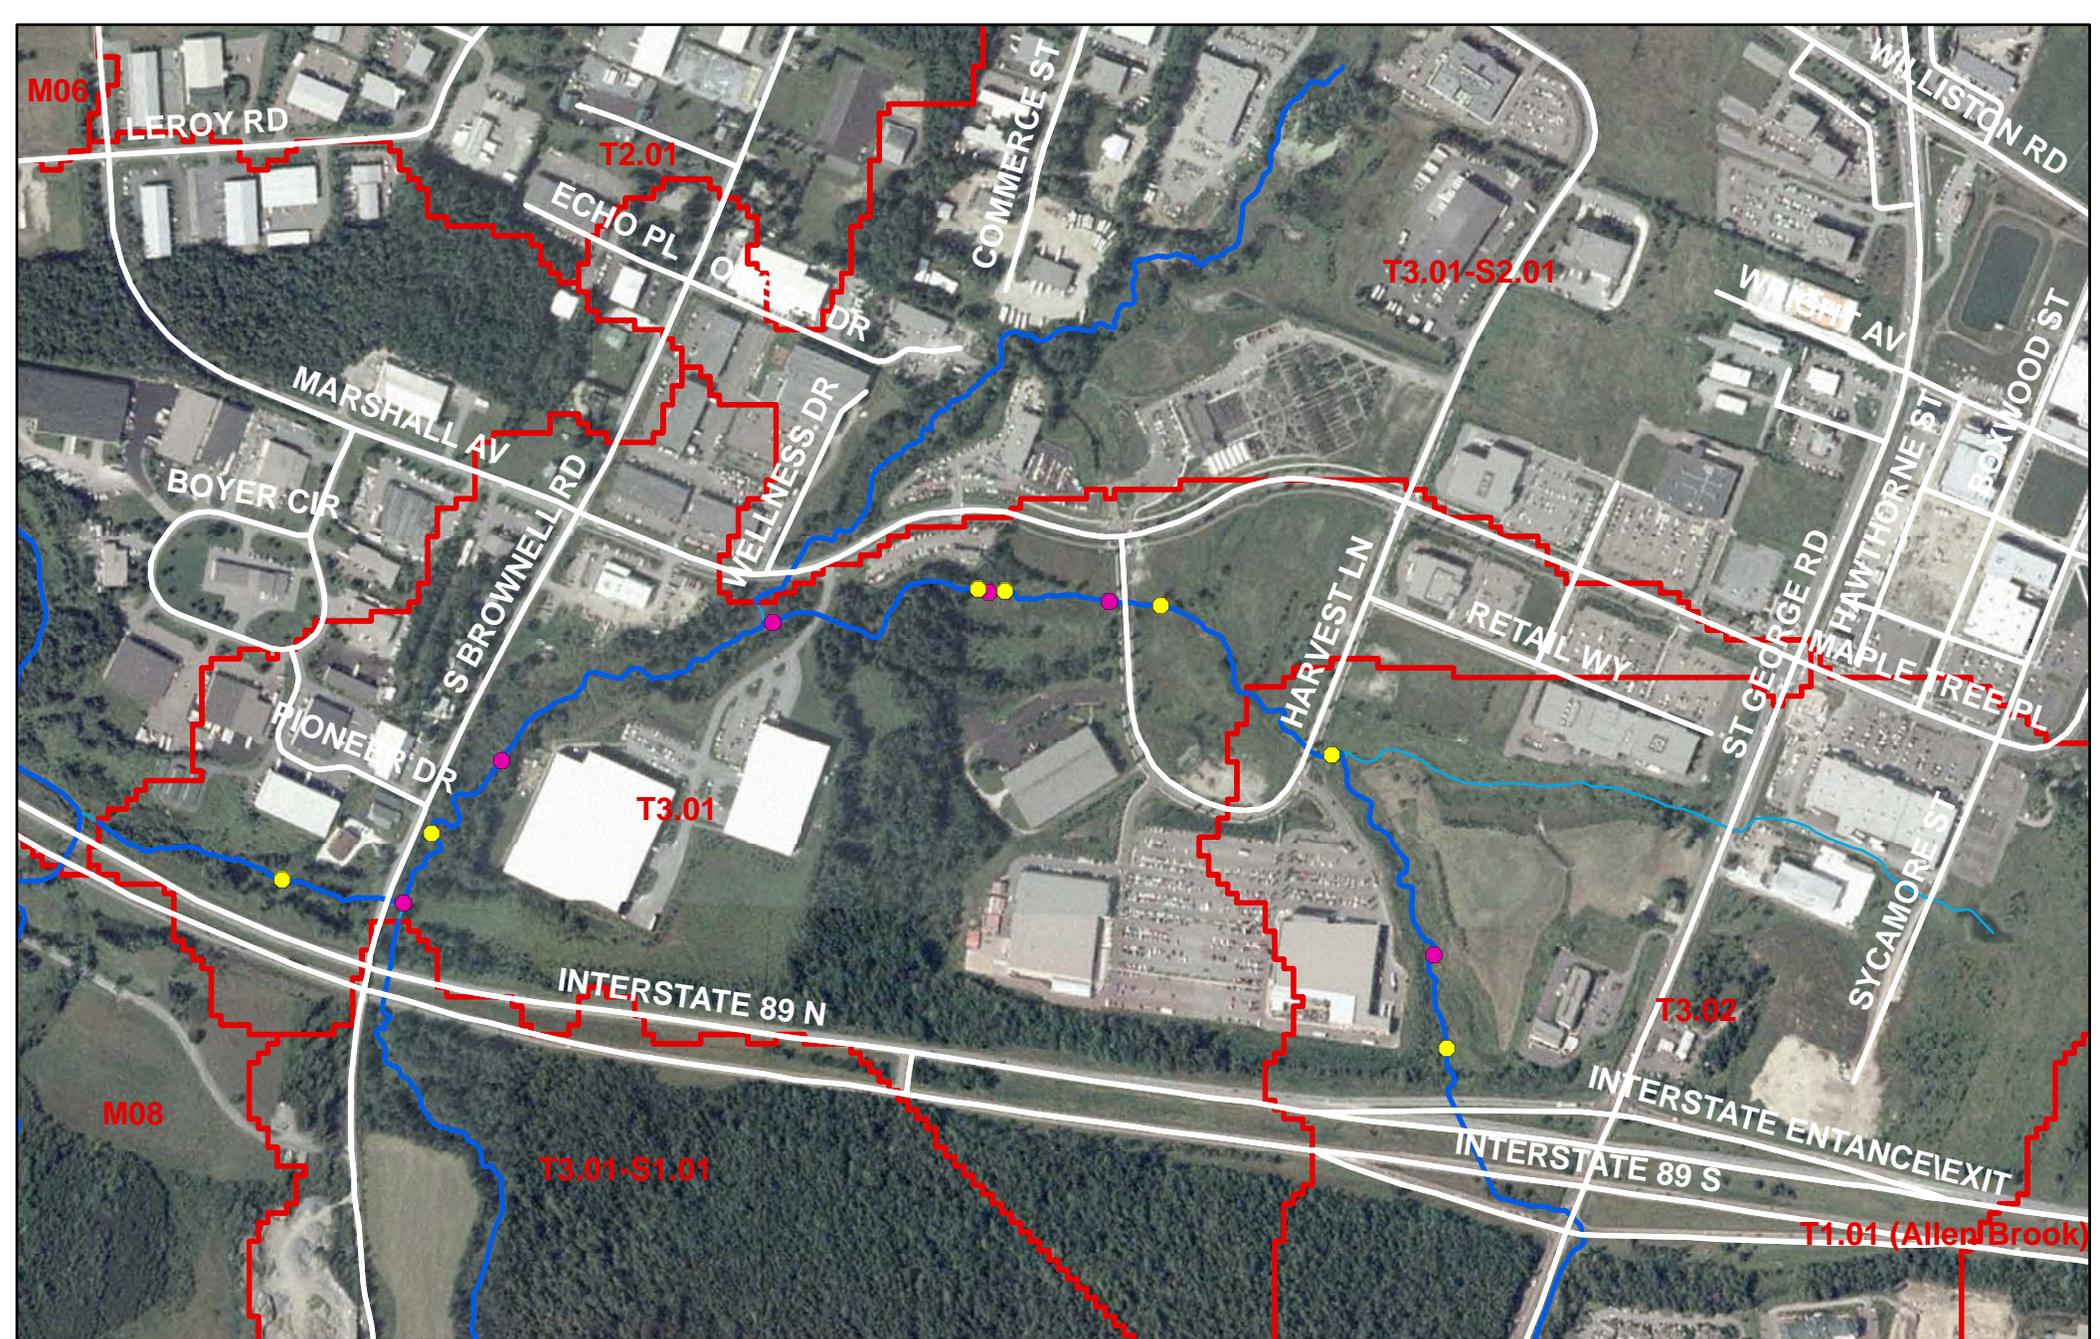
Muddy Brook Phase 2 Mapping
Reaches T3.01, T3.02,
T3.01-S1.01 & T3.01-S2.01

- Cross-Section Locations
- Segment Breaks
- ⬮ Subwatershed Boundaries
- ~ Muddy Bk Surface Waters
- ~ Minor Tributaries
